ACCIDENT INVESTIGATION COORDINATING COMMITTEE

AIRCRAFT ACCIDENT REPORT 2020/01

**FINAL REPORT ON INVESTIGATION OF THE
ACCIDENT INVOLVING VIKING AIR
DHC-6-300, 8Q-MBC AIRCRAFT
AT KUREDHU WATER AERODROME,
MALDIVES**

on 24 February 2020

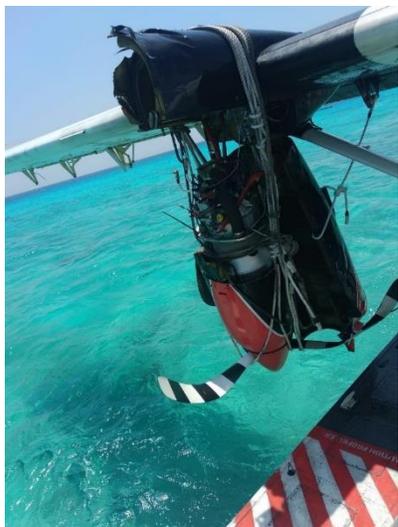
3. Right Hand engine:
 - a. Right Hand engine found fully detached from the mount/nacelle, hanging only by the fuel hoses and fuel control rods connected to it

Figure 1: Aircraft engine detached

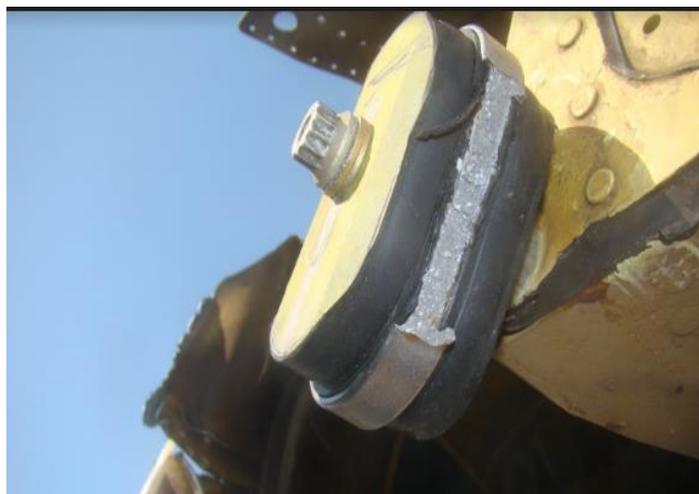
- b. One of the vibration isolators (inboard) found sheared off
 - c. Nacelle structure to which the vibration isolators (outboard and top) were ripped off

Figure 2: RH engine inboard vibration isolator mount

Examination of the RH propeller indicated that the blades were at a low pitch angle at the time of impact. It was revealed that right engine inboard mount was fractured while the outboard and top engine mounts were left intact but had torn out with the nacelle structure.

Review of the records confirm that all AMP requirements have been met on the engine vibration isolator mounts installed, and none of the three had reached the discard life. Hence, it may not be a contributing factor for premature failure of the inboard mount.

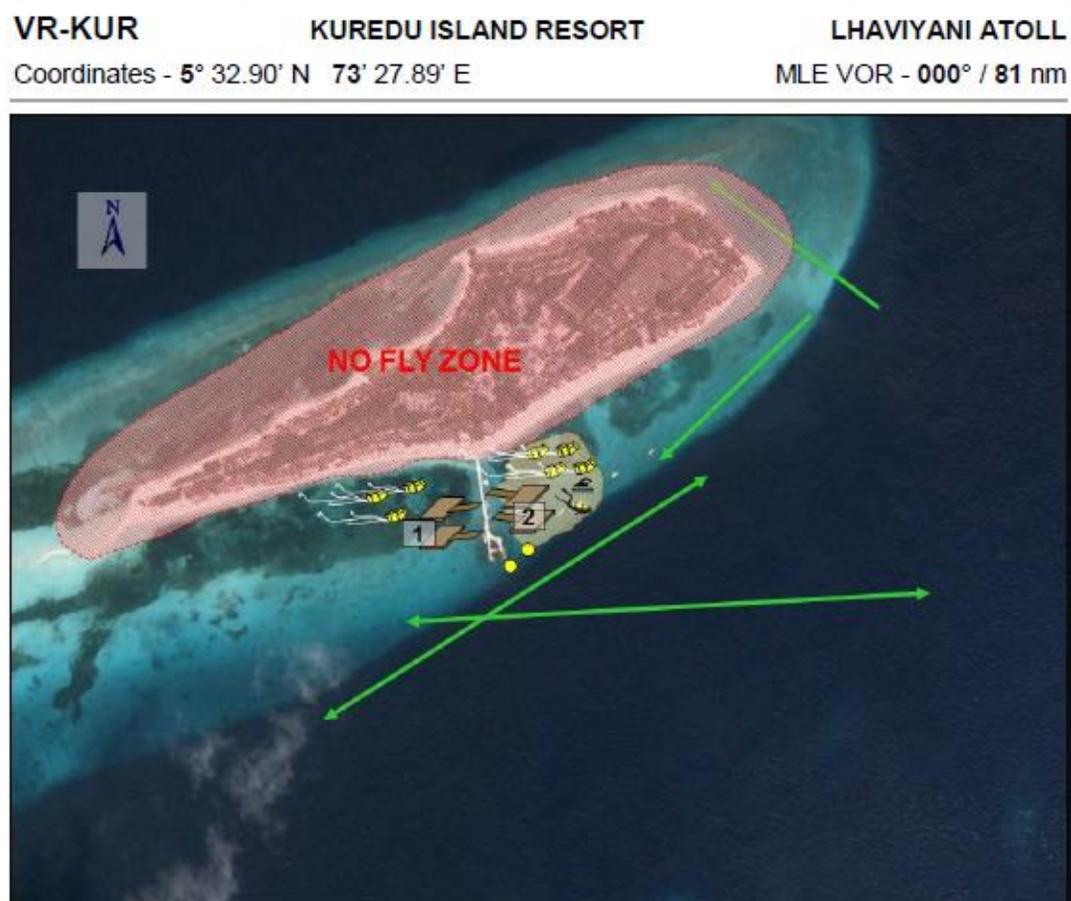
Figure 3: Kuredhu water aerodrome landing areas

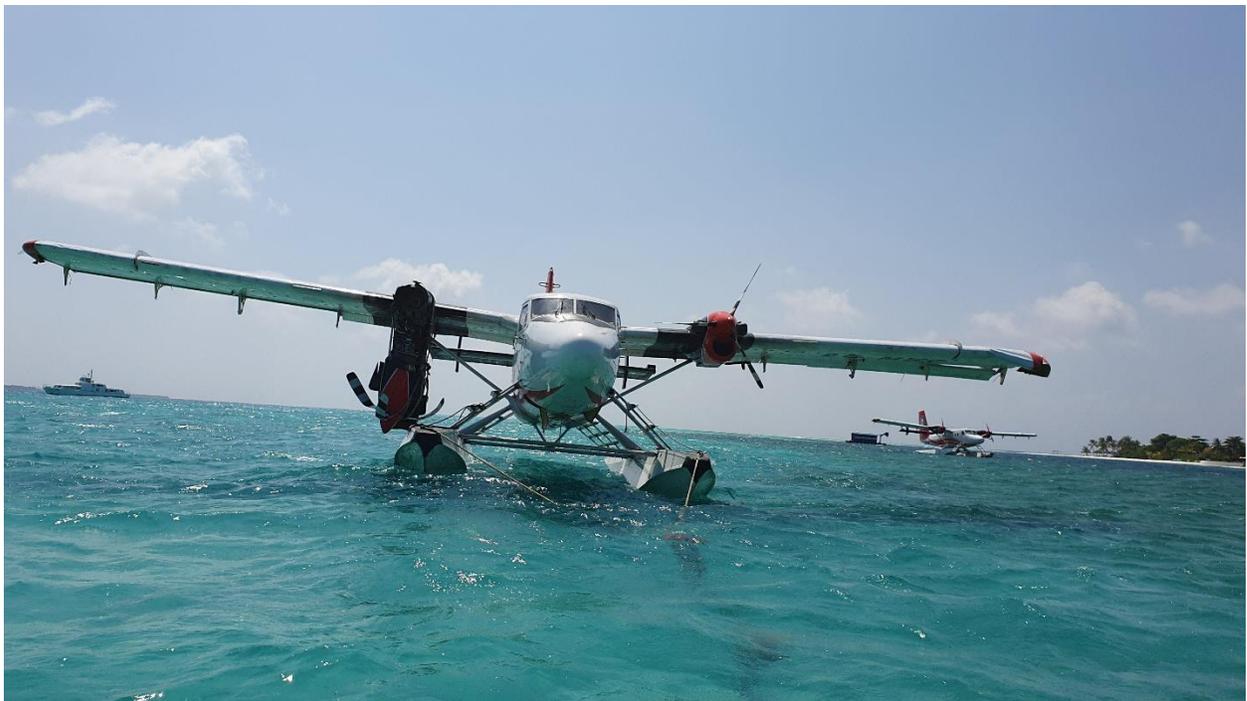
Survey of the aircraft carried out by PIC, post-accident confirmed both wingtips, flaps and ailerons were damaged. Right engine was detached while hydraulic power pack access door was ripped open. No damage to floats was evident.

Figure 4: Aircraft tied to buoy after the accident

PIC was able to put the rudder lock but could not install those for the control column as it was stuck, fully turned to the right.

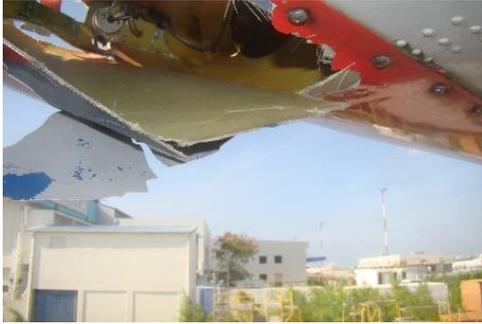
1. Right Hand Wing:
 - a. Various damages were observed on wing in the area between ribs 25 to rib 28
 - b. The leading edge bottom skin of ribs 26, 27 and 28 found buckled upwards

Figure 5: Damage to LH Wing - from rib 25 to rib 28, and wing tip were damaged

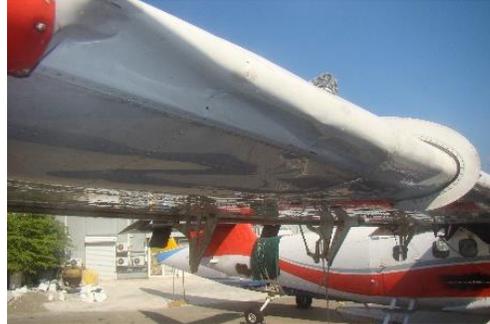
Figure 6: Damage to LH wing - leading edges of rib 26, 27 and 28 buckled

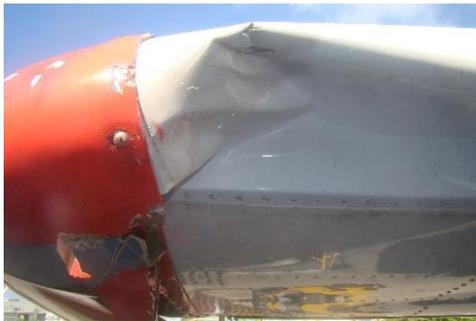
Figure 7: Damage to LH wing - dented

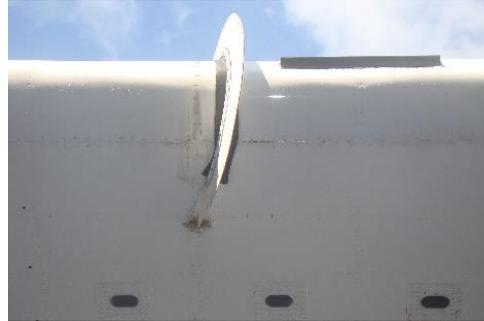
- c. Wing tip torn in several places
 - d. Wing fin dislocated with the leading edge shifted inboard
 - e. The inboard trailing flap skin were found buckled upward

Figure 8: Wing fin dislocated and the leading edges bent inboard

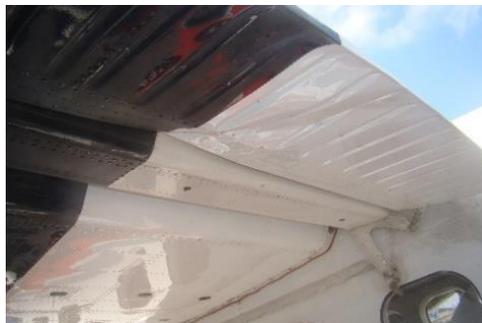
Figure 9: RH Wing - trailing flap skin buckled inward

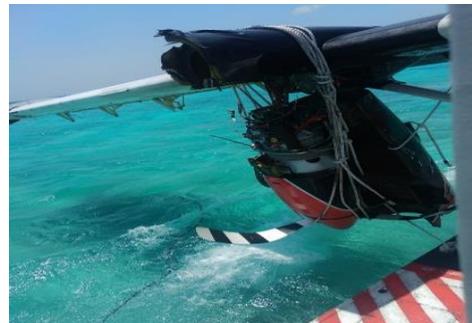
Figure 10: Right Hand engine - completely detached from the mount/nacelle

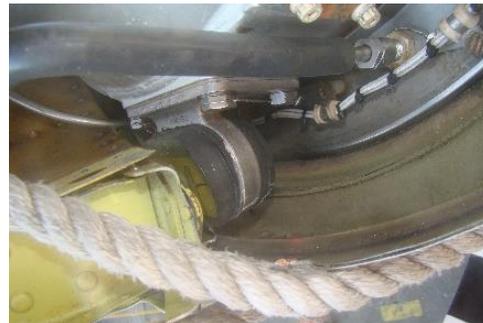
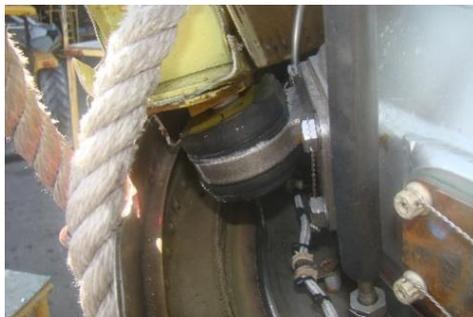
Figure 14: Right Hand engine – both the outboard and top engine vibration isolator (mounts) attaching structures ripped off

Figure 15: Right Hand engine – both the outboard and top engine vibration isolator (mounts) attaching structures ripped off

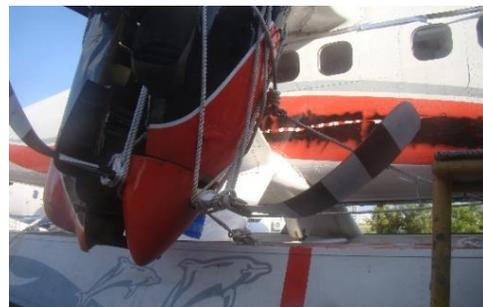
- d. RH engine propeller blades (all three of them) were found bent aft. Red paint scratch marks found on one of the blades
 - e. Nicks observed on all three blades

Figure 16: RH propeller blades bent (backward)

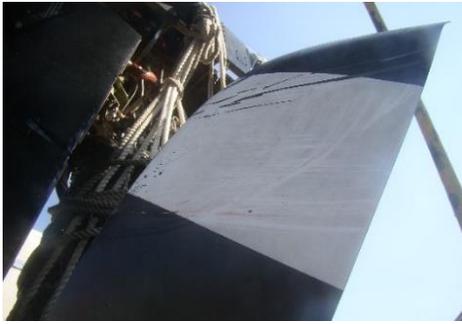
Figure 17: RH propeller blade - red paint scratch marks found possibly due to hitting the engine bottom cowl

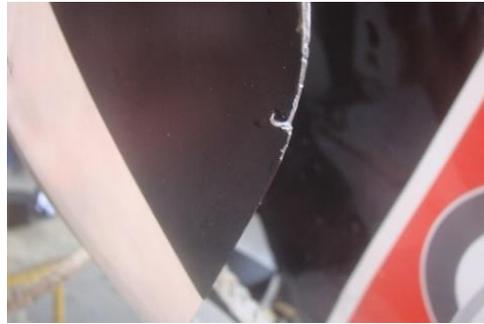
Figure 18: RH propeller – nicks observed on all three blades

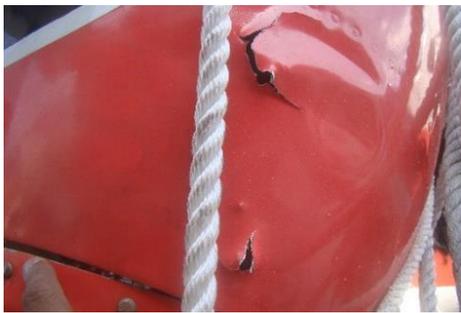
- f. Bottom engine cowling skin ruptured at several places, and attachment rivets were found sheared off
4. Floats:
 - a. LH float tip was found damaged

Figure 19: RH engine bottom cowl - skin ruptured at several places

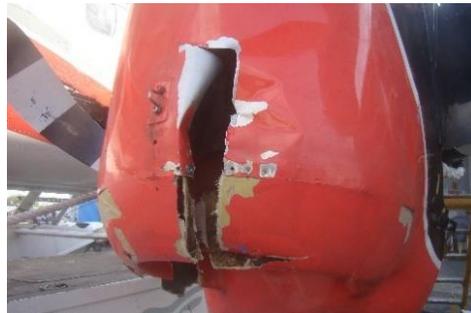
Figure 20: RH engine bottom cowl – prop blade struck through

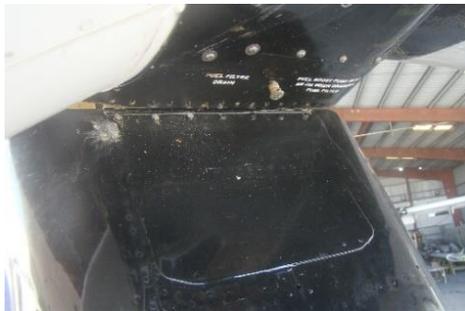
Figure 21: RH engine bottom cowl - attachment rivets were found sheared

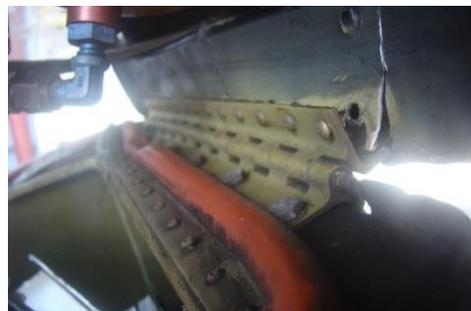
Figure 22: RH cowling – Rivets sheared

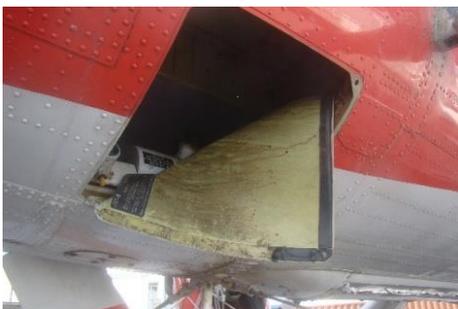
5. Airframe:
 - a. LH Hydraulic bay panel was found twisted and forward top corner bent outwards
 - b. RH hydraulic bay panel was found twisted and bent outward from bottom aft corner

Figure 23: LH Hydraulic bay panel found twisted and bent

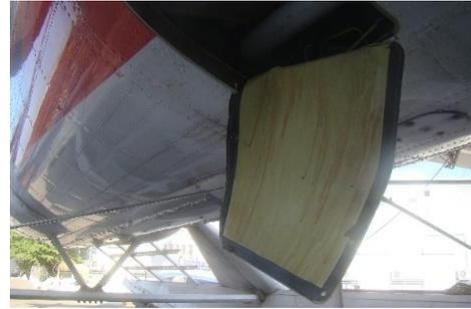
Figure 24: RH hydraulic bay panel found twisted and bent outward

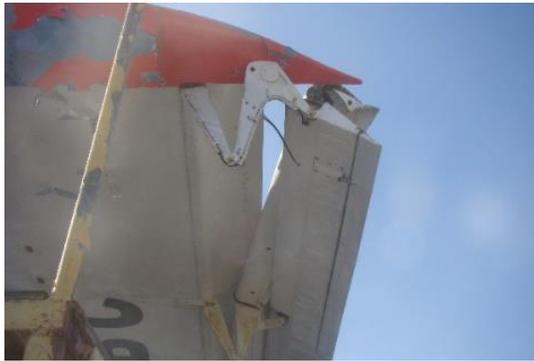
2. Left Hand Wing:
 - a. Wing tip found damaged
 - b. Wing tip Leading Edge (LE) buckled and bent downwards and aft
 - c. LH aileron (outer most) found twisted and bent upward

Figure 25: LH aileron (outer most) was twisted and bent upward
