## **Accident Investigation Coordinating Committee**

### **Report 2018/01**

Preliminary Report on the Serious Incident to  
Airbus, A330-300 (9M-XXC), A350-900 (A7-ALL)  
Velana International Airport, Maldives  
7 July 2018

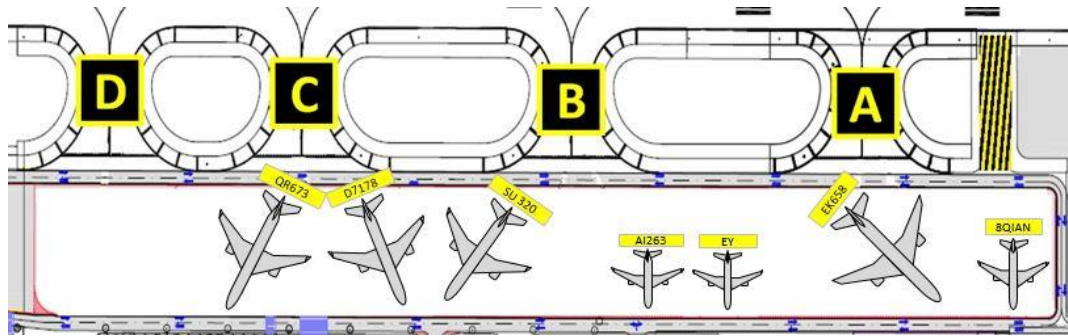
"Plan-4" was generated for the arrival of 9M-XXC (flight number D7178), among other aircraft. In this plan 9M-XXC was to be parked near taxiway C between A7-ALL (flight number QR673) and another A330 (flight number SU 320).

Figure 5 – Parking allocation for 9M-XXC

It is estimated the maximum number of aircraft that could be accommodated, when the clearance distances specified in ASC 139-5 para 3.13.6 (refer section 1.18) are applied, is six aircraft.

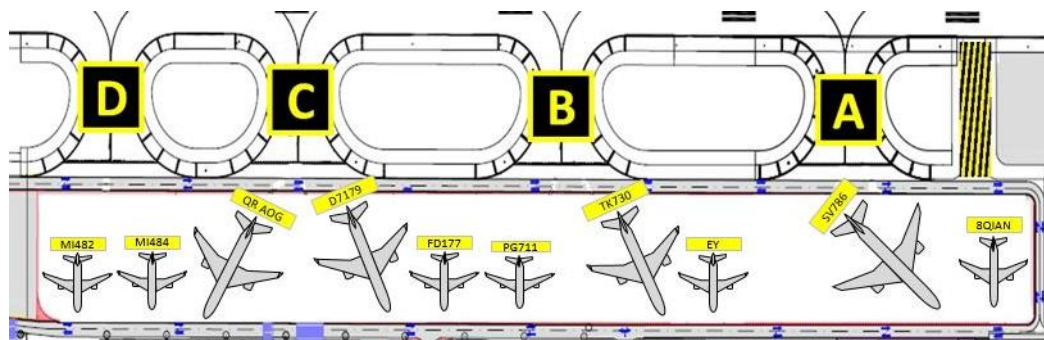
Given the parking bays are not marked, the allocation (i.e. number, type and orientation) of aircraft varies depending on the traffic. For example, the parking allocation with the most number of aircraft, for the day, was "Plan-6". In this arrangement 10 aircraft are parked.

Figure 6 – Parking Allocation with the most aircraft

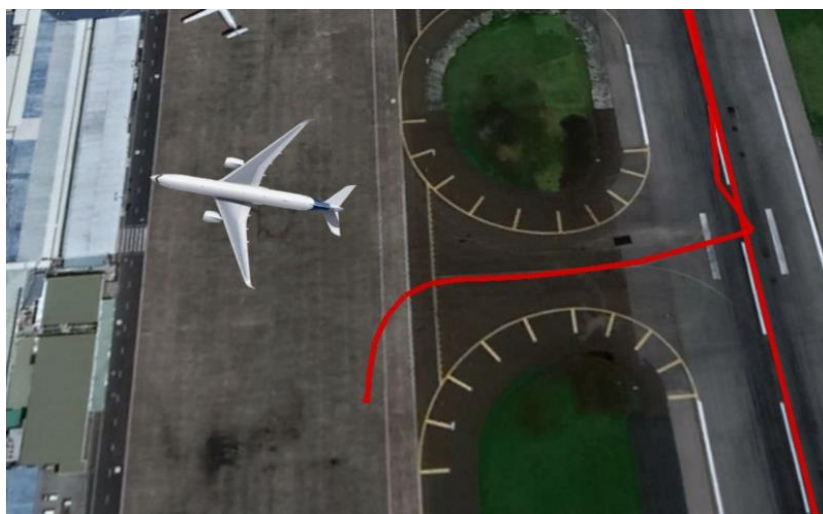
The aircraft 9M-XXC is fitted with an aircraft flight data system that records the GPS position of the aircraft. This data was provided by AirAsia X. The mapping of this data together with the position of A7-ALL (measured on ground) is shown below. Scale drawing of the aircraft are superimposed on this data to reconstruct the movement of 9M-XXC.

Figure 7 – The path (red line) taken 9M-XXC

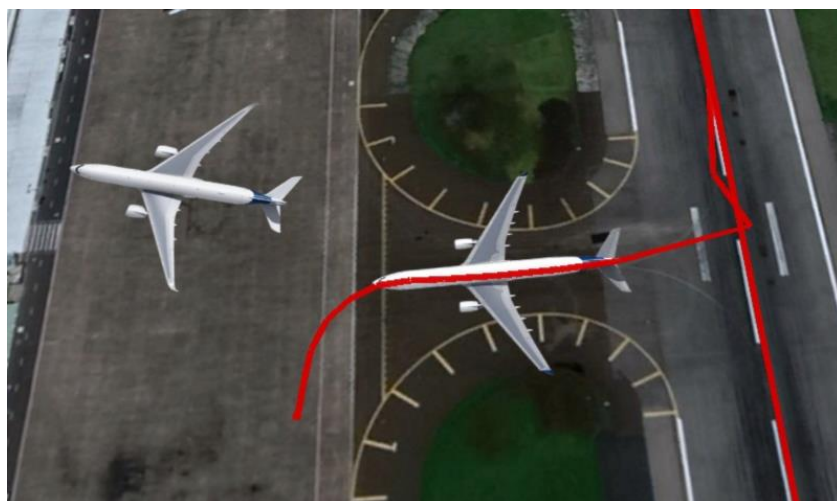
Figure 8 – 9M-XXC at taxiway C

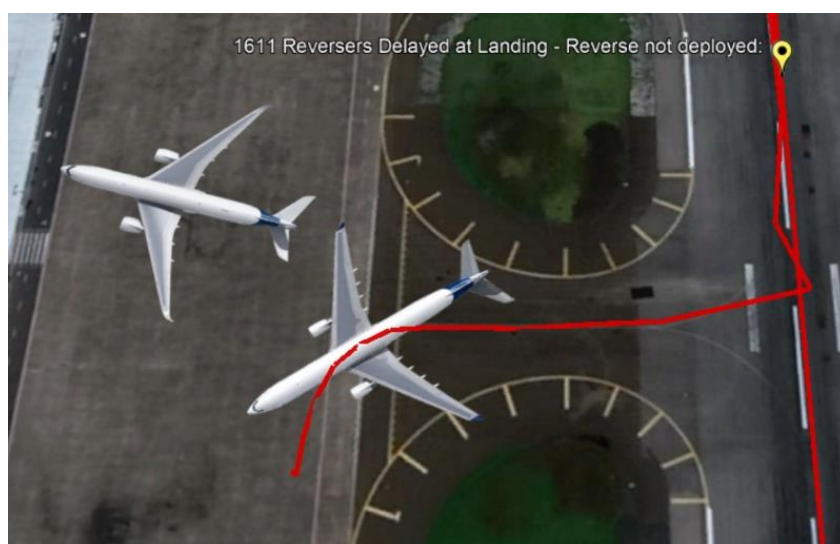
Figure 9 – 9M-XXC making the left turn

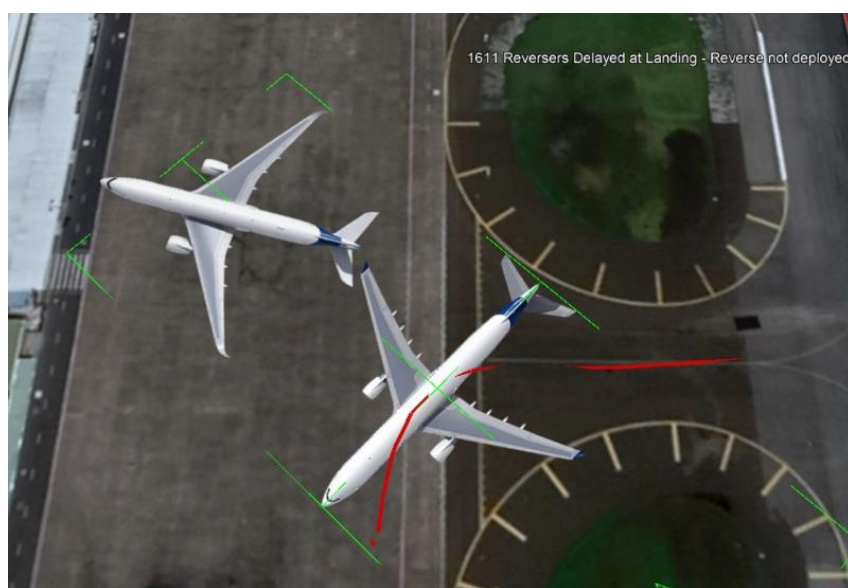
Figure 10 – Position of both aircraft prior to collision

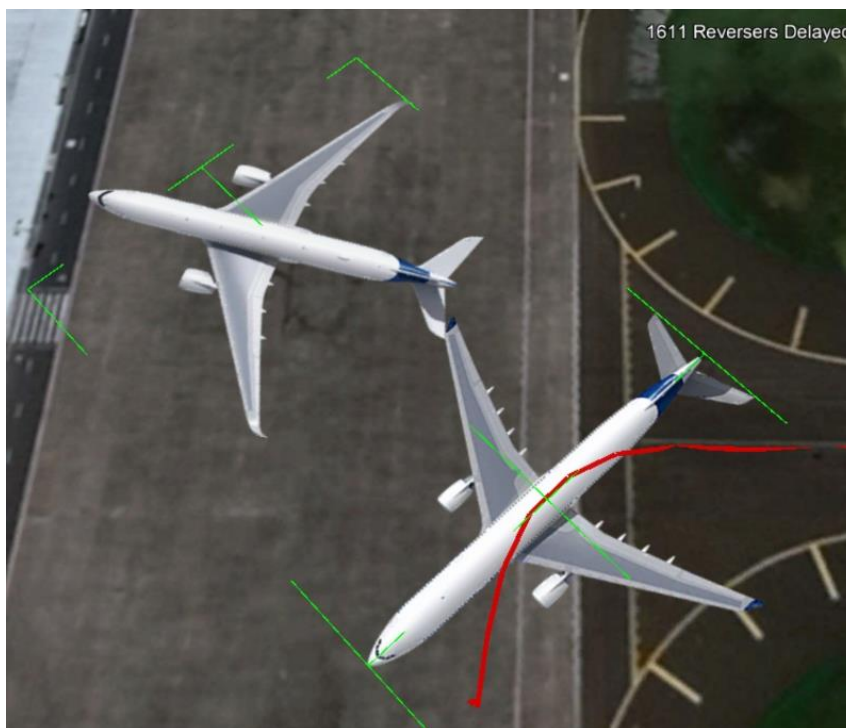
The RH winglet of 9M-XXC sustained a 3 inch dent while the LH stabiliser of A7-ALL was bent at approximately 18 inch from the tip.

Figure 11 – Position of both aircraft at collision.
