**ACCIDENT INVESTIGATION COORDINATING COMMITTEE**

**ACCIDENT REPORT (PRELIMINARY REPORT) ON  
8Q-TMD (TWIN OTTER) CRASH  
At Biyaadhoo Training Lagoon (approximately 15 nautical miles  
south west of the Male' International Airport), Maldives  
On 11<sup>th</sup> July 2011**

**Operator:** Trans Maldivian Airways  
**Manufacturer:** De Havilland (Canadian)  
**Model:** DHC-6-300 (Floatplane – Wipaire 13000)

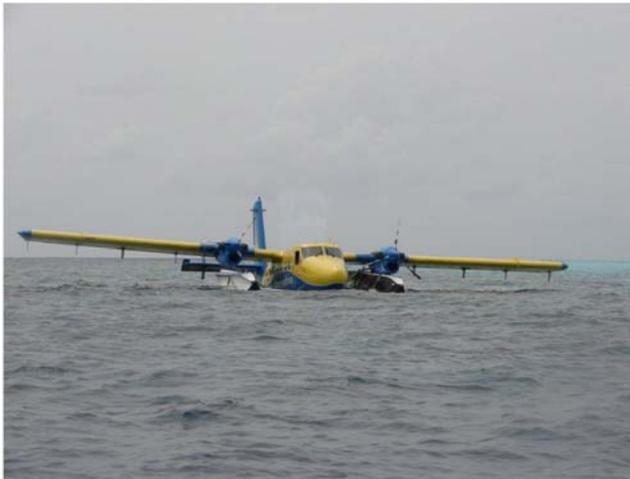
### Appendix 1

As per the crew, the aircraft initial touch down was smooth. However, they stroke a wave which made the aircraft bounce foe about 20 feet. With the low power aircraft hit the water again with great impact, resulting multiple float attachments to break. Both front and main spreader bars broke and floats rose up twisted and hitting the bottom engine cowlings. Propeller cut was found on front of both floats.

Both LH and RH Float was almost detached from the aircraft and twisted with a cut out formed on the forward of the floats by propellers (appendix 1). Both LH and RH wing struts were bent (appendix 2). Blade tips on both propellers were bent and some part torn off (appendix 3). RH forward step and RH rear stem were detached from aircraft and found near the aircraft wreckage.

Both floats almost detached from aircraft and twisted

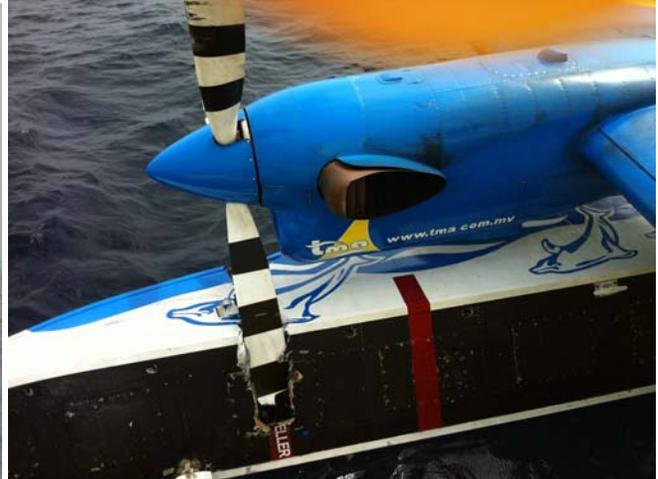
Propeller cut on right float

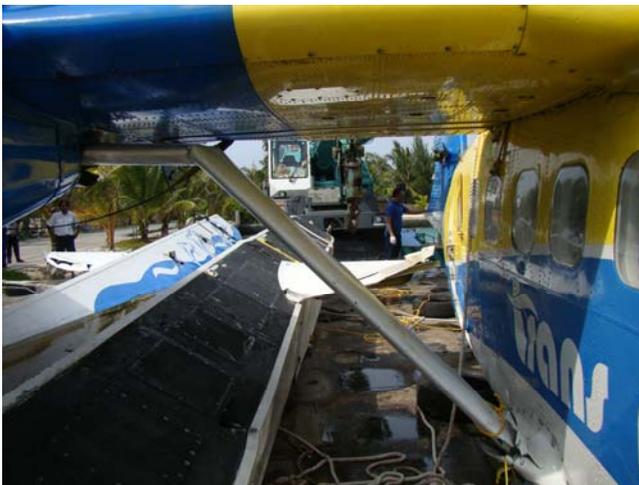
### Appendix 2

RH wing strut damaged

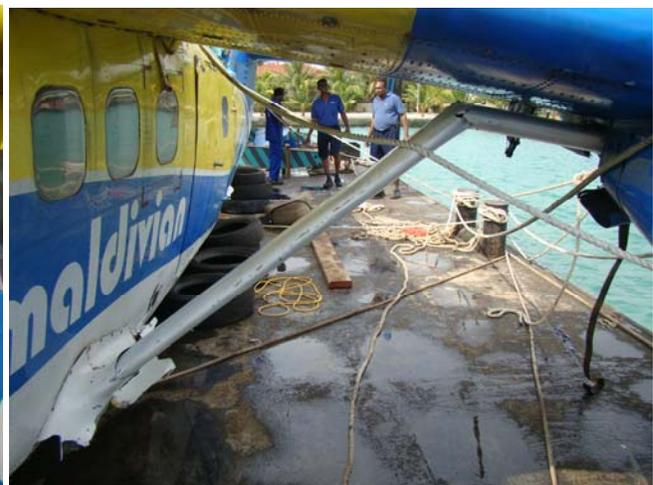
LH wing strut damaged

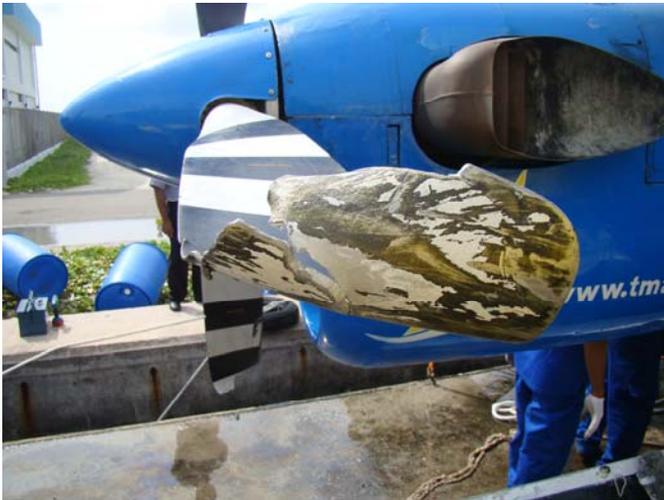
**Appendix 3**

RH Propeller blades bent and some parts worn off

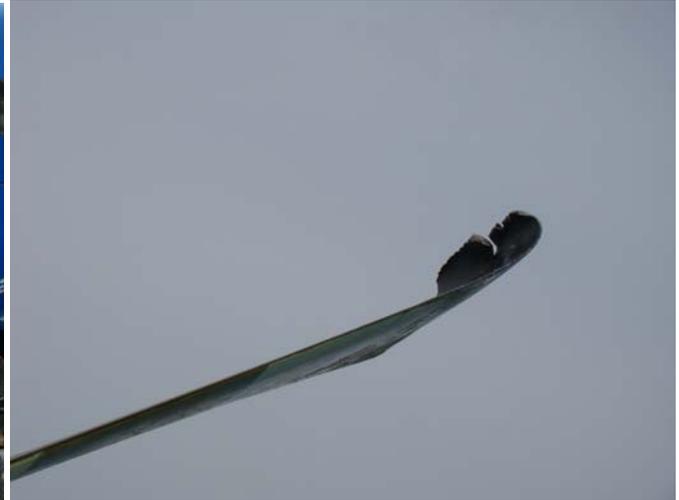
LH propeller blade damage

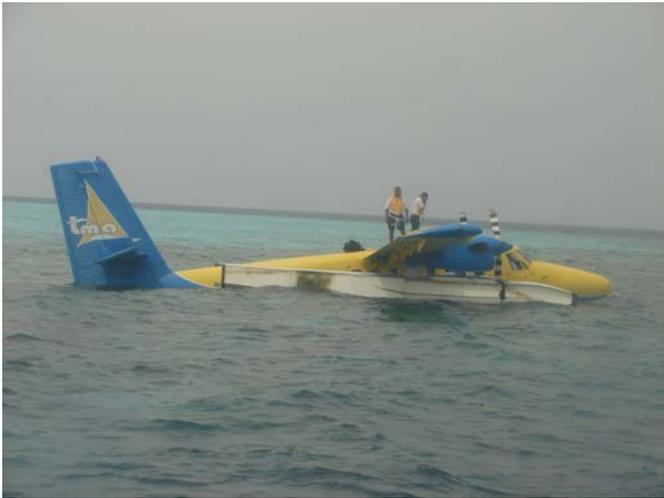
**Appendix 4**

Substantial damaged was done to the aircraft due the fact that it was on the reef half submerged for almost three days (appendix 4). Further damage was caused during the salvage operation (appendix 5)

Aircraft half submerged (on the day of accident)

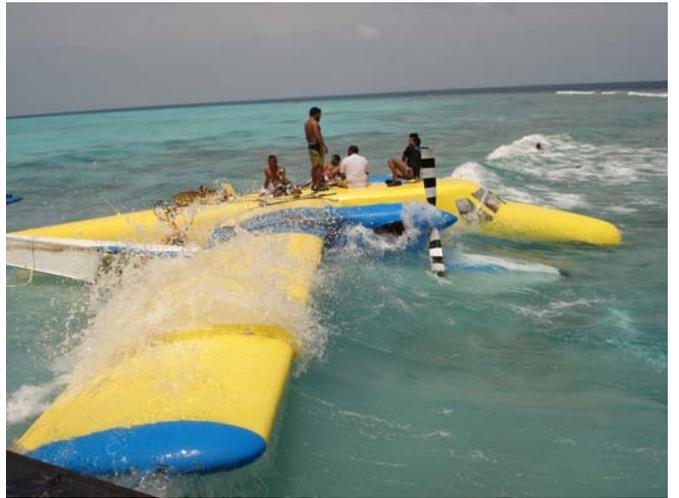
Aircraft half submerged (after 2 days of accident)

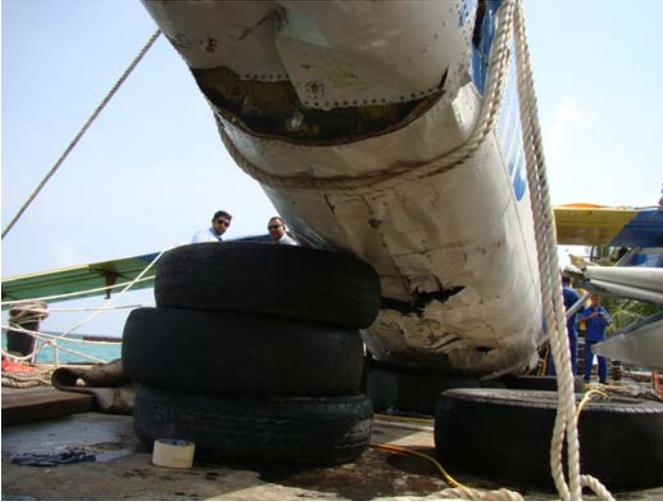
**Appendix 5**

Interviews with the crewmembers were carried out and these were compared with the actual damage to the aircraft. Engineers Damage analysis reports and photographs were analysed to identify the actual damage as there were secondary damage on aircraft due to current, waves and the reef (appendix 5). Also more damage during the salvage operation.

Secondary damage by current, reef and waves

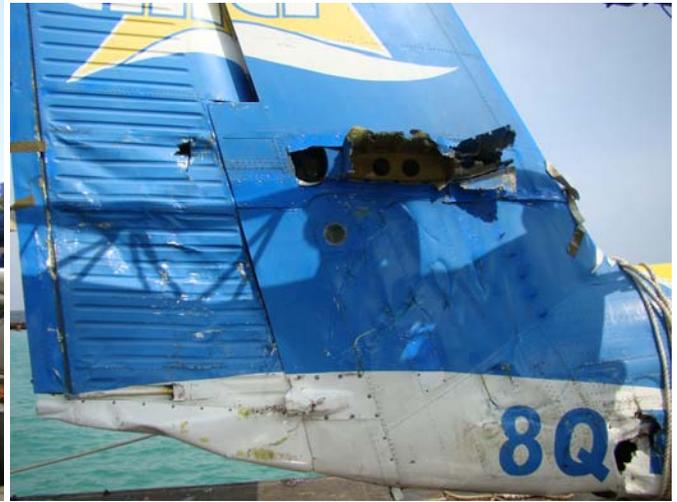
Damage during salvage operation

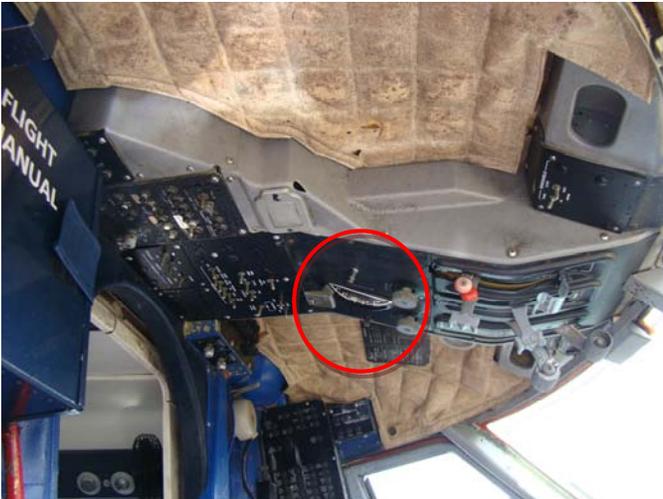
**Appendix 6**

- On the final leg of the training flight, the aircraft landed tail wind, with a simulated single engine, into the channel outside of the reef.
- As per the wreckage pictures, the flap selector were set to zero flaps and the flap angle indicator indicates zero flaps (appendix 6). Some of the external photos taken by crewmembers while the aircraft was drifting also shows the flap was at zero position.
- As per the metallurgy report, no obvious indications of fatigue or other pre-existing crack were visible. These factors are suggestive of an overload failure indicating that the load experienced during the incident exceeded the strength of the materials. (Appendix 8)

Flap selector shows zero flaps

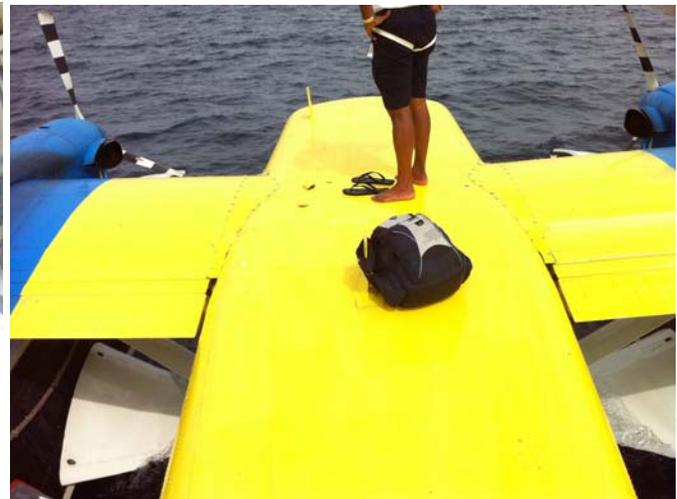
Aircraft Flap position at zero (before the rescue team arrived)
