SAFETY INVESTIGATION REPORT 2024/03

FINAL REPORT

DHC-6-300 AIRCRAFT, REGISTRATION 8Q-TBB

AT BATHALA WATER AERODROME, MALDIVES

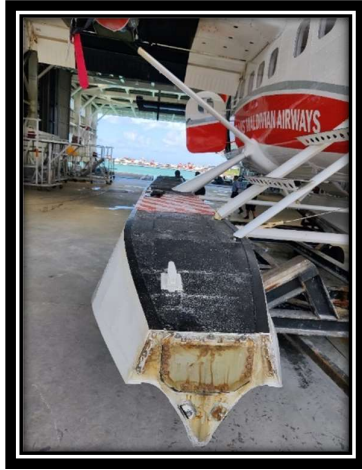
- skin and gunwall buckled between Bulkheads 21 to 24. Main strut (pylon) skin damaged.
2. Front Bumper, RH Cabin and LH Cargo Step: Detached.
 3. Drag Wire and Vertical Strut Eye Bolt: Broken
 4. Fairings: Fwd and center fairing damaged.

Fig 1: RH Float – Nose Bumper detached

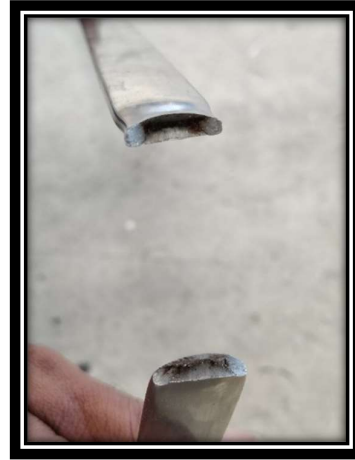
Fig 2: Float assembly flywire – snapped

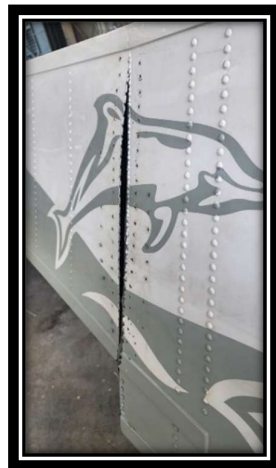
1. Skin, Chine and Gunwall: Outboard skin and chine cracked at Bulkhead 23, and inboard skin and chine buckled between Bulkheads 12 to 14. Top

Fig 5: RH float outboard skin cracked at 7th compartment line

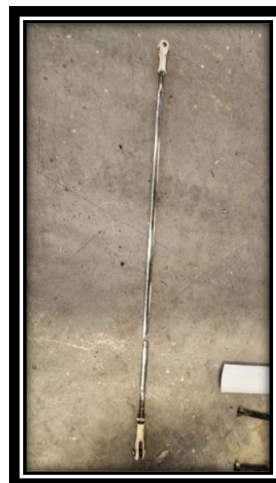
Fig 6: RH Drag wire

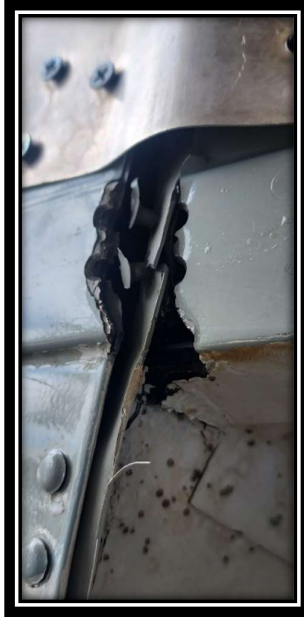
Fig 7: RH float inboard skin - ripped near compartment 6

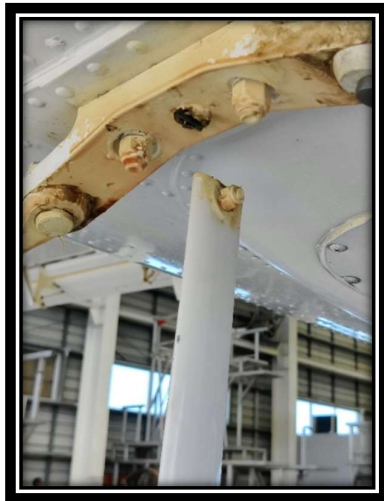
Fig 8: Vertical strut top eye bolt sheared

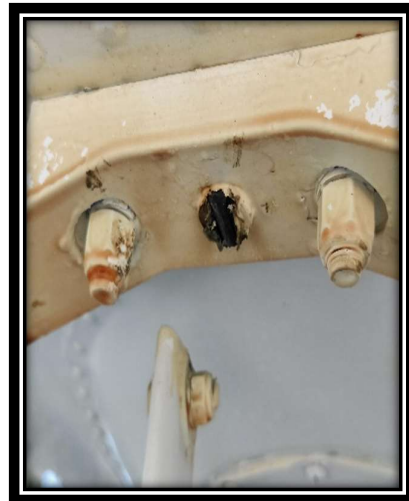
Fig 9: Vertical strut top eye bolt sheared

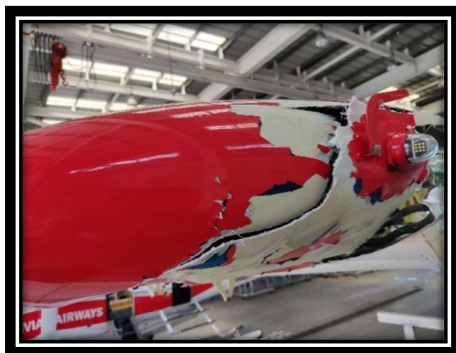
Fig 10: LH wing tip

1. Aileron & Flaps: Aileron assembly and outboard fore flap bent upwards with impact damage between STN 310–376.20.
2. Trailing Edge & Shroud: Trailing edge, shroud top and bottom skins damaged between STN 310–376.20.
3. Wing Structure: Shroud ribs and top skins affected between STN 347.50–376.20, and outboard ribs and bottom skins affected between STN 310–376.20.
4. Hinge & Attachments: Wing hinge at STN 376.20 damaged.
5. Additional Components: Aileron trim tab, wing tip, and outboard rib/skin sections damaged in the STN 310–376.20 area.

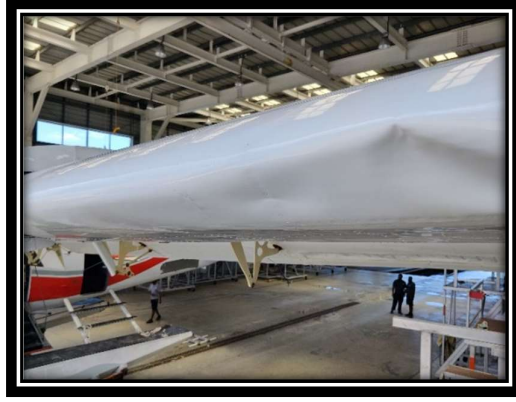
Fig 13: LH Wing Outboard leading edge skin buckled

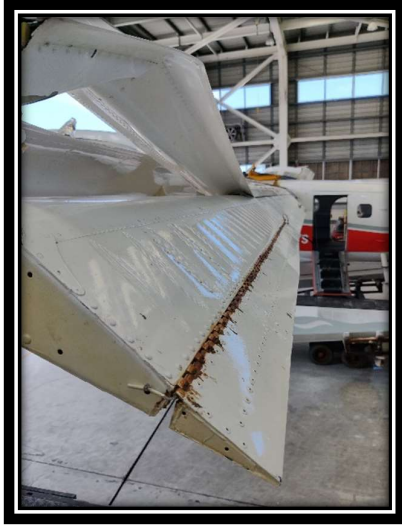
Fig 16: LH Aileron and trim tab – skin buckled

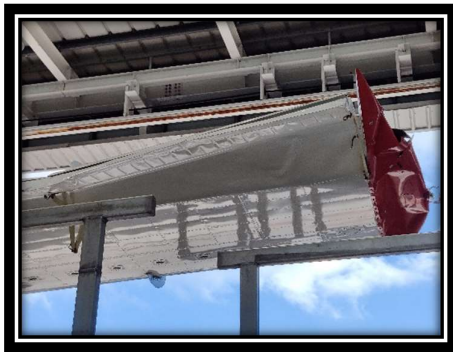
1. Aileron & Flaps: Aileron assembly and outboard fore flap bent upwards between STN 310–376.20.
2. Trailing Edge & Shroud: Trailing edge, shroud top and bottom skins damaged between STN 310–376.20.
3. Wing Structure: Shroud ribs and top skins affected between STN 347.50–376.20, and outboard ribs and bottom skins affected between STN 310–376.20.
4. Hinge & Attachments: Wing hinge at STN 376.20 damaged.
5. Additional Components: Aileron trim tab, wing tip, and outboard rib/skin sections damaged in the STN 310–376.20 area.
6. Inner Flap: Inboard trailing flap bent upwards at STN 72.5.

Fig 18: RH wing Aileron and trim tab – skin buckled RH wing tip

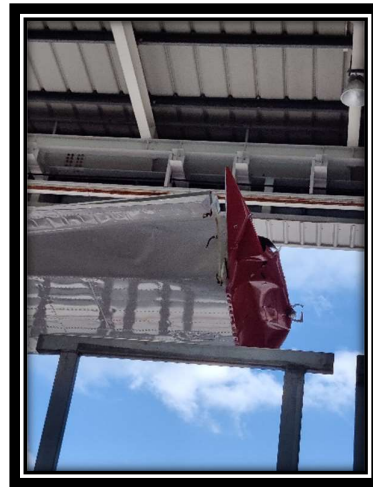
Fig 19: RH Wing tip - buckled
