Aircraft Accident Report 2017/03

Final Report on the Accident to
Viking Air DHC-6-200, 8Q-IAG
Dhoores Floating Platform, Maldives
16 November 2017

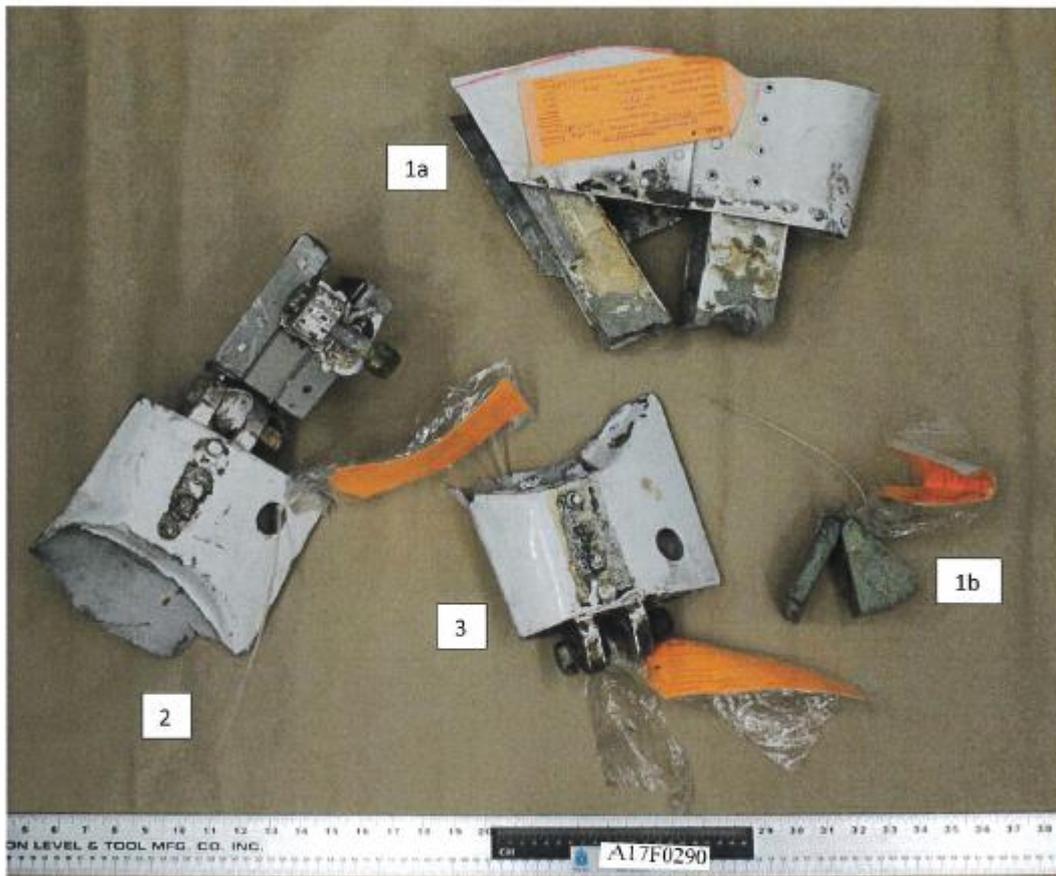
All fracture surfaces were typical for instantaneous overstress fracture. Plastic deformation accompanied the fractures, which is also consistent with an overstress fracture mode.

These components likely failed as a result of an impact during the occurrence.

Figure 1: Aircraft components photographed as received in the TSB laboratory
1a and 1b – portion of left-hand (LH) pylon to fuselage attachment
2 – part of left-hand forward (LH FWD) strut assembly
3 – part of right-hand forward (RH FWD) strut assembly

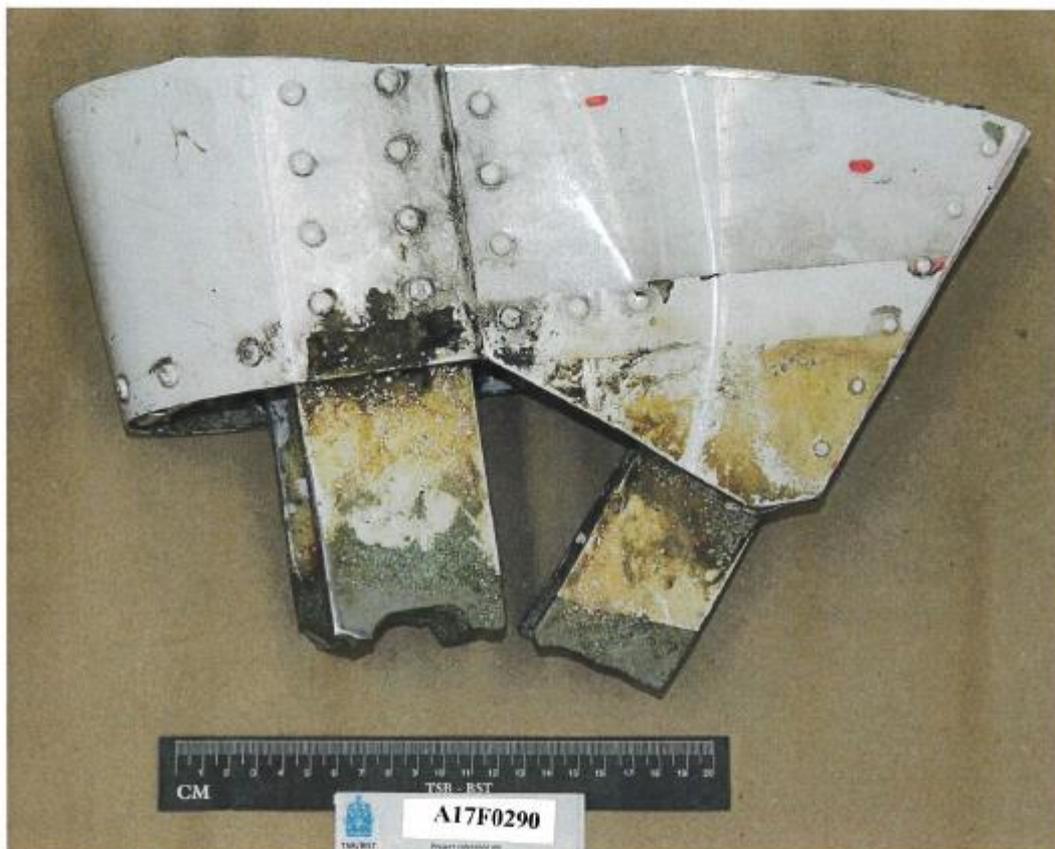
Figure 2: Cut-off piece of LH pylon to fuselage attachment (item 1a in Figure 1) photographed from the other side

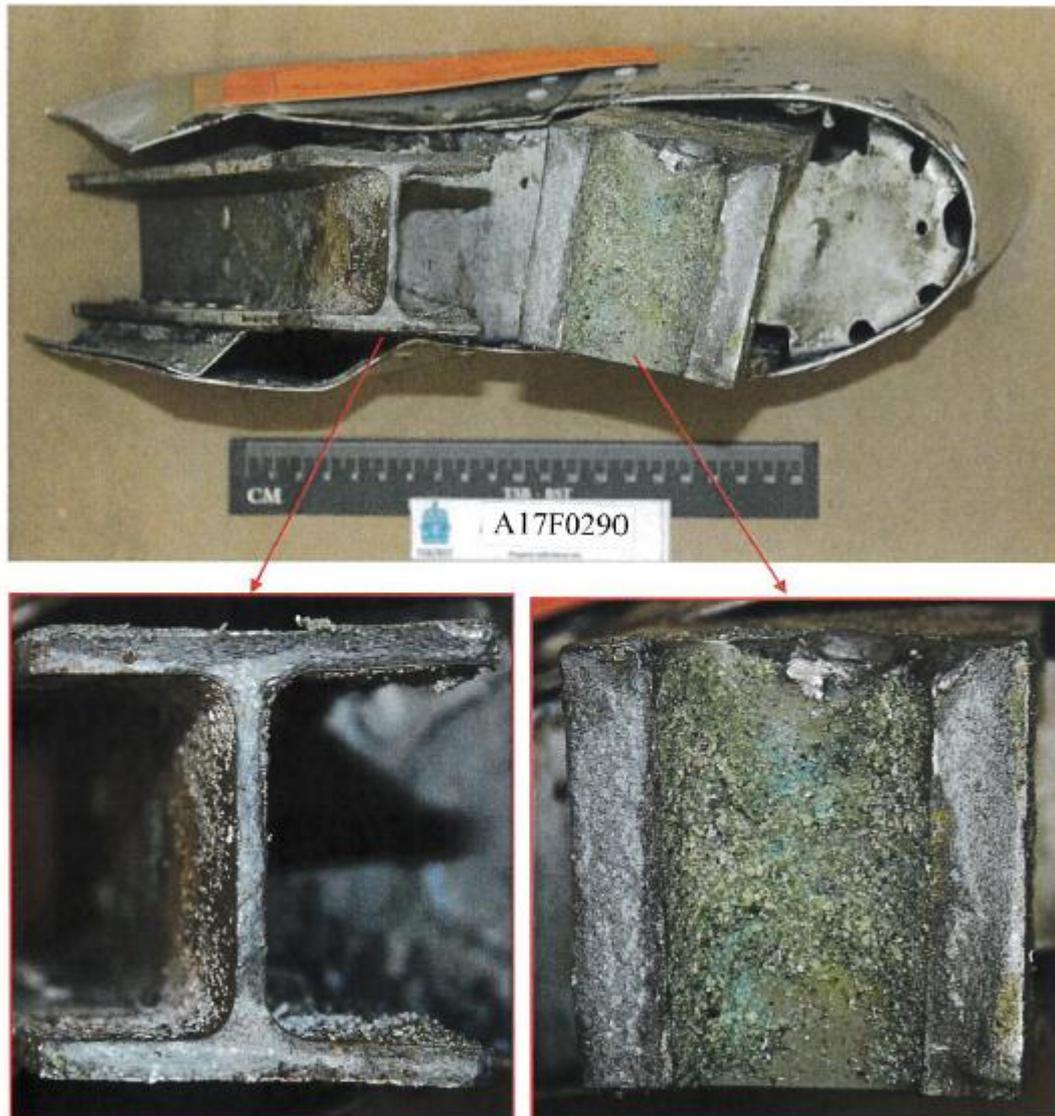
Figure 3: Cut-off piece of LH pylon to fuselage attachment (item 1a in Figure 1) photographed from the fractured side

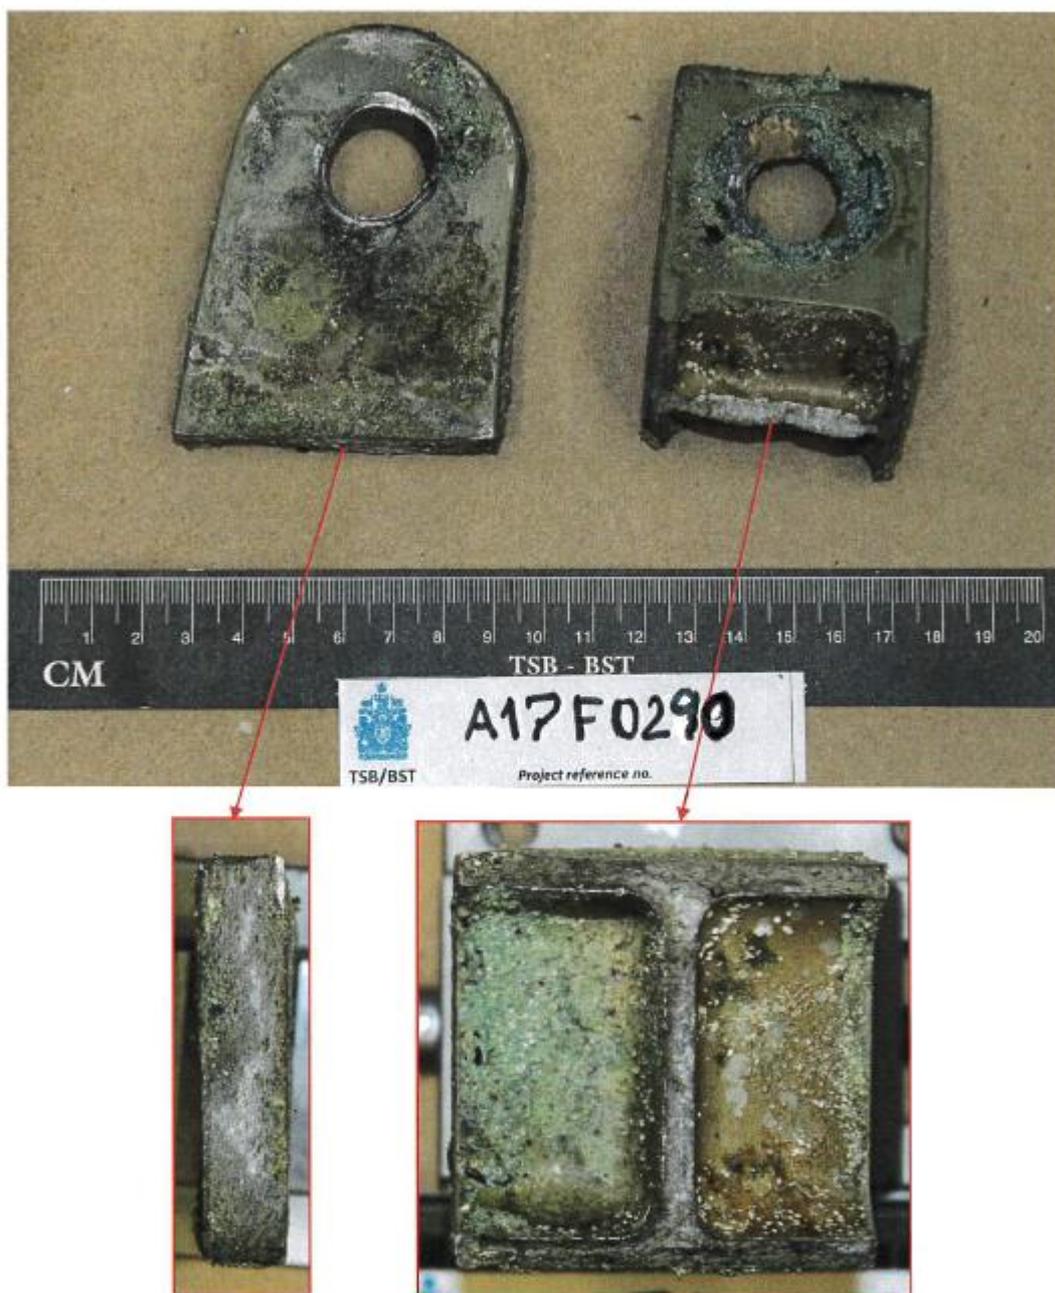
Figure 4: Separated pieces of the LH pylon to fuselage attachment (item 1b in Figure 1)

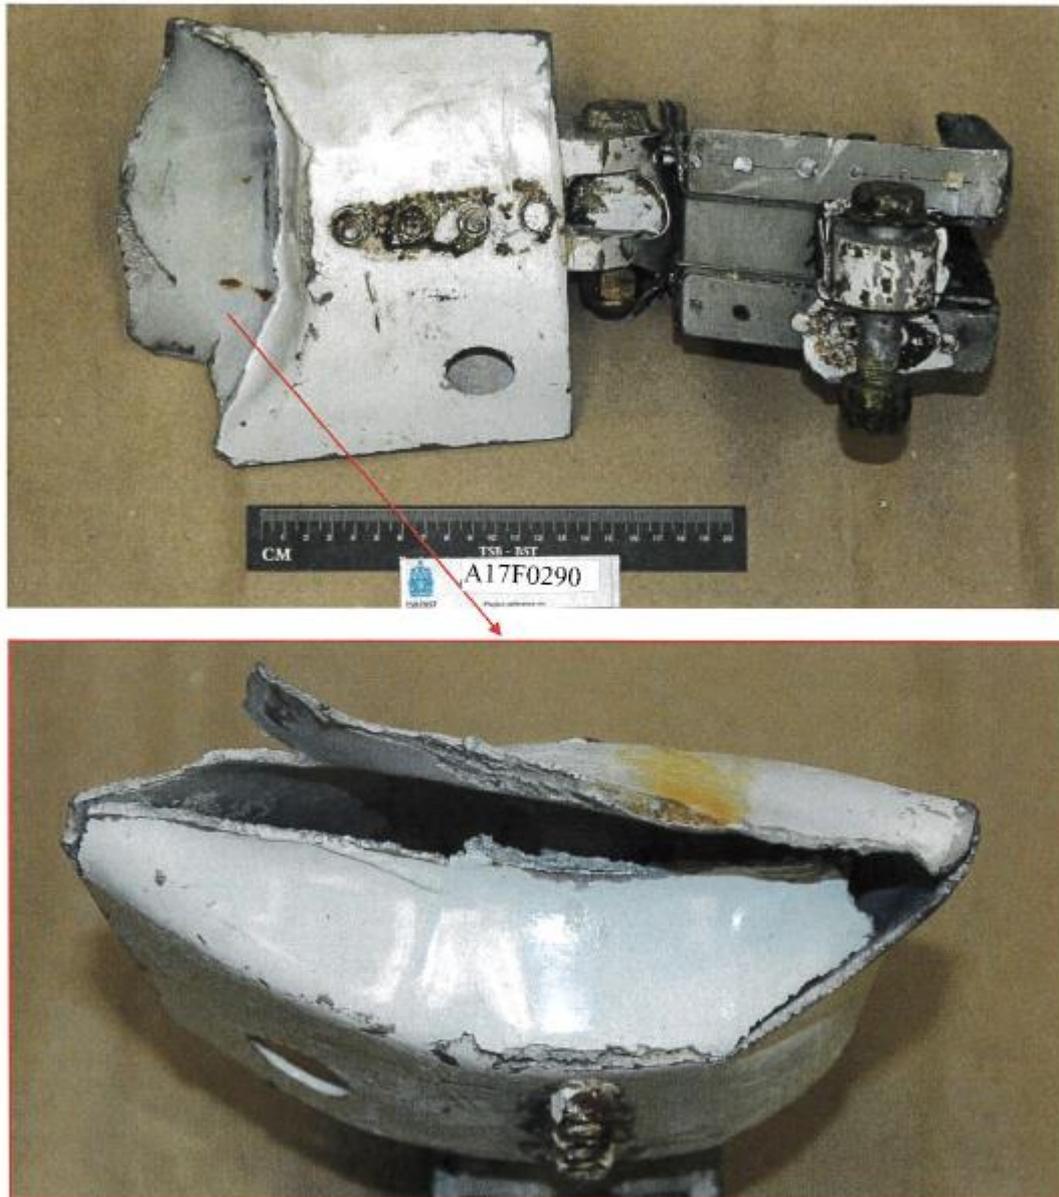
Figure 5: Part of LH FWD strut assembly

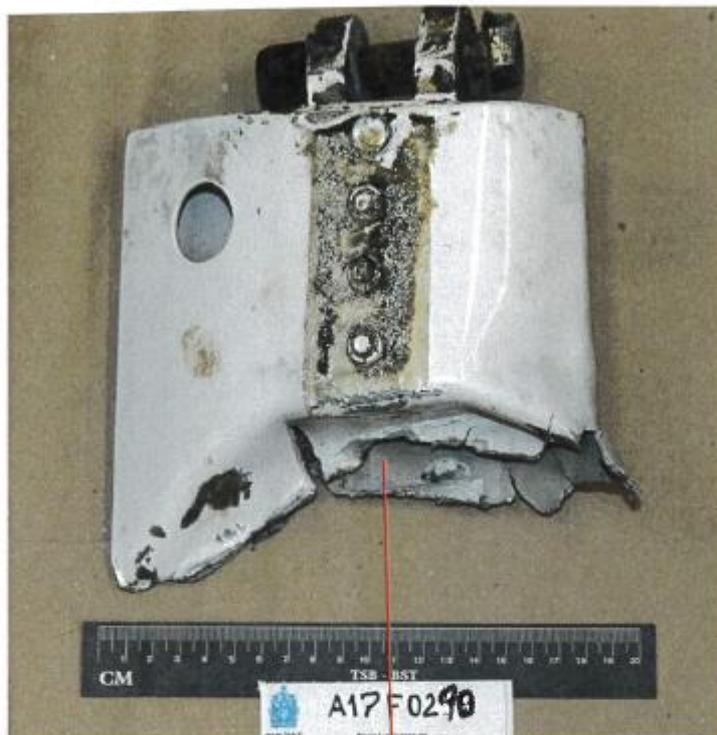
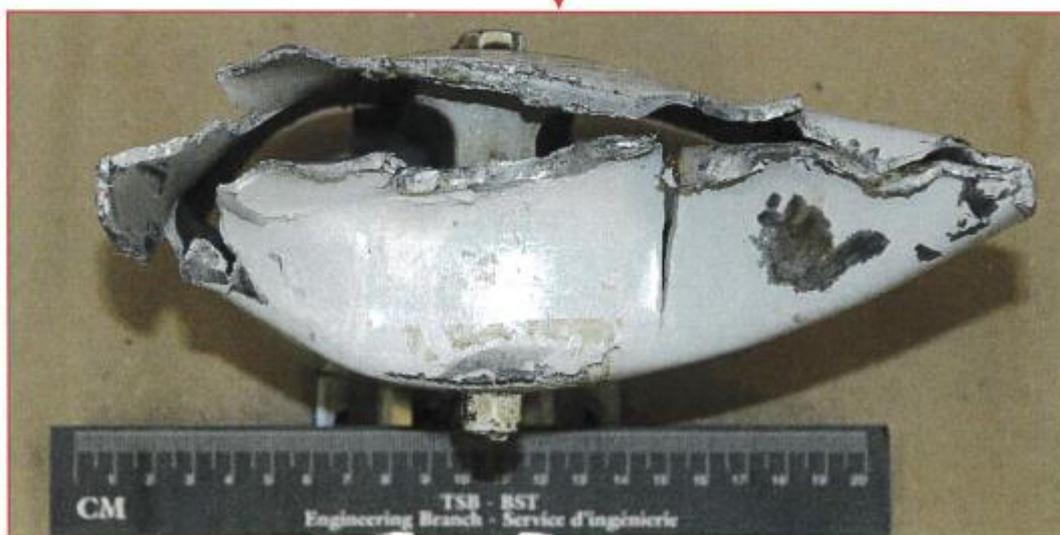
Figure 6: Part of RH FWD strut assembly
