ACCIDENT INVESTIGATION COORDINATING COMMITTEE

**ACCIDENT REPORT ON
8Q-TMT (TWIN OTTER)
That collided with the fixed platform at Condrad (Rangali),
South Ari Atoll
on 9th July 2012**

Operator: Trans Maldivian Airways
Manufacturer: De Havilland (Canadian)
Model: DHC-6-300 (Floatplane)

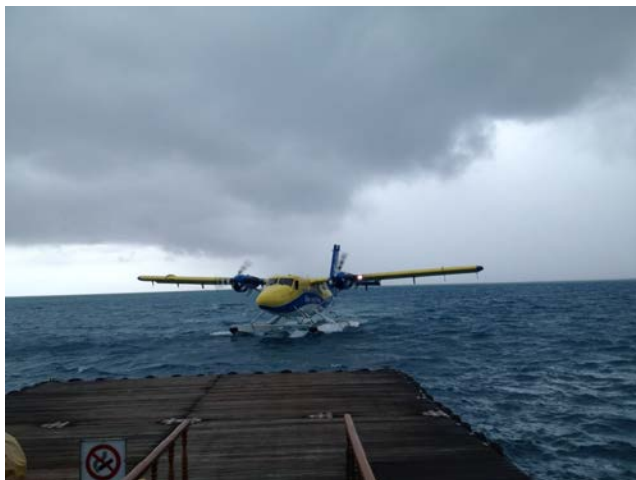
Since it was a fixed platform Crew had difficulty docking the aircraft in strong tailwind and swells. At the first attempt to dock the aircraft ended up forward of the platform which made the crew to abort docking. On the second attempt to dock, captain applied full reverse and right rudder while the co-pilot applied opposite aileron to overcome the strong winds as the aircraft approached the fixed platform. However, the aircraft moved forward and hit the platform hard and the cabin crew, who was at his station on the LH float, was flung in to the water. On impact with the platform the LH float attachments were sheared and the LH propeller blades struck the platform surface while the RH float lifted up and struck the RH propeller. The Captain reported cutting off the fuel at the first impact. The aircraft started turning, pivoting at its nose near the platform then started drifting away due to the strong winds and swells. (See appendix 2)

Image 1- photo taken during 1st attempt to dock

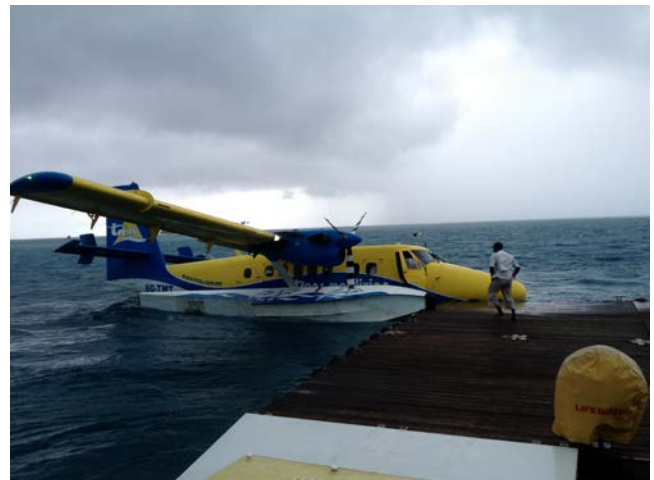
Image 2- Aircraft after the impact

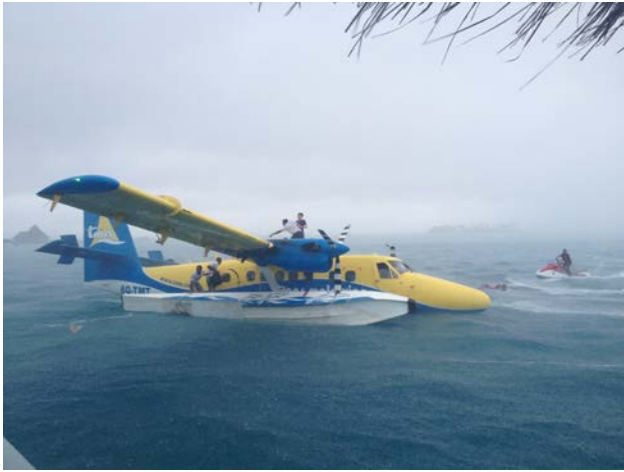
Image 3- Evacuating the passengers.
Photo also shows the weather after impact

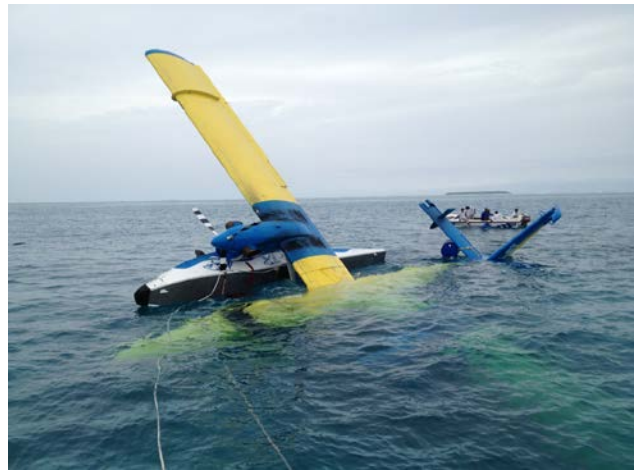
Immediately after the impact water started seeping inside the aircraft. The Captain attempted to secure the aircraft and the copilot was attempting to facilitate evacuation of the passengers. Cabin crew swam to the aircraft and joined the crew in the evacuation process. All the passengers and crew were able to evacuate the aircraft before the fuselage was fully submerged.

Image 4- Aircraft fuselage submerged

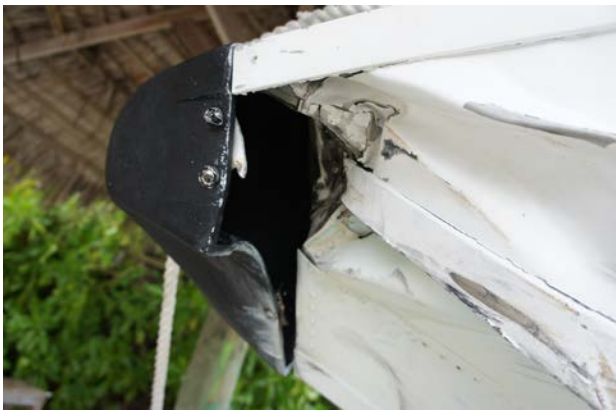
- i. L/H float with the spreader bars, boa tie and one v-strut had been completely detached from the fuselage
- ii. Damage was observed on the L/H float out board side just aft of the forward bumper
- iii. Both props damaged from strike on platform and float L/H and R/H respectively
- iv. L/H wing and L/H engine with the fuselage was submerged for several hours
- v. R/H engine and R/H wing except for wing root area was out of water throughout
- vi. Both wing struts are bent L/H due to the heavy weight of the water filled wing R/H because of R/H float being wedged from one side
- vii. Damage was observed on the fuselage underneath the cockpit.

The physical evidence shows that the aircraft LH float had hit the platform at a high speed. During the impact the lower end of the nose cone was punctured. LH float was completely detached from the aircraft few minutes after the impact. Barrels were tied to the aircraft to make it float and moved the aircraft to staff Accommodation Island in the same lagoon as Conrad resort. Secondary damage to the aircraft fuselage and doors were caused during salvage. (See Appendix 2)

Image 5- LH Float damaged during the impact

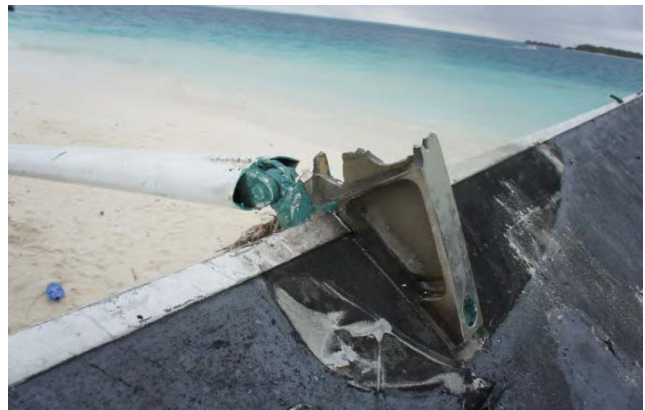
Image 6- LH Float attachments

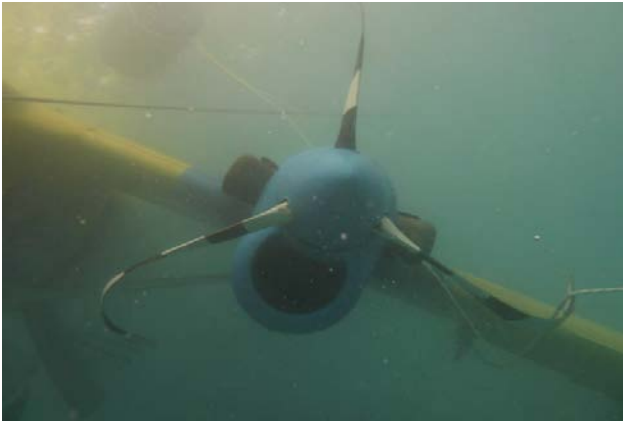
Image 7- LH Propeller

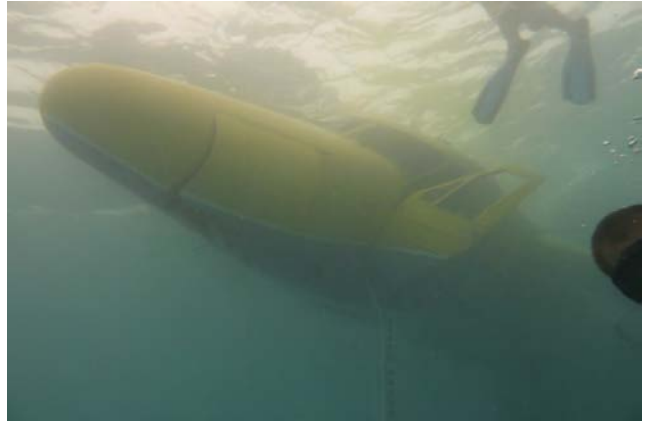
Image 8- Aircraft fuselage

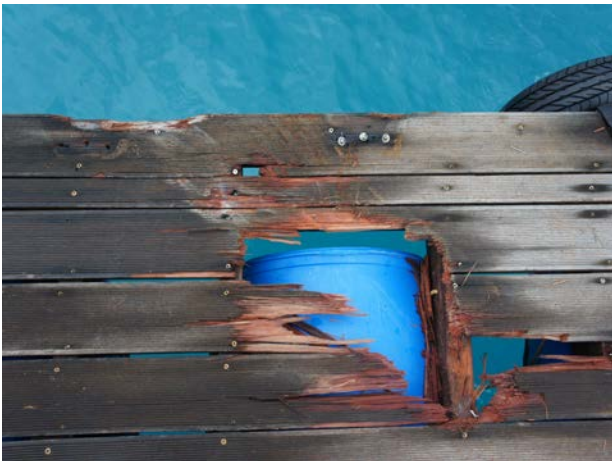
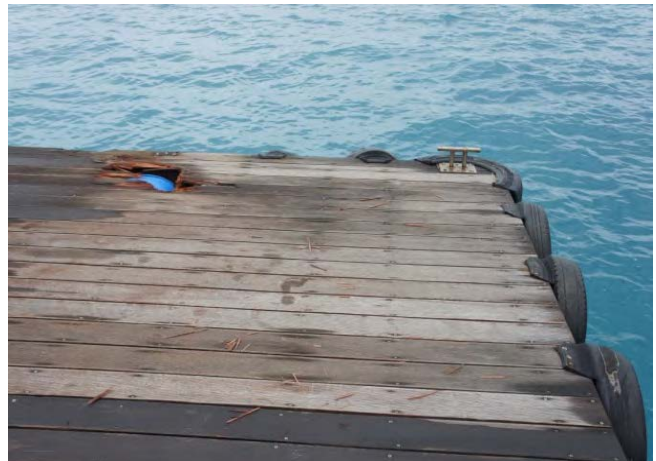
Platform Damages

The platform was punctured due to the repeated strikes of the propeller and some rubber tires on the edge were cut off with the impact.

- Floating platform to be installed as an alternate docking option during adverse weather conditions at locations where fixed platforms are used.
- A procedure for the flight crew to get weather information (wind direction and speed) at all out stations.
- Operational limitations to be introduced for all operational phases (take-off, landing, docking, beaching etc) of the flight.
- Cabin crew to wear life vest while operating outside the aircraft.
- "Decision making" to be emphasized in CRM training.
- Review company procedure for medical examination of the crew after an accident.
