SAFETY INVESTIGATION REPORT 2023/02

# FINAL REPORT

**AIRCRAFT IMPACTED A SWELL DURING TAKE-OFF**

**VIKING AIR DHC-6-300 TWIN OTTER, 8Q-ISI**

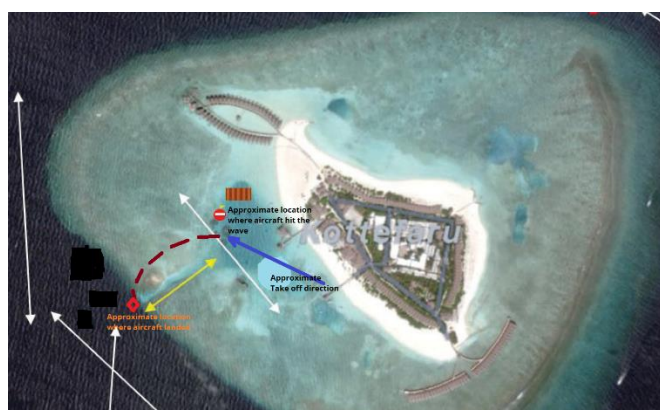
Fig. 2: Approximate take-off- line, flight path and landing location

The PF attempted to take-off in a westerly direction (See Fig 2 above) from within the house reef, while a left cross wind was present. The water condition was found to be rough with heavy winds and high swells. The crew initially planned to take-off parallel to the swells but was unable to do so due to the rough water conditions, and due to swells approaching from multiple directions. Both crew members discussed regarding the best take-off line, and the selected take-off line was confirmed by the PIC, which was a line regularly used for take-off, which required initiating the take-off run near the northern side of the service jetty, and taking -off towards north west, past the arrival jetty. The PF stated that the take-off was conducted as they do for any rough water conditions by holding the controls to prevent from hitting the swells. PIC stated that the attempted take-off from within the house reef was to avoid the rough waters outside the lagoon area.

During the take-off run, just past the fairway (boat entrance) of the reef, a high swell hit the aircraft and the aircraft was hurled around 10 feet into the air.

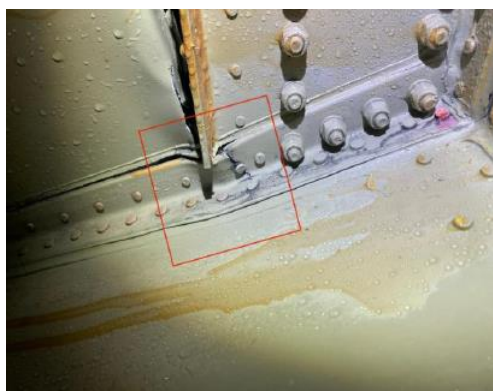
1. The LH inboard AFT stiffener (p/n: 13A01427-022) of number 6 bulkhead found cracked.
2. The LH inboard AFT stiffener (p/n: 13A01427-010) of number 6 bulkhead found cracked.
3. The channel (PANEL FT. Spreader bar Support RH, p/n: 13A01160-003) that houses the left float FWD attachment fitting found cracked.
4. The channel (PANEL AFT. Spreader bar Support LH, p/n: 13A01160-004) that houses the left float AFT attachment fitting found cracked.

**Figure 1:** The left hand inboard AFT stiffener (ARM-PANEL-#6 BULKHEAD, PN: 13A01427-022) of the number 6 bulkhead has been cracked

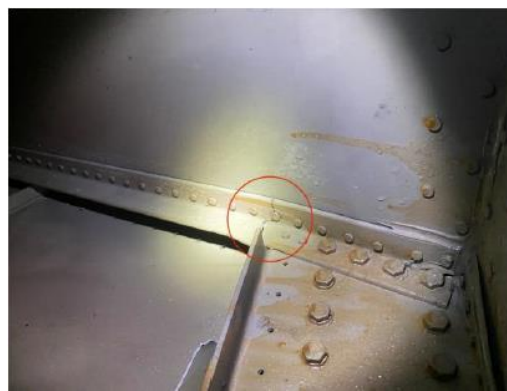
**Figure 2:** The left hand inboard AFT stiffener (ARM, PANEL, RH, #6 BULKHEAD, PN: 13A01427-010) of the number 6 bulkhead has been cracked

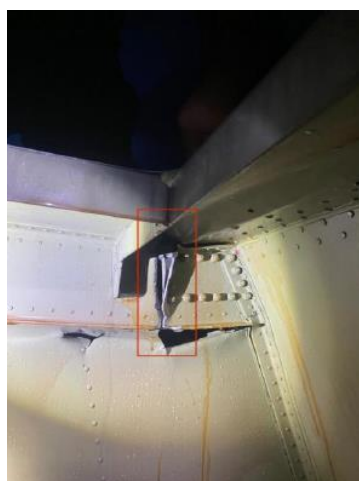
**Figure 3:** The channel (PANEL FT. SPREADER BAR SUPPORT, RH, PN: 13A01160-003) that houses the left float FWD attachment fitting cracked

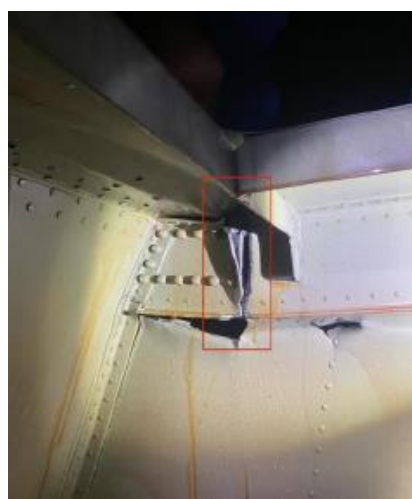
**Figure 4:** The channel (PANEL FT. SPREADER BAR SUPPORT, LH, PN: 13A01160-004) that houses the left float AFT attachment fitting cracked

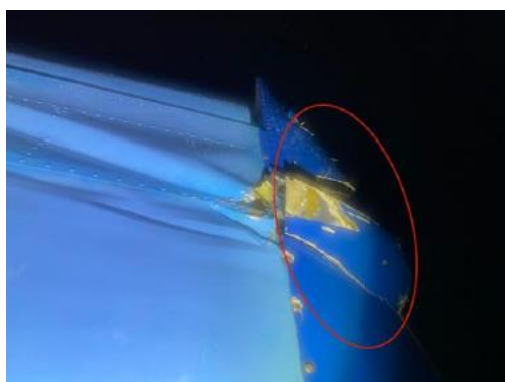
5. Left wing tip fairing (p/n: C6W1004-1) found damaged.
6. Left wing outboard trailing edge skin found dented.
7. Left float number 6 bulkhead body panel (p/n: 13A01150-052) found torn.
8. Leading edge skin of the left wing outboard fore flap dented beyond allowable limits.
9. Left float right side panel (p/n: 1011235) of number 8 bulkhead found torn.
10. Left float top skin found dented and damaged at number 6 bulkhead.

**Figure 5:** Left wing tip fairing (PN: C6W1004-1) damaged

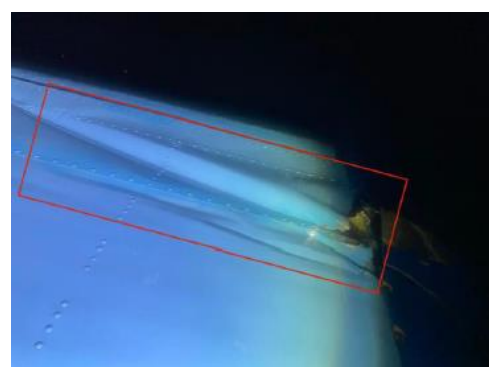
**Figure 6:** Left wing outboard training edge skin dented

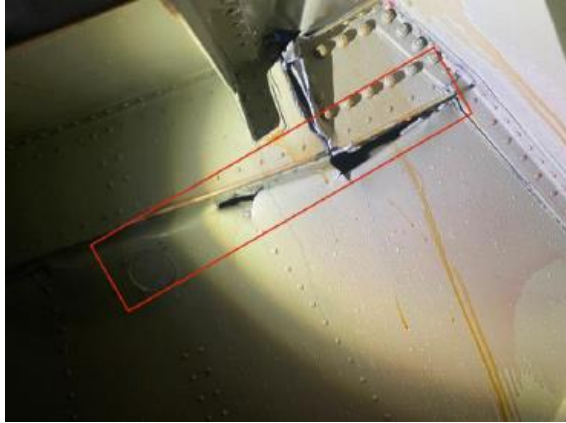
**Figure 7:** Left float number 6 bulkhead body panel (PN: 13A01150-052) torn

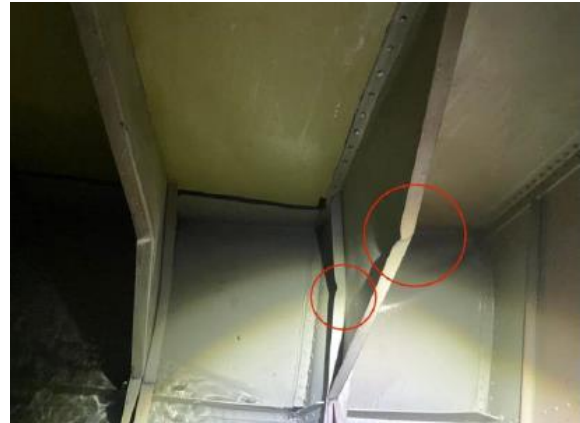
**Figure 8:** Right hand side panel (PN: 1011235) of number 8 bulkhead torn

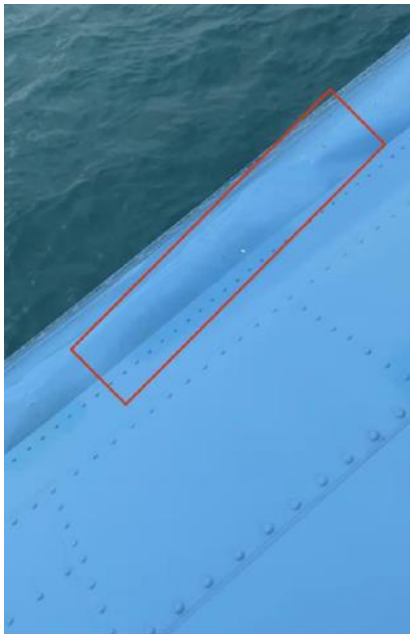
**Figure 9:** Leading edge skin of the left wing outboard fore flap dented beyond the allowable limits

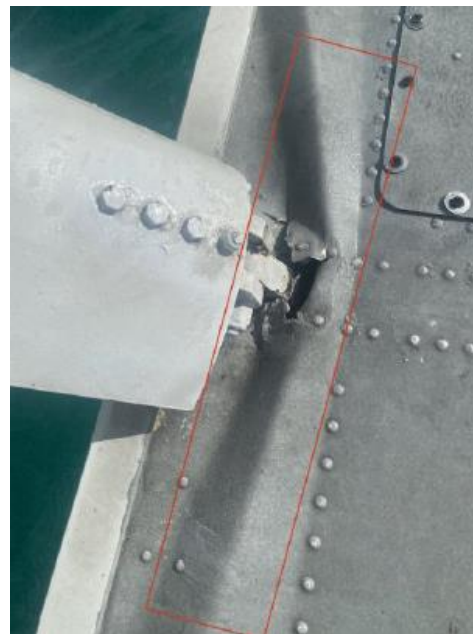
**Figure 10:** Left float top skin has been dented and damaged at number 6 bulkhead
