ACCIDENT INVESTIGATING COORDINATING COMMITTEE
MALDIVES CIVIL AVIATION AUTHORITY
2nd Floor, Velaanaage, Ameer Ahmed Magu, Male', 20096, Maldives

PRELIMINARY SAFETY INVESTIGATION REPORT

Report Number: 2024/02/P
Date: 31 July 2024

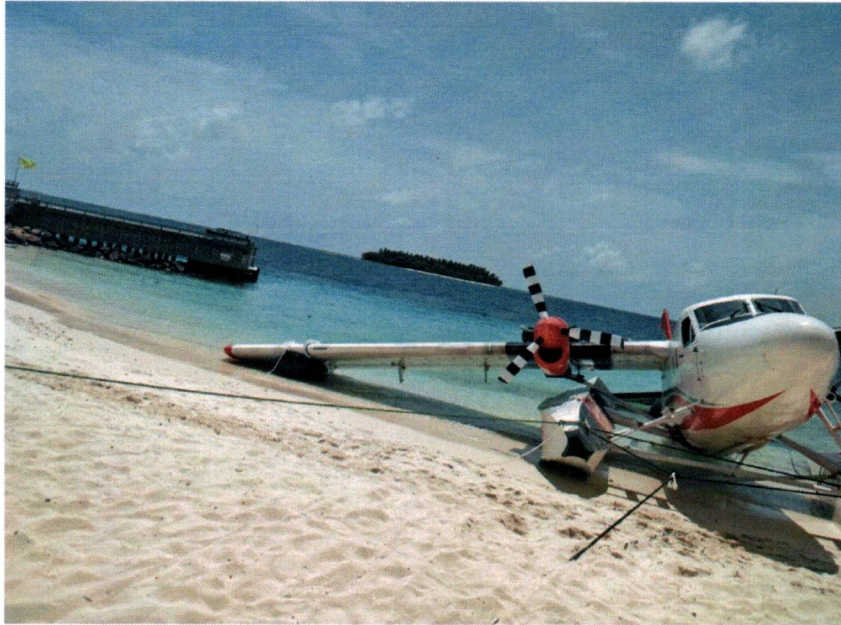
Fig 1: Aircraft beached on Miriandhoo Island

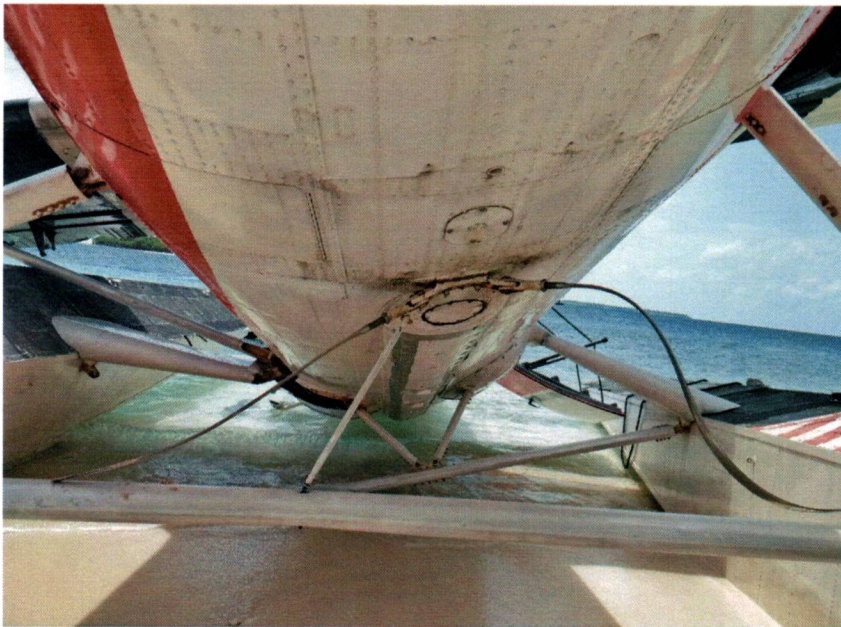
1. Visible damage on the float assembly.
2. Rear spreader bar attachment bolt missing.
3. Right float aft spreader bar, float attachment fitting damaged.
4. The right propeller blade cut into the right float.
5. Flywire LH buckled and RH snapped.

Fig 2: Flywire RH snapped; LH buckled

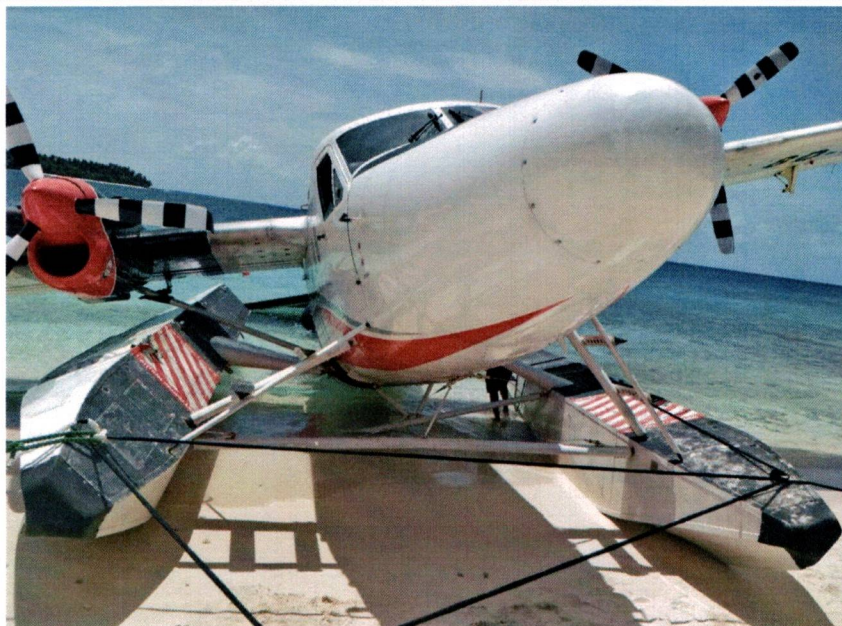
Fig 3: Aircraft beached – RH float detached at aft fitting

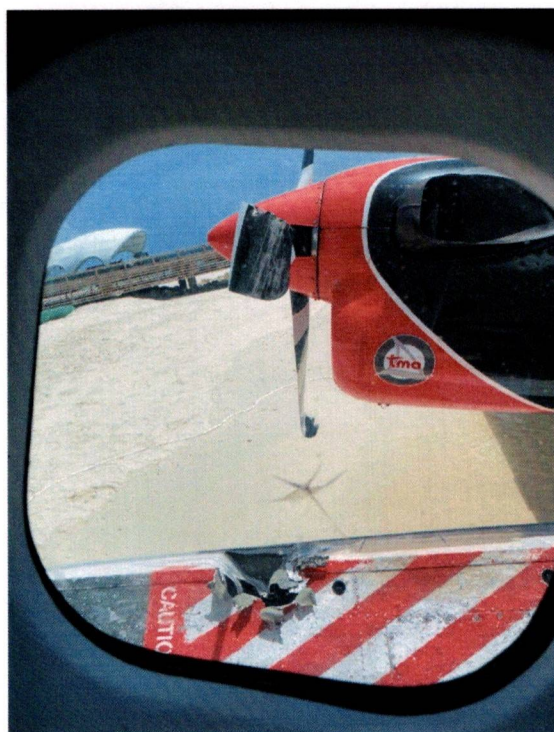
Fig 8: Damages on RH propeller and RH float

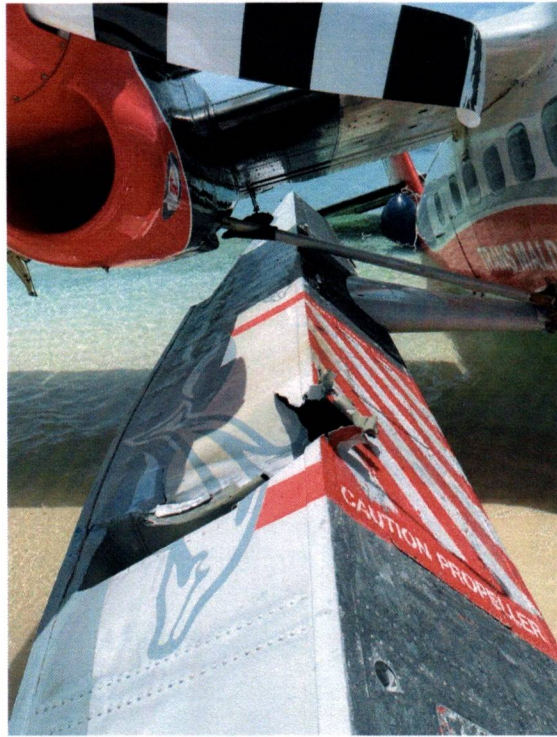
Fig 9: Damages on RH float
