ACCIDENT INVESTIGATION COORDINATING COMMITTEE

SERIOUS INCIDENT INVESTIGATION REPORT 2024/02

FINAL REPORT
ON INVESTIGATION OF THE SERIOUS INCIDENT INVOLVING
DHC-6-300, 8Q-TMO AIRCRAFT
AT WESTIN MALDIVES (MIRIANDHOO) WATER AERODROME,
ON 09 JUNE 2024

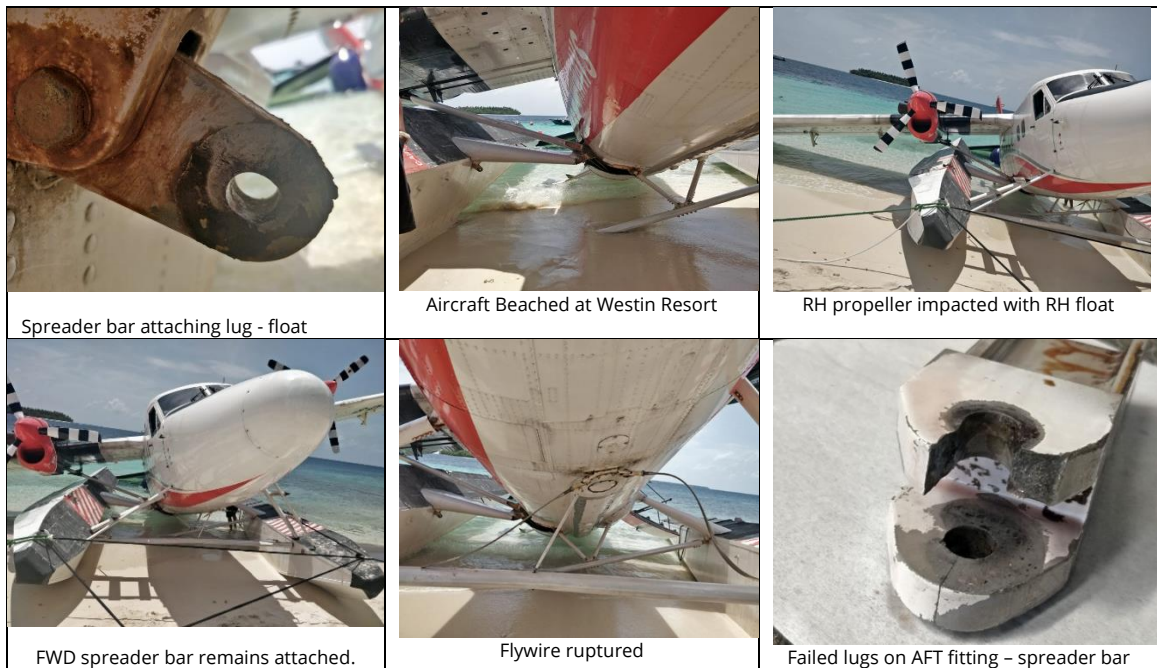
- RH attachment point completely detached and submerged.
- Attachment bolt missing; indicating that the bolt sheared.

2. RH propeller impacted float, damaging prop and fuselage, consequential damage.
3. Forward Spreader Bar:
 - Remained attached to the floats.
 - Flywires damaged, jury strut detached from fuselage.
 - RH stairs detached (likely during beaching).
 - LH float strut cover damaged due to float spreading.
 - Wing fairings and sling points inspected; attachment points secure.
 - RH aft attachment broken; forward point cracked.

The extent of the damage sustained by the Floats as well as airframe structures and airframe components can be captured from the photo images shown in the table below.

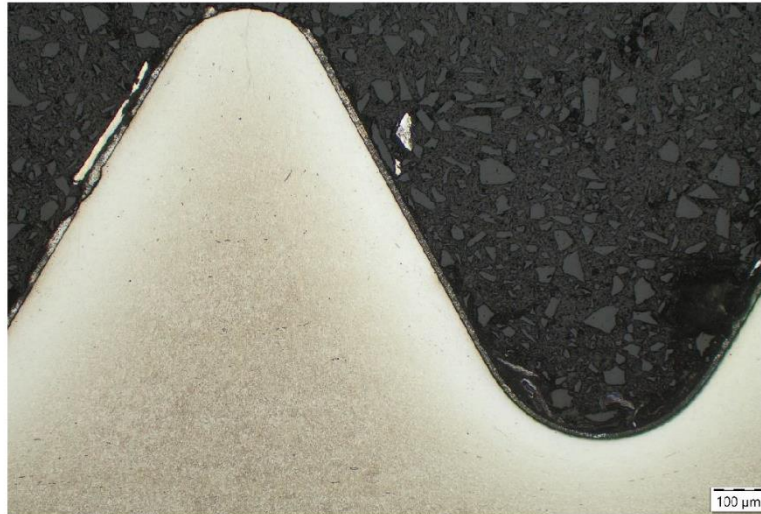
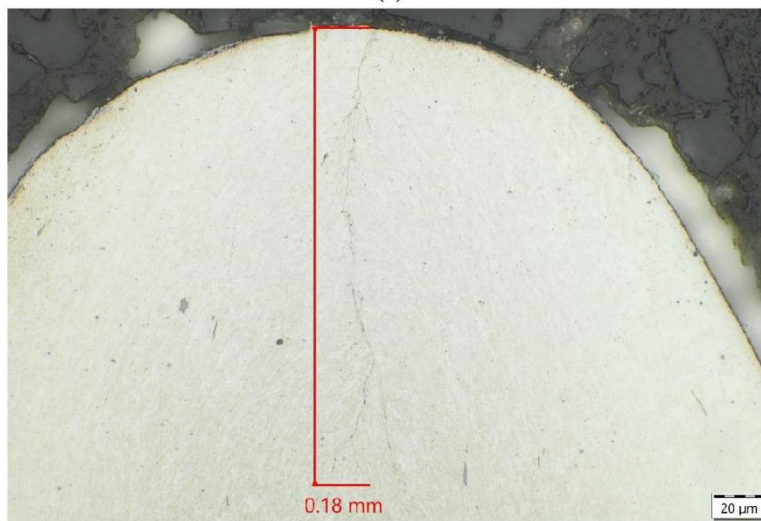
From the results of the evaluations carried out there is no evidence of fatigue cracking or catastrophic failure observed in any component. However, the metallographic evaluation of Bolt 1 (Fig. 10) showed that it was exhibiting branching cracks at thread tips. All bolts were confirmed to be Grade 8640 steel with a tempered martensite microstructure, and fittings were of 2024 aluminum alloy. Surface inclusions (Fig. 12 and 16) were observed at or near the surface of the bolt holes of all fittings, which may serve as stress concentration sites.

No signs of fatigue were evident during the evaluation. However, branching cracks on the thread tips of Bolt 1 may be of interest. Determination of the cause of the cracks is beyond the scope of this evaluation. The fittings exhibited inclusions near the surface of the bolt holes which could act as sites for stress concentration.

Fig. 10 The surface of the metallographic specimen prepared from Bolt 1 is presented in (a) and a crack in the tip of the thread is presented at higher magnification in (b). The microstructure was indicative of tempered martensite. Grain flow from the forming operation is evident in the view. The crack is measured in the view. 2% Nital.

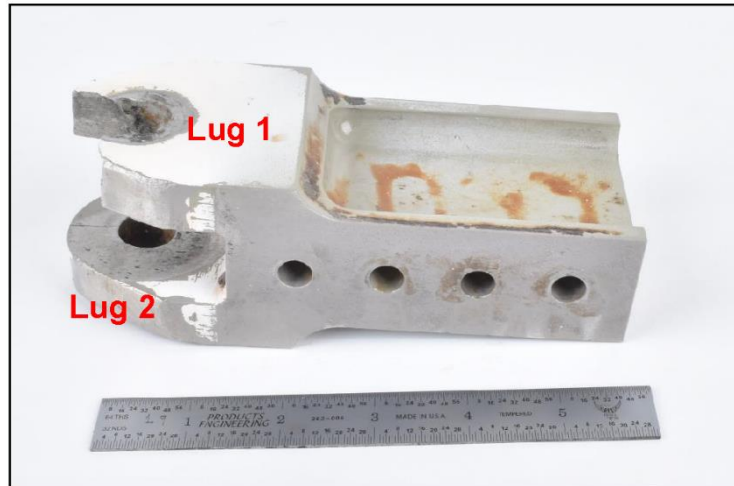
The report states that the cracked fitting (P/N 13A03030-004) showed significant corrosion damage. The hours and cycles accrued on the part could not be

Fig. 1 The failed fitting, identified as Part A, is shown as received. The lugs are identified as Lug 1 and 2 in view. The scale is in inches.

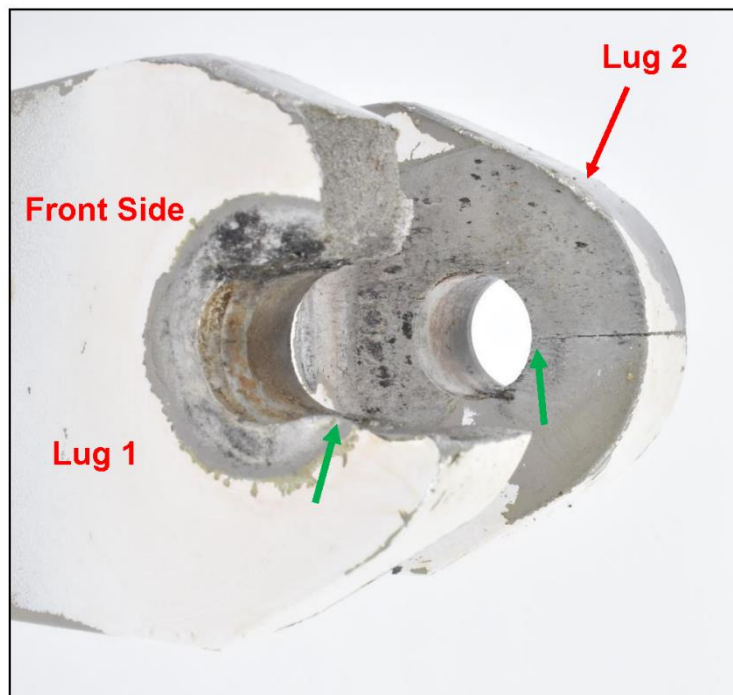
1. Surface degradation: The fitting's surface showed signs of wear, including the loss of paint and epoxy coating, which would have protected it from corrosive elements (Figures 2-5).

Fig. 2 A close examination of Part A is shown. The majority of the surfaces on Lug 1, Lug 2, and the bores no longer appear to have paint or epoxy layers. Rust color deposits are visible throughout the bores. Green arrows indicate crack initiation sites on at the bore of each lug.

1. Implement scheduled detailed inspections of all float fitting lugs and bolts for signs of corrosion, paint/coating damage, or cracking. Given that IGSCC can progress internally, use non-destructive inspection techniques (dye penetrant or eddy current testing) focused on the lug bore areas to detect any cracks that may initiate at bolt holes in close coordination with STC holder.
2. Ensure that the protective finishes on the fittings (primer and paint) are intact and renewed as necessary. Any paint/primer wear in areas like the bolt bore or lug surface should be promptly touched up to restore a barrier against moisture ingress.

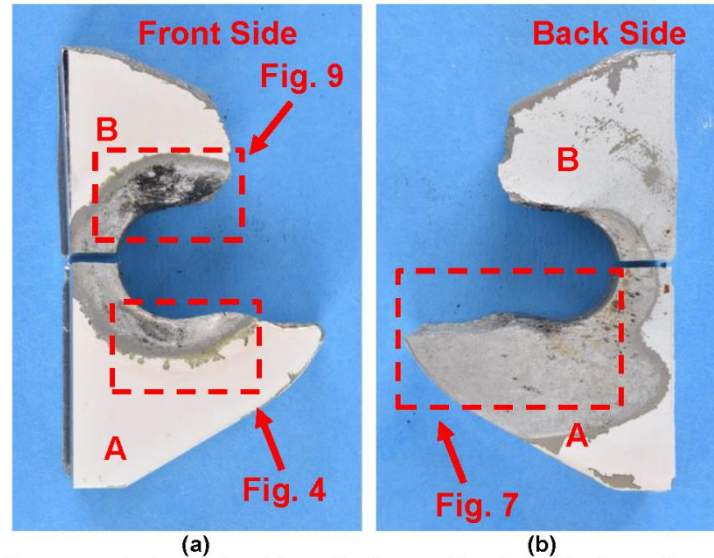
Fig. 3

A macro photograph of Lug 1 after cutting into Sections A and B for further examination is shown in (a), and after reorientation in (b). The highlighted areas are indicated for higher magnification studies, and are shown in Figure 4, 7 and 9.

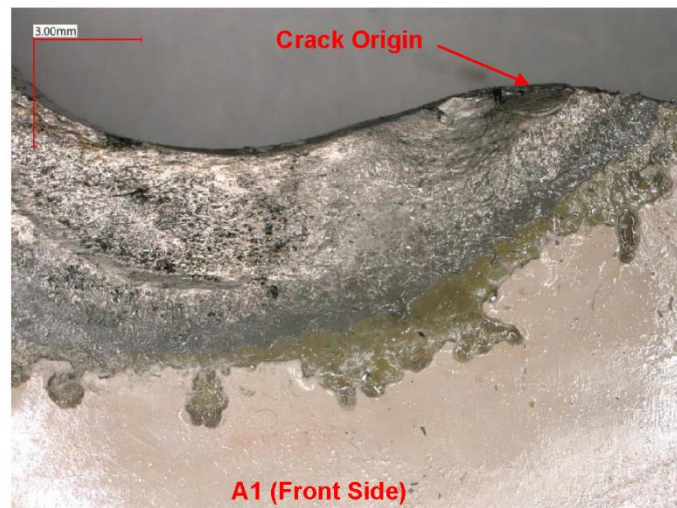
Fig. 4

An overall view of the front side of Section A, highlighted in Figure 3, exhibits features indicating that the surface where the crack initiated no longer has paint or epoxy layers. Extensive rust-colored deposits and corrosion pits are evident on the surface.

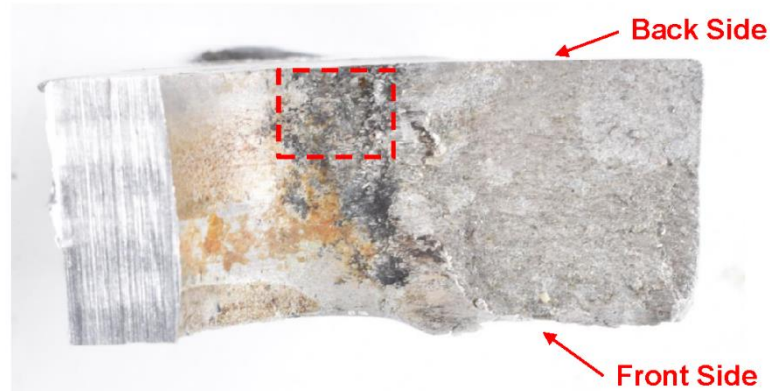
2. Corrosion-induced cracking: The pitting corrosion likely formed between the bore and the bolt due to crevice corrosion, which was further aggravated by the lack of surface coatings (Figures 5-13).
3. Presence of intermetallic particles: Corrosion preferentially attacked areas containing intermetallic particles, particularly copper-rich phases, making these areas more susceptible to stress corrosion (Figures 14-17).

Fig. 5 An overall view of the surface of the crack from Section A is presented. Rust-colored deposits are evident on the surface of the bore. The fracture is on the right side of the section shown. The highlighted area is indicated for a higher magnification study, as shown in Figure 6.

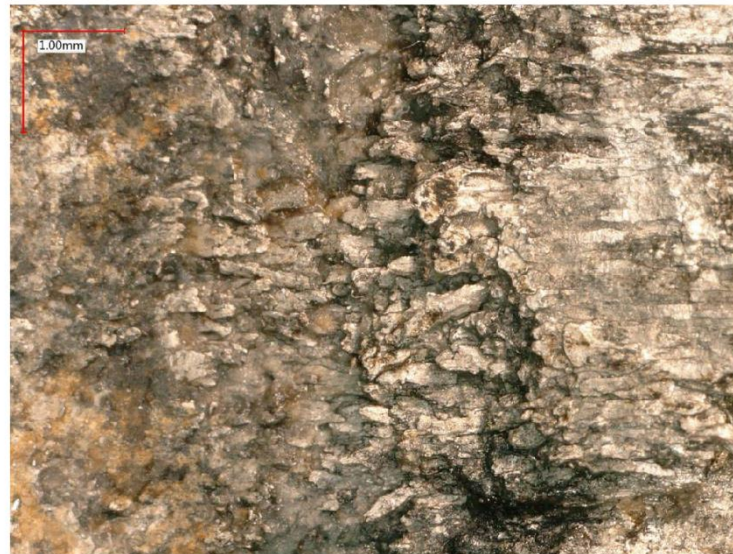
Fig. 6 A higher magnification image of the fracture surface reveals corrosion deposits and intergranular cracking corresponding to the highlighted area from Figure 5.

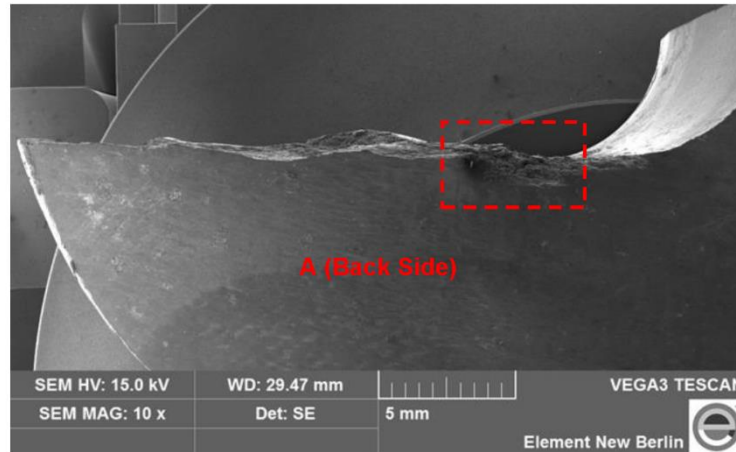
Fig. 7

A secondary electron (SE) micrograph of the backside view of Section A as indicated in Figure 3 shows the crack origin site and the fracture extending from the bore to the end of the fitting. The highlighted area is likely the crack initiation site and is shown at a higher-magnification in Figure 8.

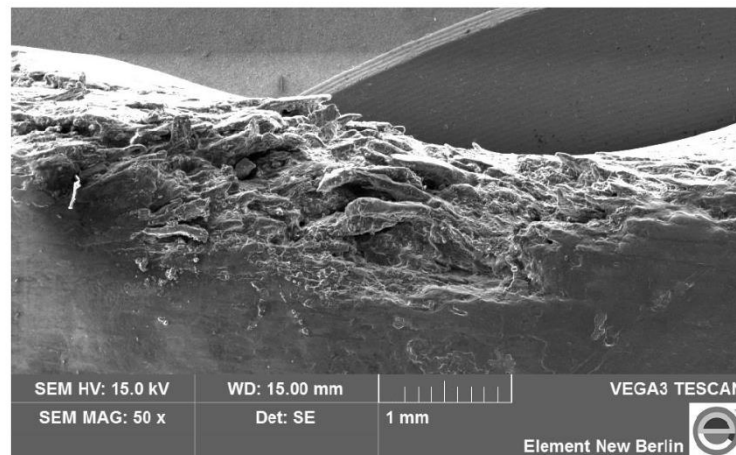
Fig. 8

Evaluation of the fitting concluded that the failure was attributed to intergranular stress corrosion cracking (IGSCC), initiated at a pitting corrosion site that developed at the bore of the lug (Fig. 8). Cracking propagated along elongated grain boundaries, consistent with IGSCC caused by applied stress and a corrosive environment, which is the case in the Maldives, given the chloride-rich environment. SEM/EDS analysis reaffirms this, showed high chlorine content in corrosion products, indicating a marine-induced corrosion mechanism. Protective coatings were missing at the crack origin, likely worn off during service. No evidence of overload or fatigue fracture was found, confirming environmental-stress synergy as the root cause.

The highlighted area from Figure 7 is shown at higher magnification. The surface reveals the crack origin region with surface pitting and intergranular cracking features.

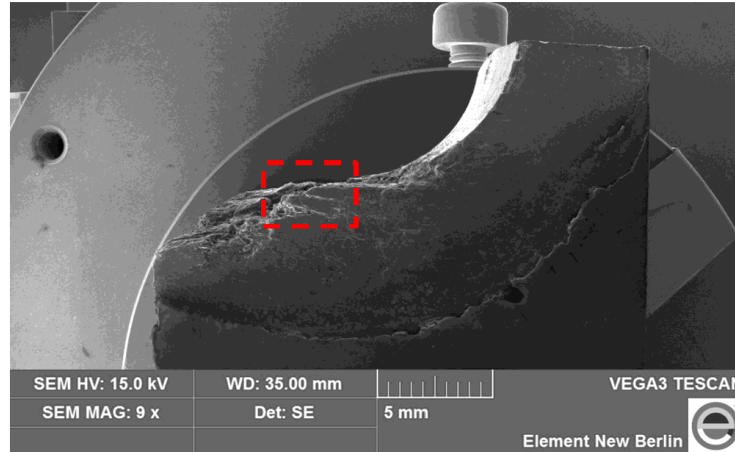
Fig. 9 An SE image of the front side of Section B is presented, including the crack origin site and propagation path. The position of this surface is defined in Figure 3. The highlighted area is selected for higher magnification SEM analysis, presented in Figure 10.

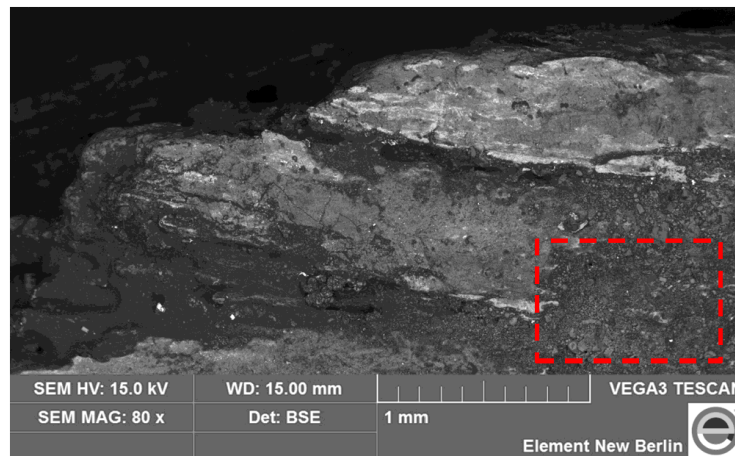
Fig. 10 A backscattered electron (BSE) micrograph shows the area indicated in Figure 10 at a higher magnification. The surface exhibits a significant amount of corrosion products. The highlighted area is further examined in Figure 11 using SEM/EDS analysis

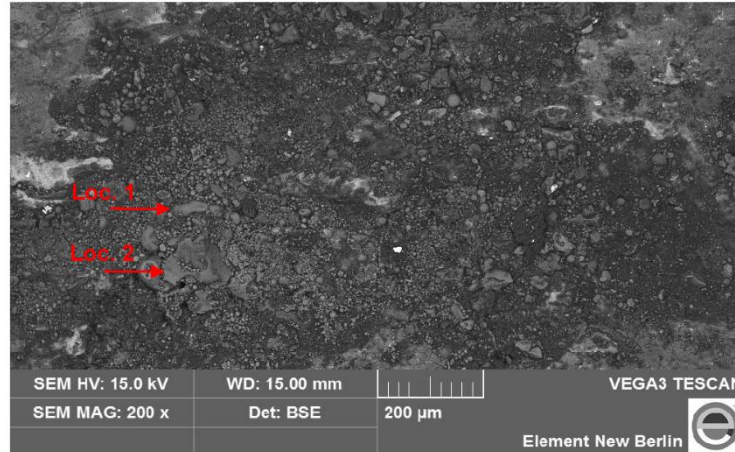
Fig. 11 The highlighted area from Figure 10 is shown at higher magnification. The surface exhibits accumulated corrosion products. EDS analysis was conducted at two locations, as indicated by the arrows and labels in view. The results are presented in Table 1.

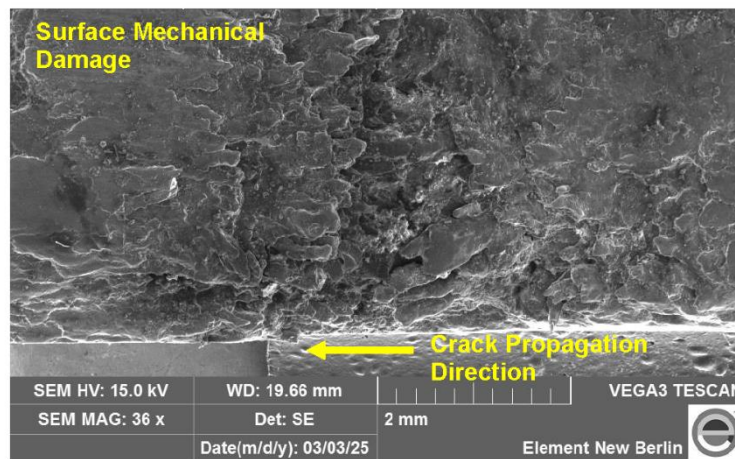
Fig. 12 An SEM image of the fracture surface of Section A, corresponding to Figure 7, is presented. The fracture surface exhibits intergranular cracking at the crack origin, which is at the center of the image, followed by post fracture mechanical damage along the crack propagation path, located on the left side of the image.

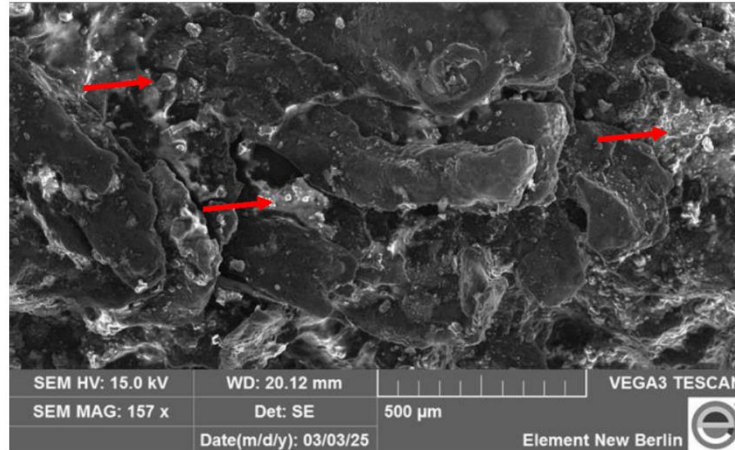
Fig. 13 A higher magnification view of the crack origin reveals intergranular cracking. Corrosion deposits are evident on the fracture surface and along the grain boundaries as indicated by red arrows.

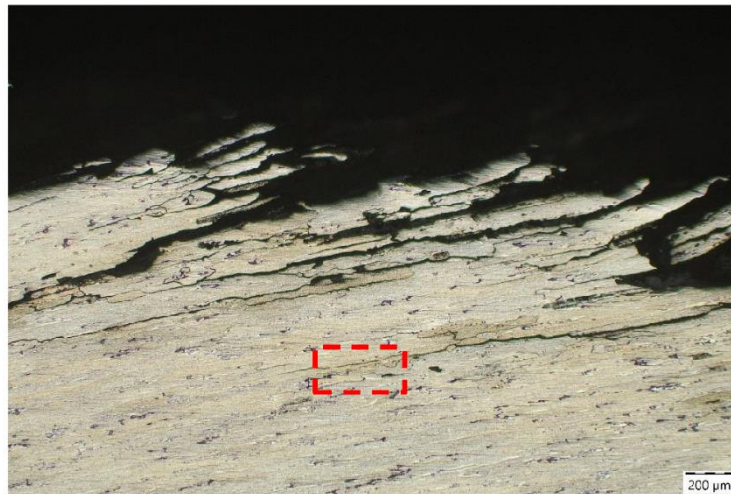
Fig. 14 A microscopy image of the backside surface of Section A, through the region indicated in Figure 8, is presented, showing secondary intergranular cracks adjacent to the primary crack. The secondary cracks propagated along elongated grain boundaries. The highlighted area was selected for a higher-magnification study, presented in Figure 15. Keller's reagent.

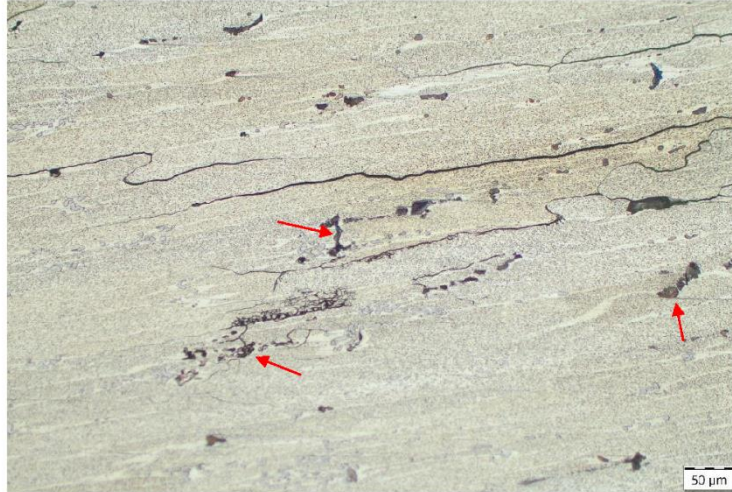
Fig. 15 The highlighted area from Figure 14 is shown at higher magnification. The surface exhibits intergranular cracks and the formation of precipitates along grain boundaries. Corrosion attack is evident around the precipitates, as indicated by the red arrows. Keller's reagent.

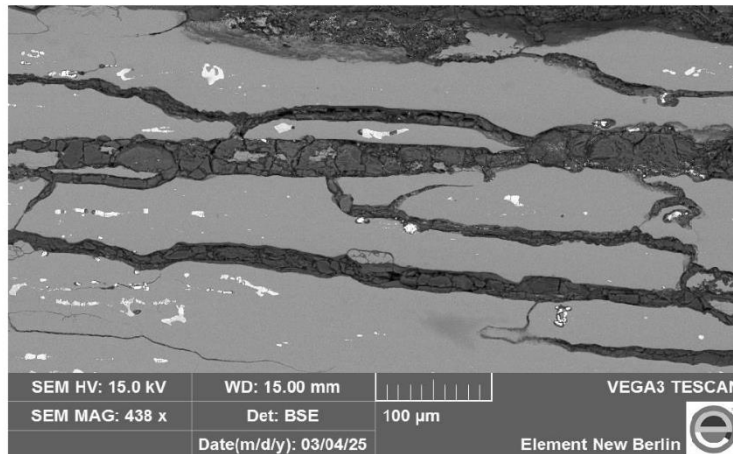
Fig. 16 A BSE-SEM image of the secondary cracking adjacent to the crack origin is presented. The white regions indicate the presence of precipitates in the aluminum alloy. As-polished.

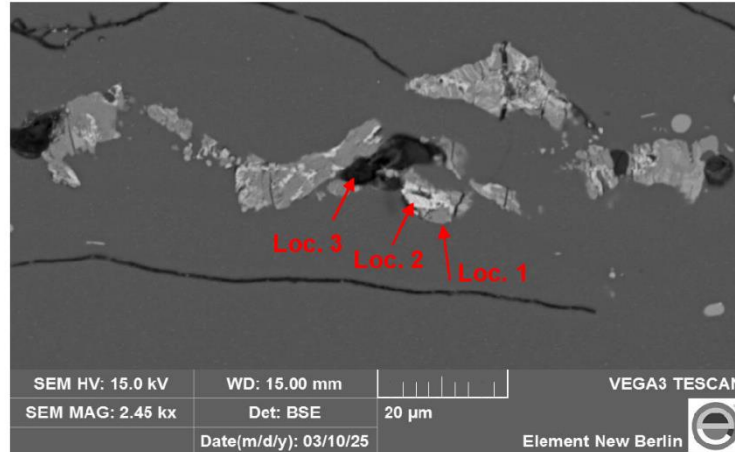
Fig. 17

The BSE-SEM image of secondary cracks is presented at higher magnification. The surface exhibits lighter regions presenting the distribution of coarse intermetallic particles. EDS analysis of the precipitates was conducted at two locations of precipitates and at corrosion products along the precipitates, indicated by arrows and labeled in the image. The results are presented in Table 1b. As-polished.
