ACCIDENT INVESTIGATION COORDINATING COMMITTEE

AIRCRAFT ACCIDENT REPORT 2020/01

**PRELIMINARY REPORT ON INVESTIGATION OF THE
ACCIDENT OCCURRED ON VIKING AIR
DHC-6-300, 8Q-MBC AIRCRAFT
AT KUREDHU WATER AERODROME,
MALDIVES**

on 24th February 2020

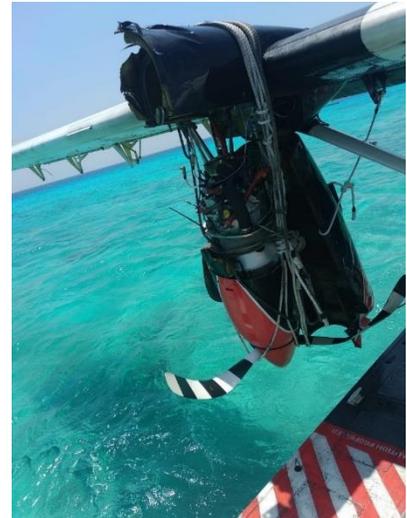
Figure 1: Aircraft engine detached from all three mounts after the accident

3. Right Hand engine:
 - a. Right Hand engine found fully detached from the mount/nacelle, hanging only by the fuel hoses and fuel control rods connected to it
 - b. One of the vibration isolators (inboard) found sheared off
 - c. Nacelle structure to which the vibration isolators (outboard and top) were ripped off
 - d. RH engine propeller blades (all three of them) were found bent aft. Red paint scratch marks found on one of the blades
 - e. Nicks observed on all three blades

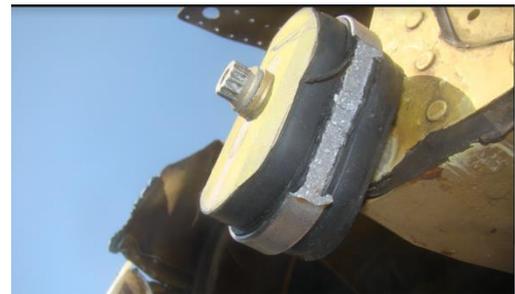
Figure 2: RH engine inboard mount

Since it is not common for vibration isolators to shear in the way it did, Engine vibration isolator assemblies installed on the right-hand engine, at the time of the accident require metallurgy tests to determine the cause of the failure.

- The Engine vibration isolator assemblies installed on the right-hand engine which failed during the landing had previously undergone eddy current inspections as called for in the Maldives CAA Airworthiness Directive. The mount has sufficient hours left for next inspection;

- Since fracture of the engine mounts had occurred on several other DHC6 aircraft in the past, it is recommended that sheared mount undergo metallurgical test alongwith one other serviceable engine mounts belonging to the same batch available with the operator;
