ACCIDENT INVESTIGATION COORDINATING COMMITTEE

SAFETY INVESTIGATION REPORT 2022/01

**INVESTIGATION OF THE RUNWAY EXCURSION
SERIOUS INCIDENT INVOLVING BOMBARDIER DHC-8-300 AIRCRAFT,
8Q-IAK OPERATED BY ISLAND AVIATION SERVICES (IAS)
AT KADHDHOO AIRPORT, MALDIVES**

05 May 2022

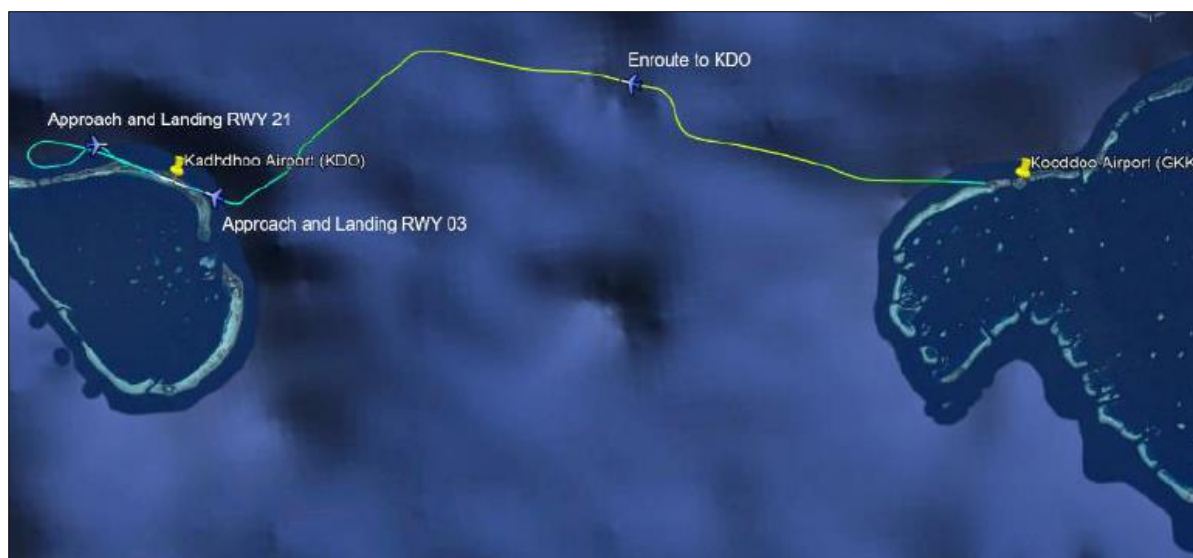
**Figure 4 - Flight Track Information**

The aircraft, enroute to KDO being unable to fly the most direct route had to deviate to the east quite considerably due to adverse weather conditions as evident from **Figure 4 – Flight Track Information**. Before descent checklist was followed by the crew. On receiving surface wind conditions from KDO, the crew requested to land on Runway 03 in lieu of the runway 21 in use. Following approval by the ATCO the aircraft approached Runway 03 to land but shortly before touchdown at 04 ft RA, the PIC, who was also the PF decided to initiate a go-around. Mechanical turbulence and gusting wind conditions experienced by the aircraft was the reason for PIC initiating a go-around. Turbulence was evident from **Figure 5 – FDR Data** with a minimum value of 0.69g at 22ft RA and a maximum value of 1.47g at 12ft RA. PIC asked FO if they should go-around, to which FO agreed and PIC initiated a go-around. The go-around was initiated at 4 ft RA.

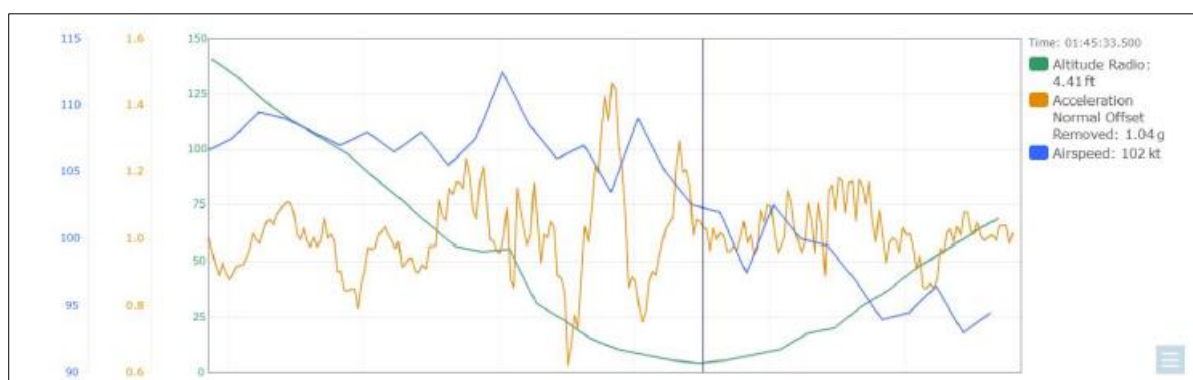
**Figure 5 - FDR Data -First Approach**

The figure 5 above shows normal acceleration, radio altitude and airspeed while Figure 6 shows parameters from 1000 feet at runway 03 until 1500 feet after the go-around.

4. On the attempt to land on Runway 03 at KDO, the aircraft encountered mechanical turbulence and gusting winds which led the crew to initiate a go-around instead of landing. Vertical acceleration of the aircraft reached 1.47G at 12ft during this attempt to land;

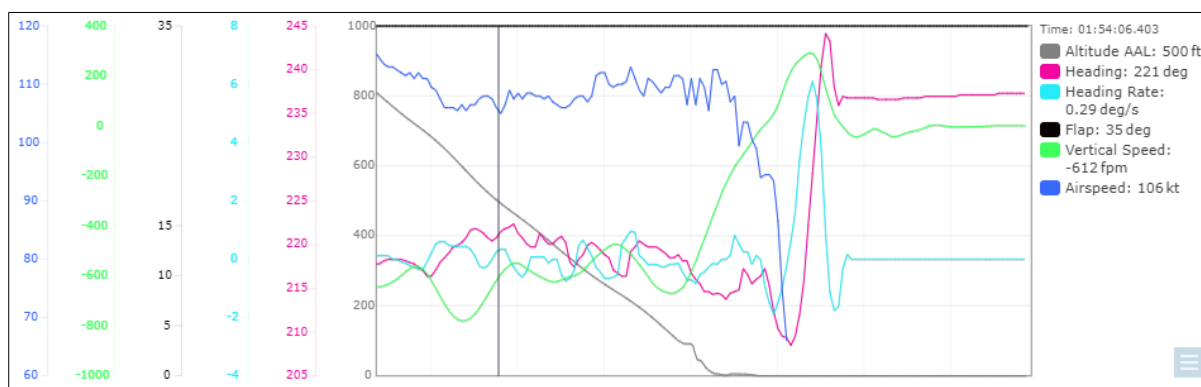
Figure 7 – FDR Data, Second Approach

At 01:54:06 UTC, during the second (final) approach, passing 500 feet for landing runway 21 the heading of the aircraft was 221 degrees. The flap was set at 35 degrees with vertical speed at 612 feet per minute and air speed at 106 knots, as evidenced by **Figure 7 – FDR Data, Second Approach**.

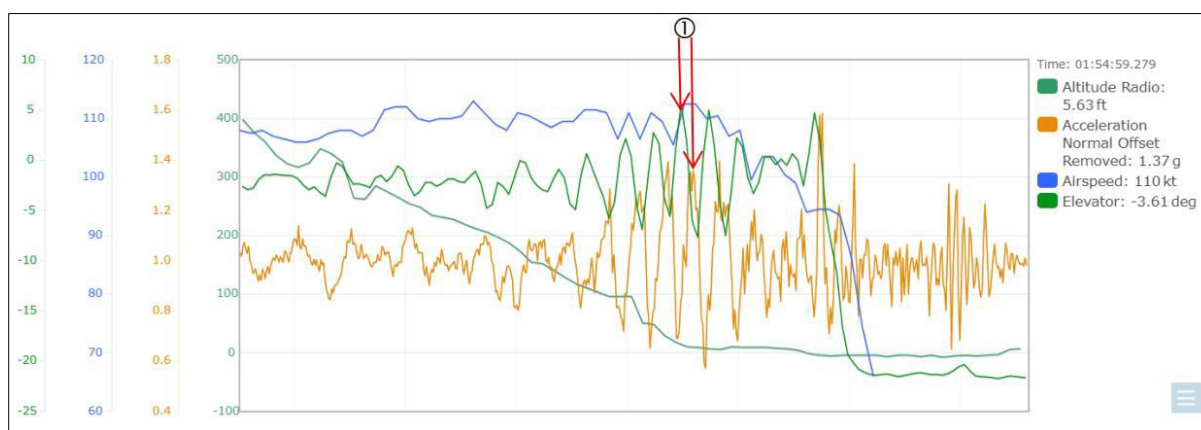
Figure 8 – FDR Data, Second Approach

FDR data indicated oscillations in elevator deflection that coincided with the peaks in normal acceleration which can be seen in **Figure 8 – FDR Data, Second Approach**. The range of each elevator deflection oscillation was in excess of 7 degrees with transition across the 0.0-degree threshold. The size of oscillations diverged in increasing value. Acceleration of the aircraft was found to be normal. During the landing roll and runway excursion, the aircraft's heading veered to the right from a minimum of 208 degrees to a maximum of 244 degrees. The runway heading was 209 degrees. The aircraft came to a stop on a heading of 237 degrees, though.

5. During landing at runway 21, FO can be heard requesting PIC to cut the power. This is a likely indication that the aircraft had excessive power while it was flared which led to ballooning and floating.

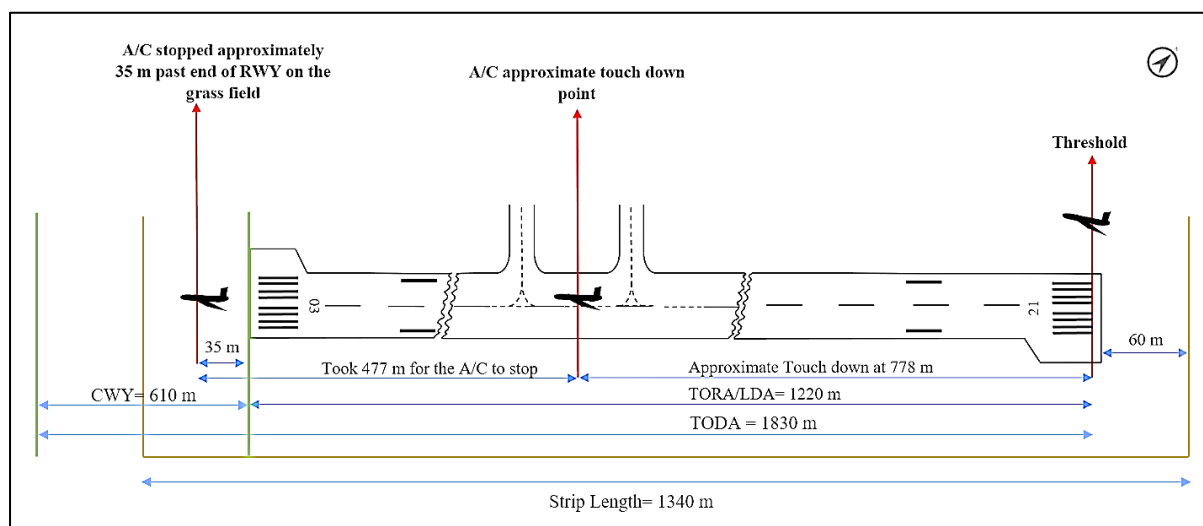
Figure 9 - Distances, touchdown and stop points

Measured from the tyre marks to the location where the aircraft stopped the total distance travelled approximates at 477 meters (1,565 feet). The aircraft crossed Runway

03 end by around 35 meters (**Figure 9 and 10**). The landing distance required for landing the aircraft in the configuration (calculated unfactored) it was, using Flap 35 (using Dash 8 Flight Manual perf. chart 5-11-2), approximates at 570 meters (1,870 feet) for a landing weight of 38,482 pounds and a head wind of approximately 5 knots. The distance from the touch down point to the Runway End was only 442 meters (1,450 feet).

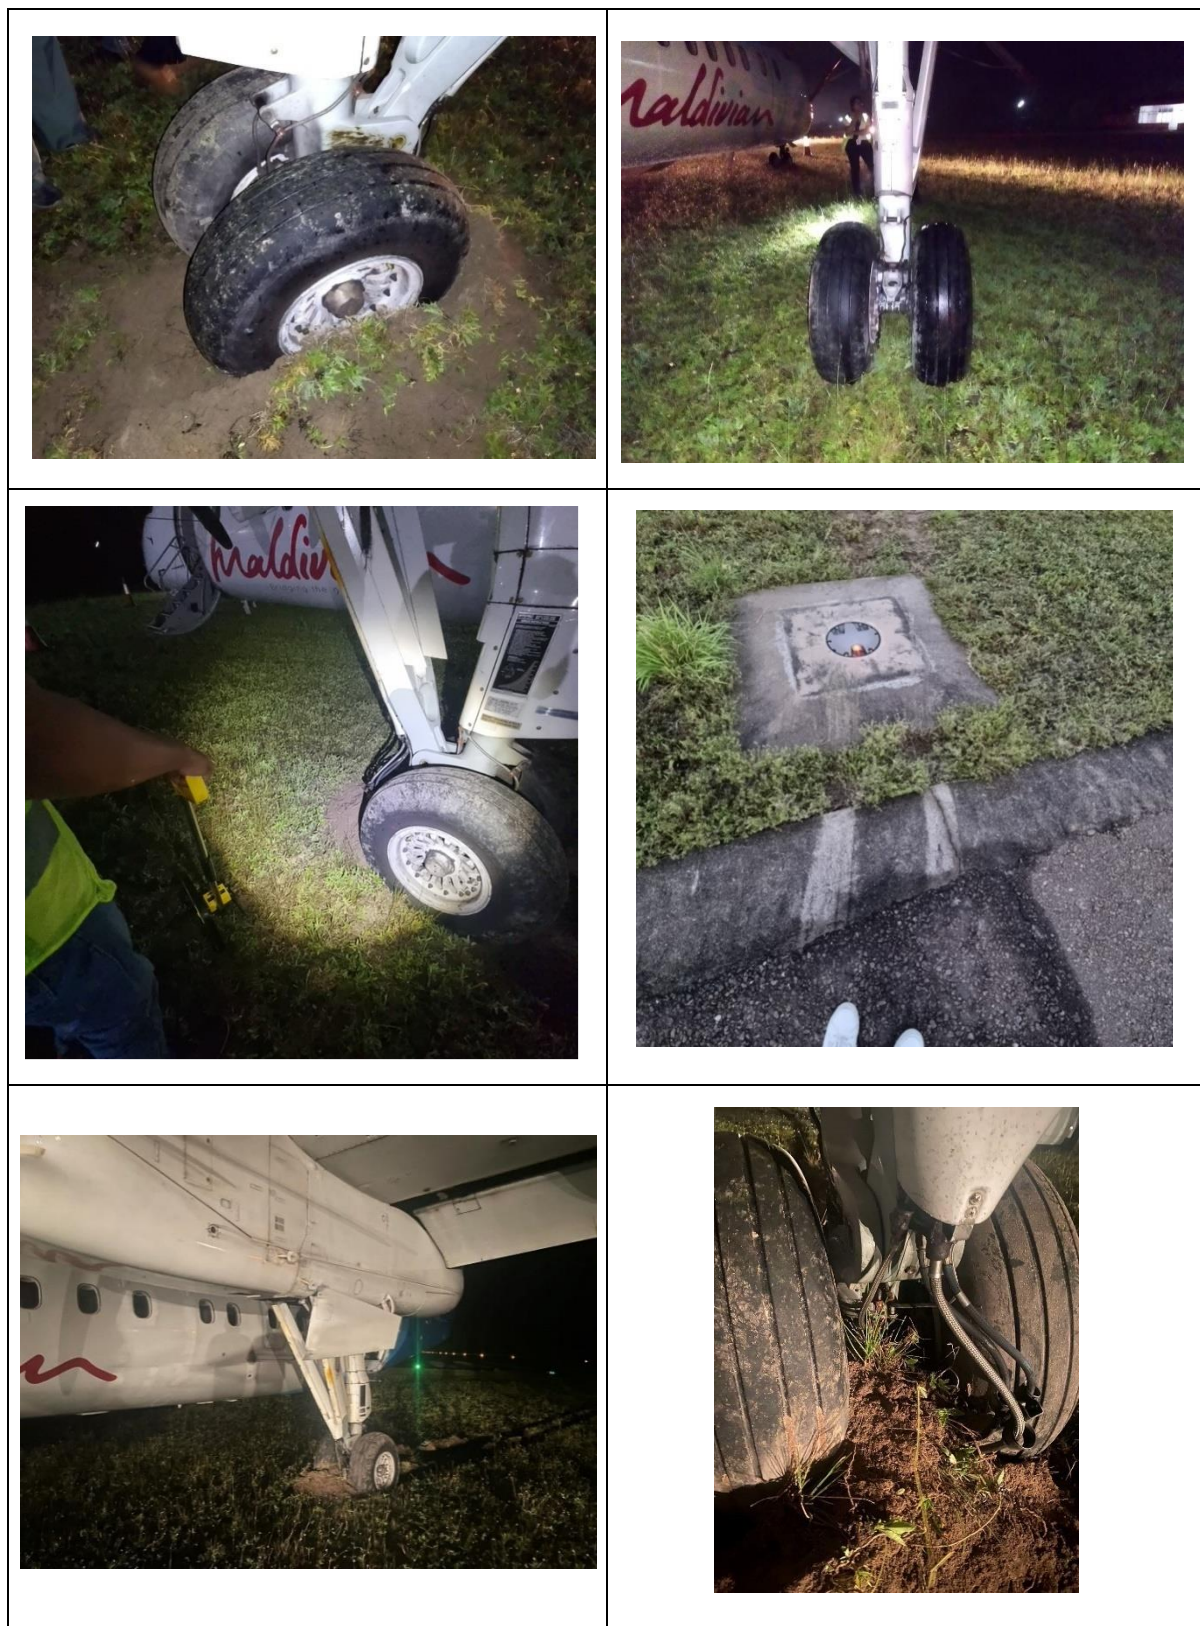
4.3 Photos of the aircraft on accident site

The aircraft approached Runway 21 and touched down approximately 442 meters before the end of Runway 21 and overran on to the grass, finally stopping approximately 35 m (115 feet) past the end of the runway.

Aircraft did not sustain any damage as a result of the excursion.
