ACCIDENT INVESTIGATION COORDINATING COMMITTEE

AIRCRAFT OCCURRENCE INVESTIGATION 2021/02

FINAL REPORT

**INVESTIGATION OF THE SERIOUS INCIDENT INVOLVING
TRANS MALDIVIAN AIRWAYS OPERATED VIKING AIR DHC-6-300
8Q-MBC FLOATPLANE AT FINOLHU RESORT WATER AERODROME,
MALDIVES**

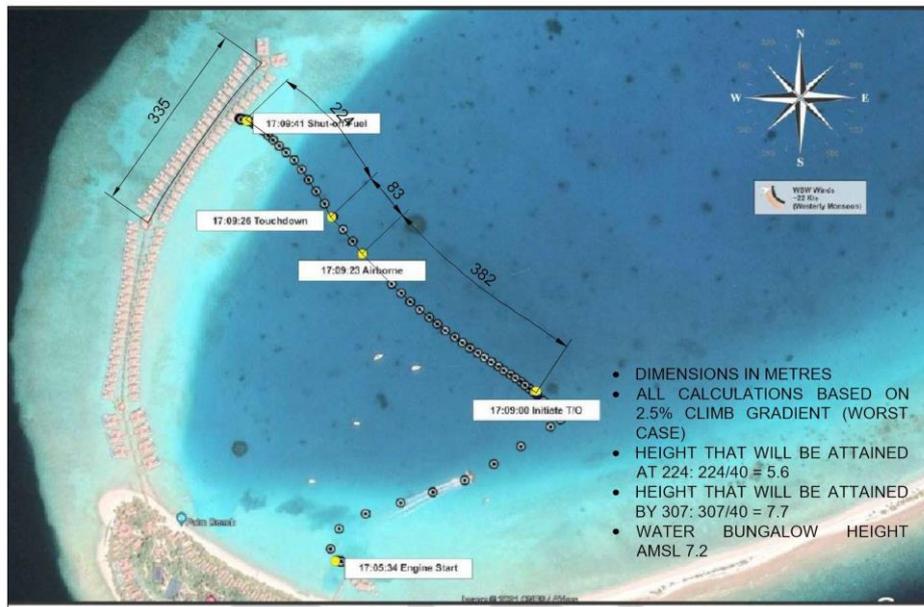
The G950 data suggests the aircraft lifted off within 23 seconds into the take-off run and the aircraft appeared to be off the water for about 3 seconds covering a distance of about 164 feet. When the aircraft settled back on water, the aircraft was approximately 750 feet from the water villas.

The PIC recalls that as soon as the aircraft was airborne, an unfavorable gust of wind caused the aircraft to settle back on water. The G950 data also indicated that, at around the same time, engine power on both engines was reduced to idle thus indicating the take-off was aborted at that point.

Fig. 2: 8Q-MBC – Flightpath recreated using data from Garmin G950 Aonics suite provided by the operator

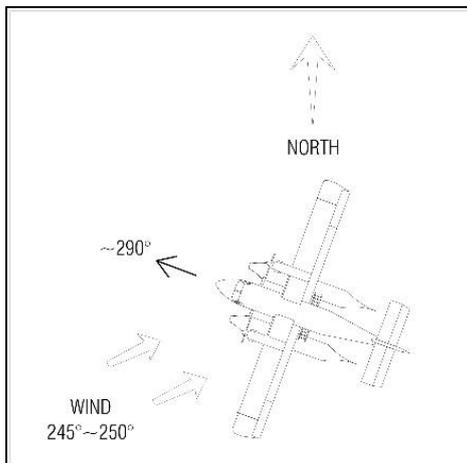
The PIC who was the PF, stated that the weather was below favorable conditions at the time of the incident. He noted that on the incident flight the most favorable take-off path would have been a westerly direction as the wind was from WSW. However, in order to avoid taking-off towards the island or between the island and the water villas (over the walkway between the island and the water villas) the PIC chose a north westerly direction towards the water bungalows (having an approximate height of 7.2 meters above mean sea level). The PIC confirmed that once airborne, he was hoping to level off and turn right slightly and climb out to avoid flying over the water bungalows.

Fig 3: Aircraft T/O direction

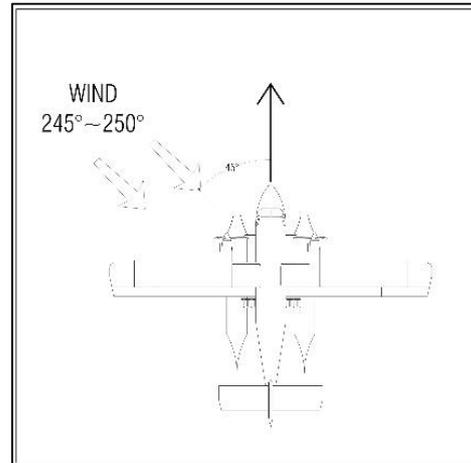
Fig 4 : Aircraft vs. cross wind direction

The maximum demonstrated cross wind component as per the Operator’s OM-Part B clause 1.10.1 “Crosswind and headwind component” (Volume 1 DHC-6 Floatplane operations) is 17 knots measured at 6 feet. This is not a limitation but a demonstrated crosswind – published by the manufacturer.

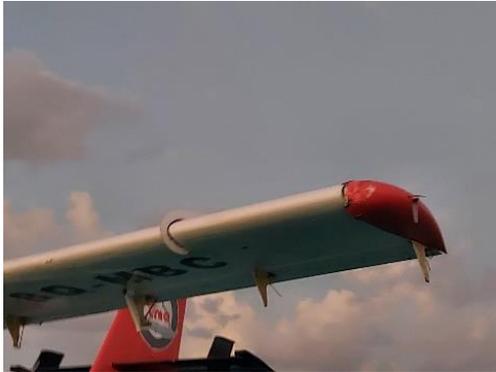
1. Left Wing leading edge dented in three places
2. Right Wing tip fairing damaged
3. Right propeller – One blade damaged

Figure 9: Left Wing Aircraft 8Q-MBC

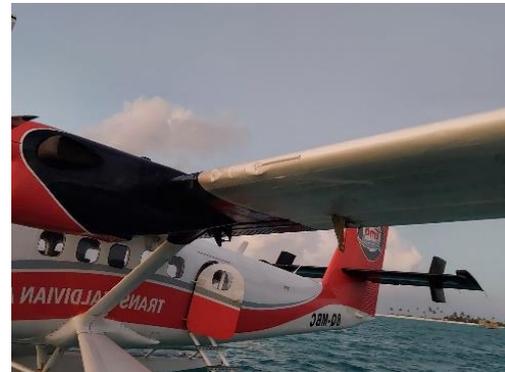
Figure 10: Damage to LH wing

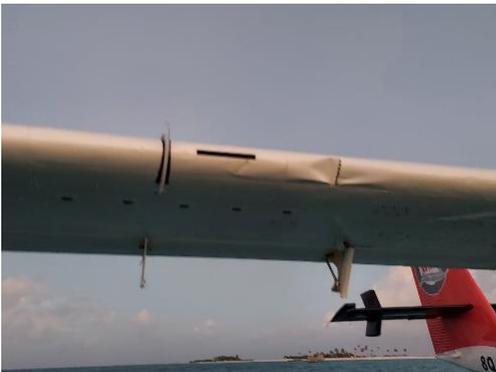
Figure 11: Damages to Right Wing

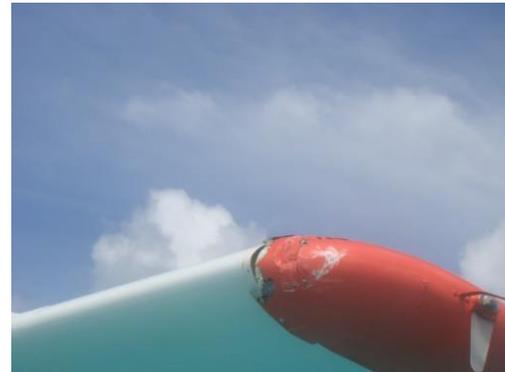
Figure 12: Damage left wingtip fairing

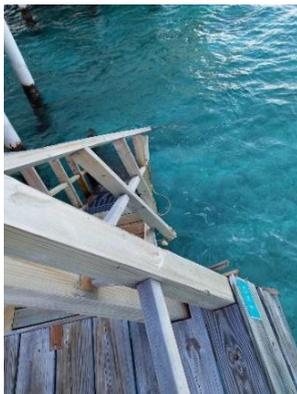
As a result of the aircraft coming in contact with the wooden structure the staircases of two water bungalows were found damaged. These include dislocation of several deck planks.

Figure 13: Damages to jetty of water bungalow

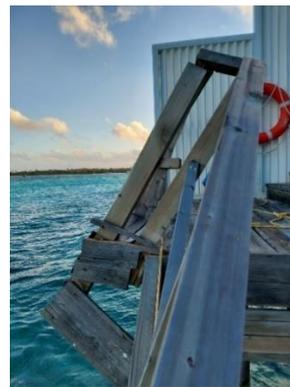
Figure 14: Damages to water bungalow

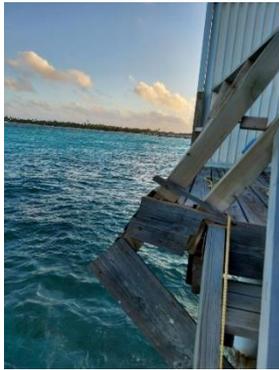
Figure 15: Damages to jetty of water bungalow

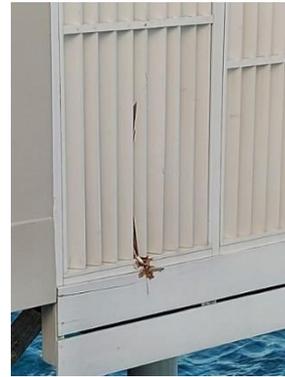
Figure 16: Damages to jetty of water bungalow

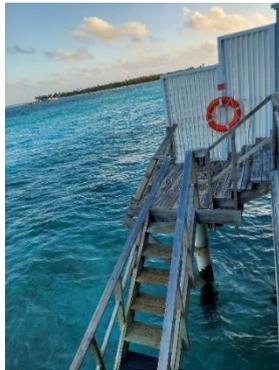
Figure 17: Damages to jetty of water bungalow

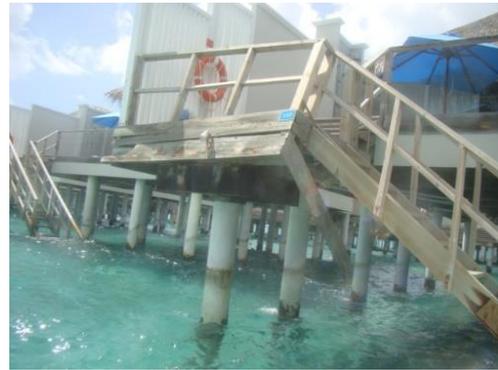
Figure 18: Damages to jetty of water bungalow

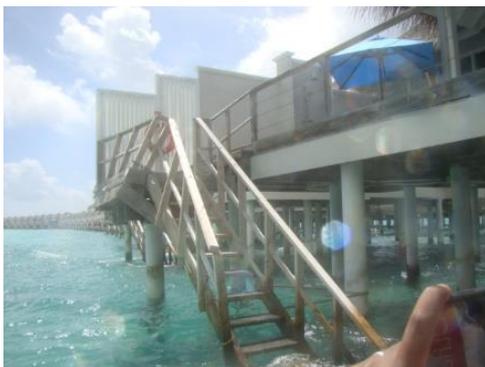
Figure 19: Damages to jetty of water bungalow

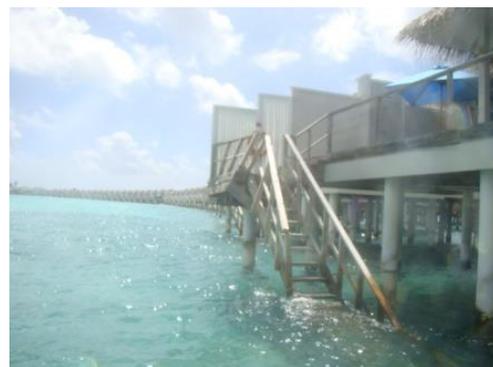
Figure 20: Damages to jetty of water bungalow

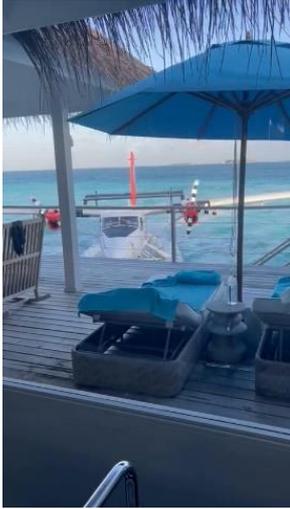
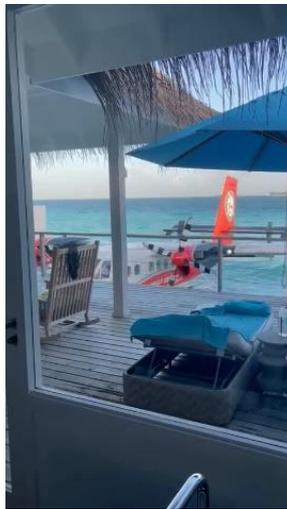
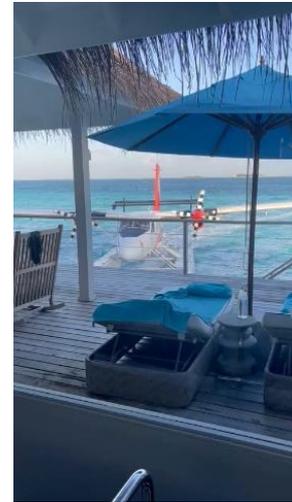
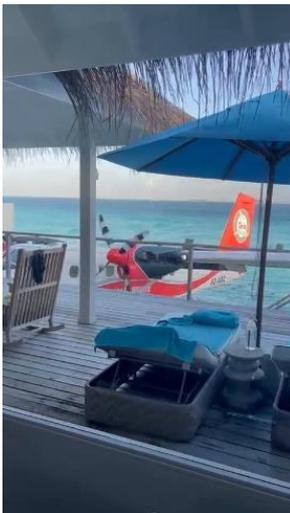
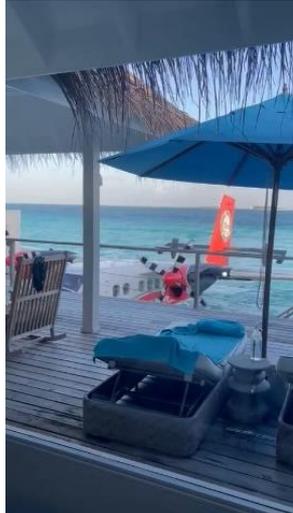
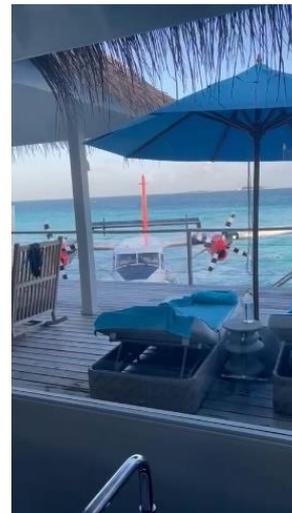
4.6 Still pics – in sequence; captured from the Video at the time aircraft came in contact with the bungalow

After the engines were shut down, the aircraft moved forward under momentum and came in contact with two water bungalows. As a result, the aircraft and the bungalows sustained damages. RH propeller, RH wing tip and the LH wing of the aircraft were damaged. The wooden staircases of the two bungalows were damaged.
