AIRCRAFT SERIOUS INCIDENT REPORT 2020/02

**FINAL REPORT ON INVESTIGATION OF THE
SERIOUS INCIDENT INVOLVING CESSNA 172 RG AIRCRAFT, 8Q-GAD,
OPERATED BY ASIAN AVIATION ACADEMY
AT GAN INTERNATIONAL AIRPORT, MALDIVES,
ON 04 JANUARY 2020**

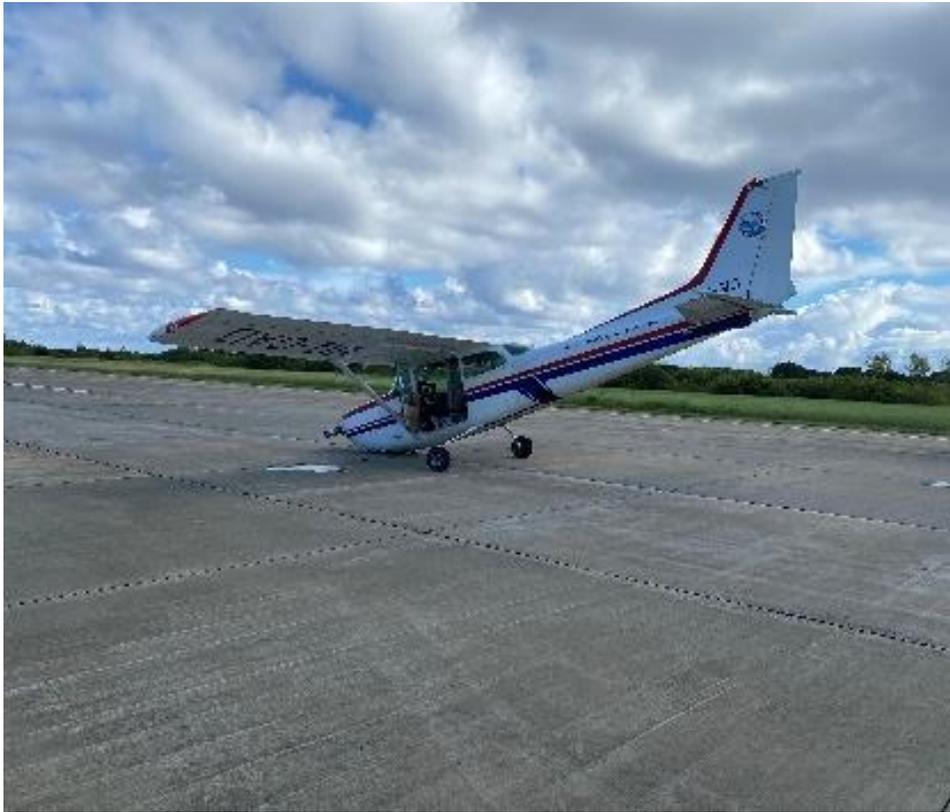
After having exhausted all their efforts to confirm positive extension of the landing gears with ATC, the instructor pilot landed the aircraft. On landing however, the nose landing gear collapsed (Appendix, Figure 1, para 5.5). Aircraft came to a halt with the propeller striking the runway. The crew evacuated the aircraft without any injuries.

Figure 1: Aircraft on runway

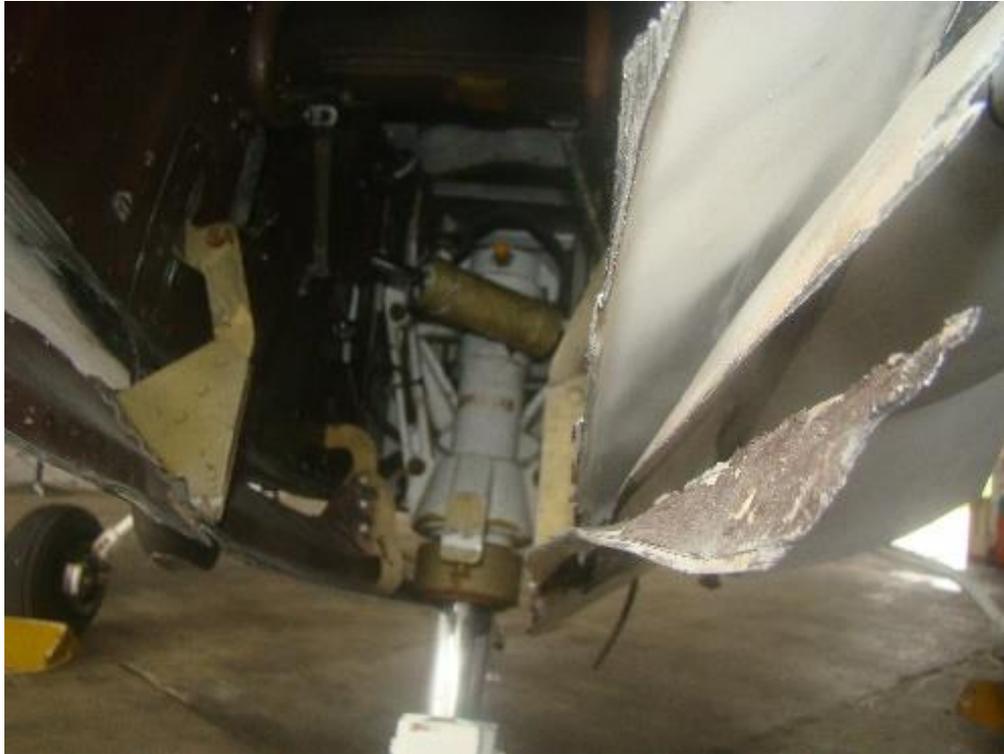
Figure 2: NLG wheel well

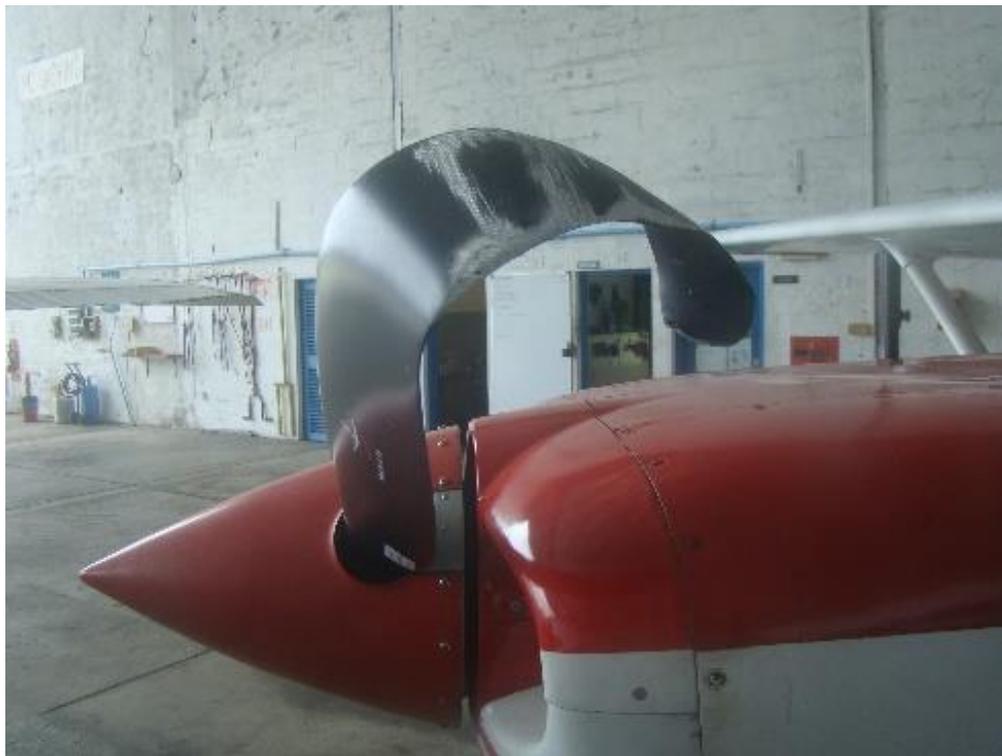
Propeller is found badly damaged; blades bent, twisted and chafed, as seen in the images in the Appendix 5.7 of this report.

Figure 3: Bent Propeller

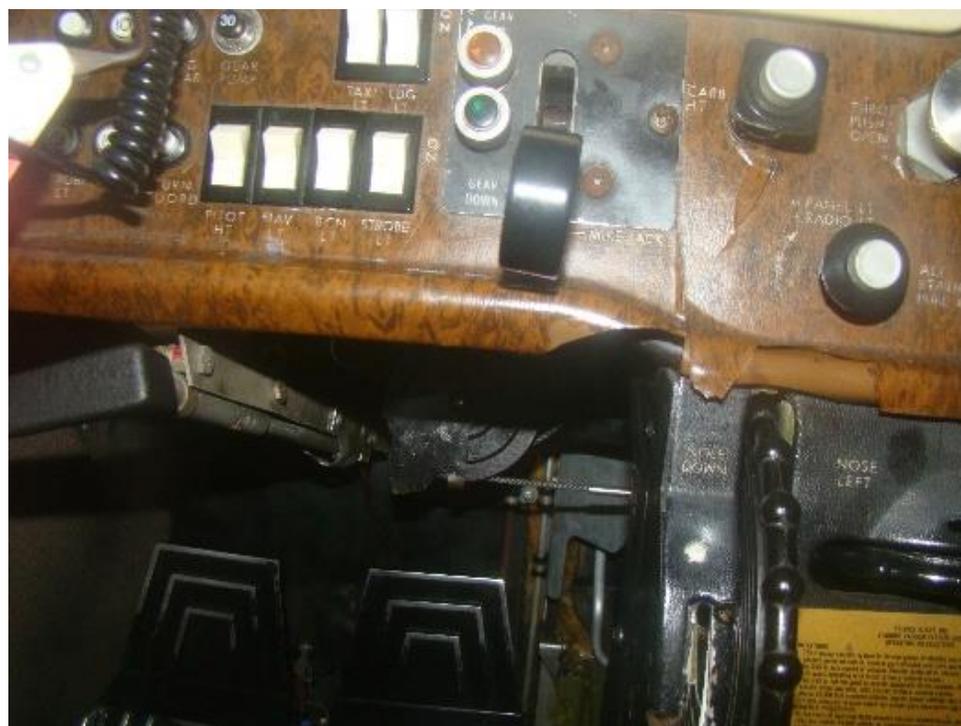
The aircraft is incorporated with a modification; installing a red indicator light replacing the UP indicator (amber) light which cautions the pilots of GEAR UNSAFE condition. The GEAR UNSAFE (red) light is ON anytime the gear is in transit (retract cycle), or whenever system pressure drops below 1000 psi with the safety (squat) switch closed.

Physical survey carried out confirm that AAA had installed an indication light (red) in the cockpit of the aircraft on the aircraft to indicate a 'gear unsafe indication light (red)' condition. While its intent is sincere, AAA could not demonstrate approval of the modification by MCAA and hence it is construed as an unapproved modification.

Figure 5: landing gear selector switch and gear position indicator lights

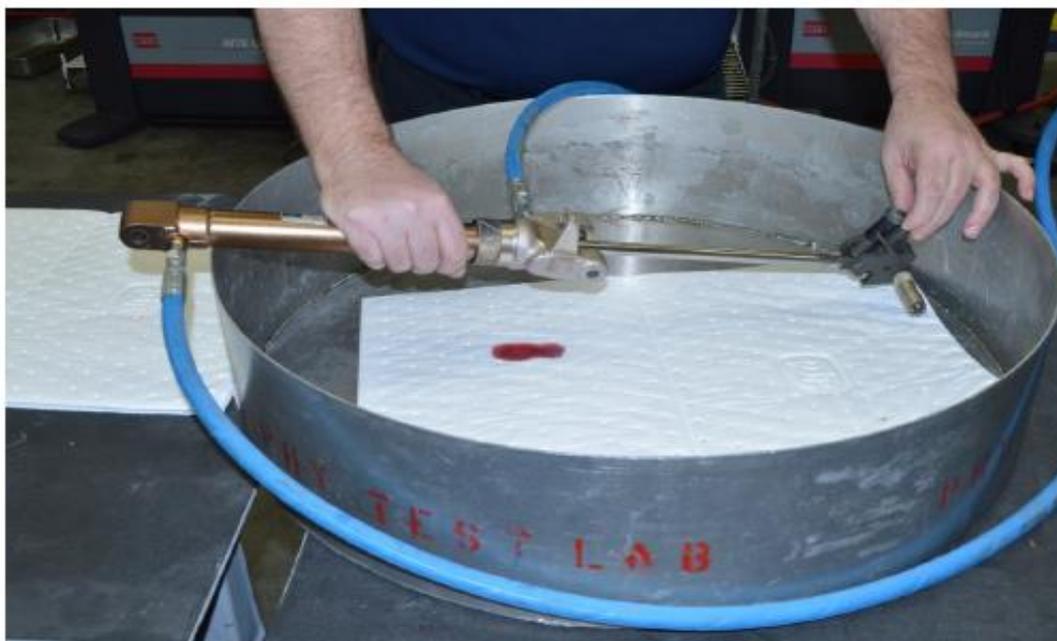
The actuator was initially pressurized to unlock the actuator. The lock mechanism disengaged; no anomalies were noted. The valve on the hand pump was selected to pressurize the actuator retract (gear extend) port. Initially, before a pressure buildup, a significant leak was observed at the actuator rod seal (Figure 3). Pumping was continued and the leakage stopped. The actuator was hydraulically retracted to the locked position, no anomalies were noted with the lock mechanism. The actuator was once again hydraulically extended. During the second retraction, alternating side load to the rod to actuator cylinder interface was applied. While manipulating the actuator, significant leakage was once again observed. The leakage was intermittent throughout the stroke, depending on sideloading and hydraulic pressure.

Figure 3 Piston Rod Leakage

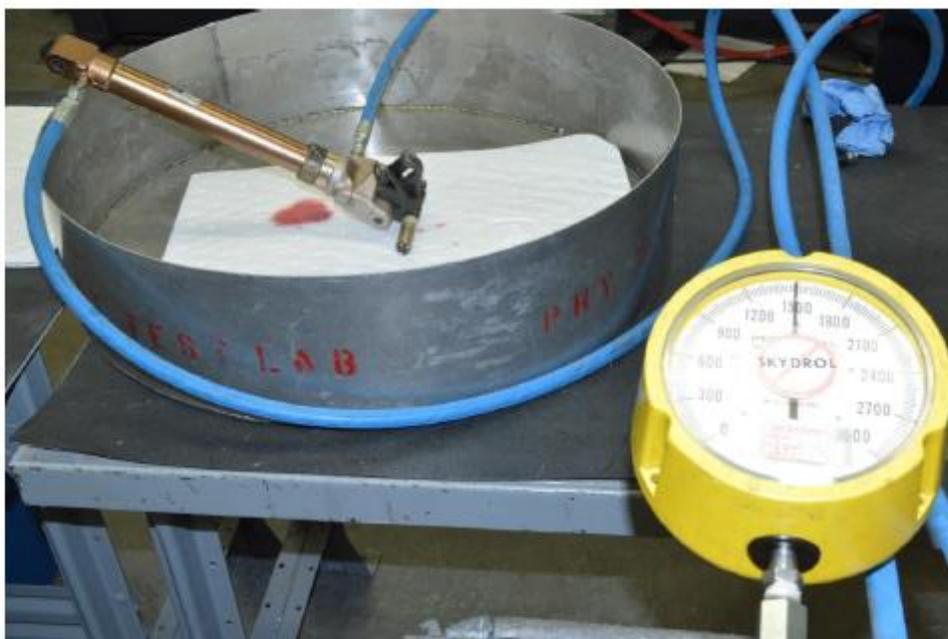
A test was performed to determine the integrity of the piston and cylinder. The actuator was hydraulically actuated to the fully retracted position and 1500 psi was applied. Significant piston seal leakage was not observed. During this test the rod seal that previously experienced significant leakage did not leak (Figure 4). The opposite was performed, pressure was applied to the extend port. The actuator bottomed in the cylinder in the extended position and 1500 psi applied, internal piston leakage was not observed.

Figure 4 Piston Leakage Check

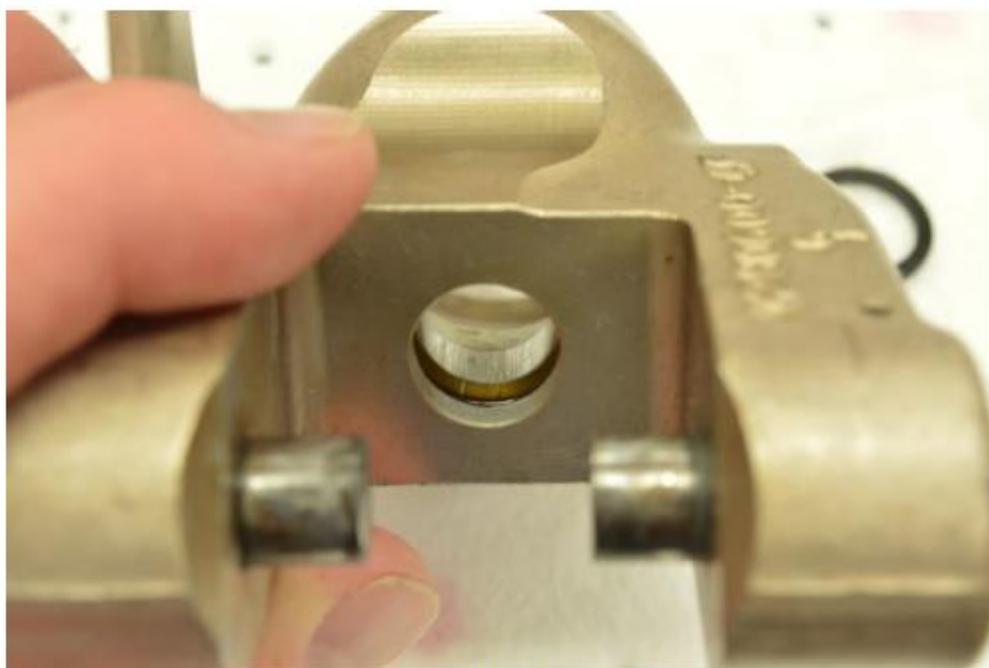
A disassembly was performed. Visual examination revealed wear and scratches in the Bearing End bore PN 1280600-5 (Figure 5). Visual examination of the rod revealed an area near the rod end with slight scoring, scratches and wear. The rod seal and backup ring was intact and did not show visually obvious defects.

Figure 5 Bearing End Bore

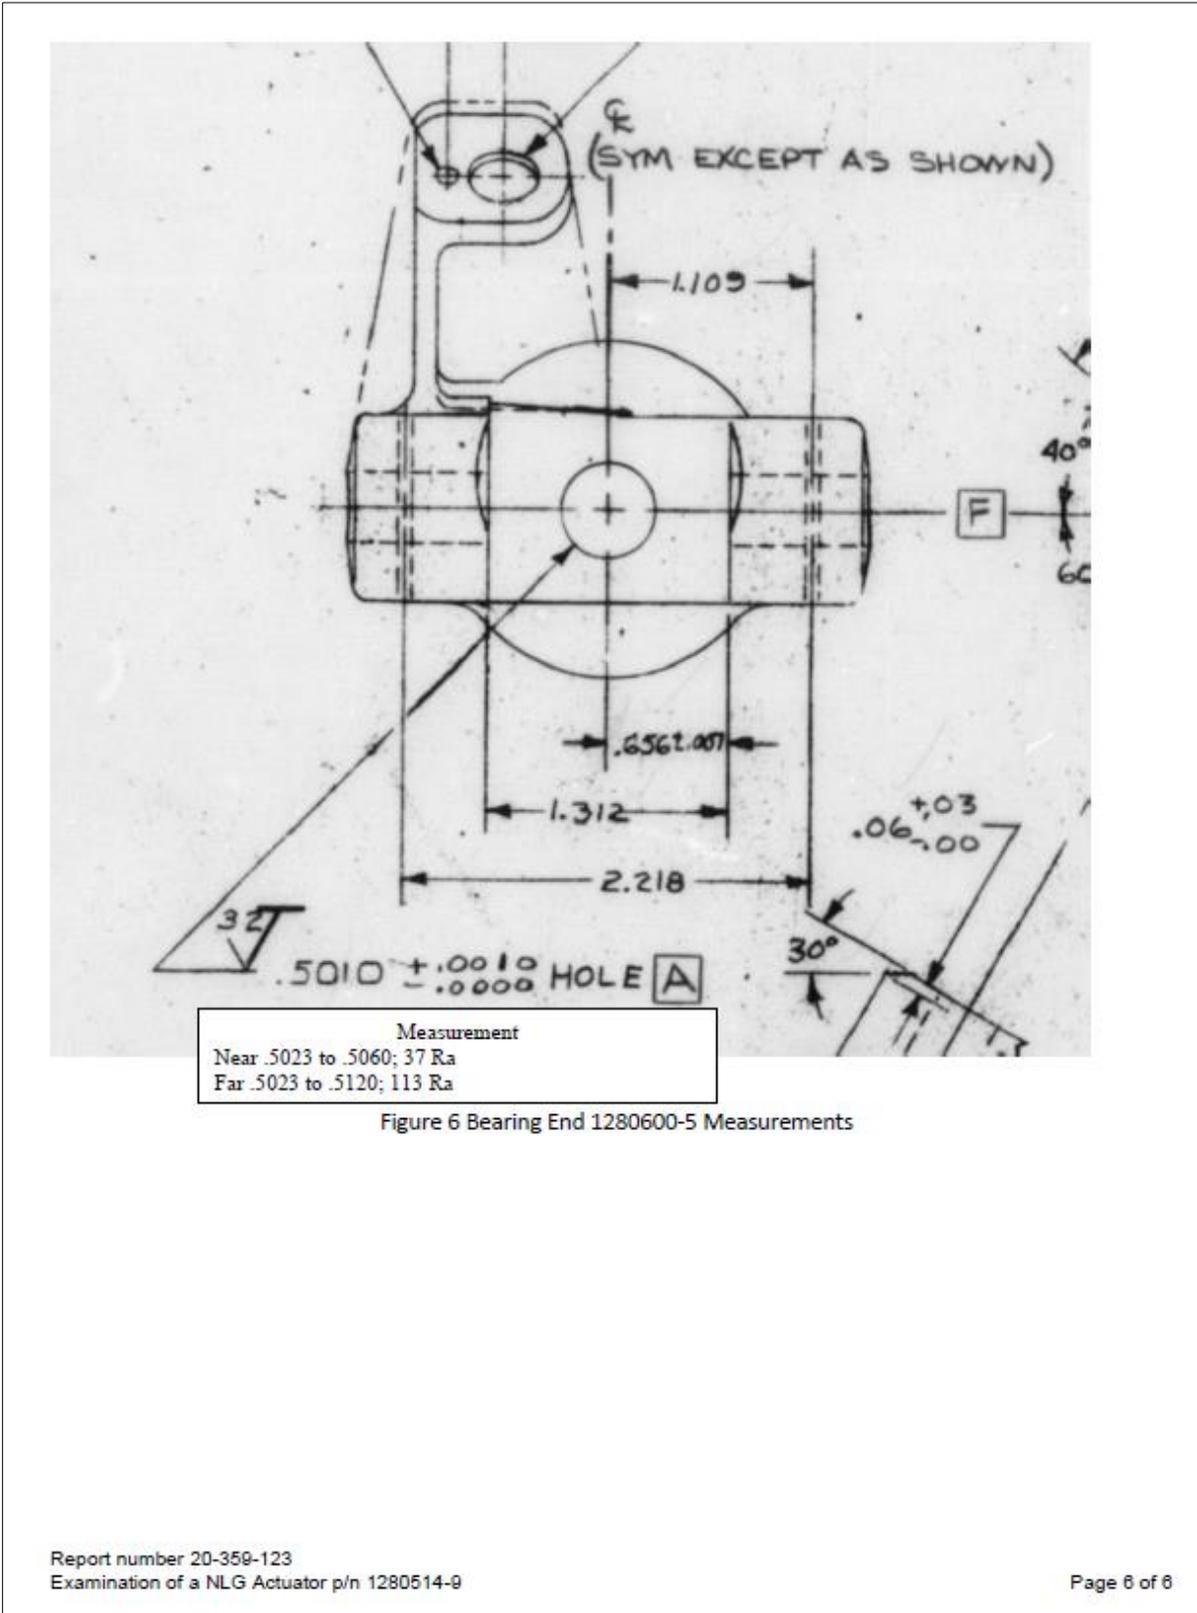
Dimensions of the Bearing End PN 1280600-5 and Piston PN 1280241-2 were taken. The Bearing End bore presented significant wear with the surface finish and dimensions beyond limits (Figure 6). The Piston rod presented significant wear with the dimensions and surface finish beyond limits.

The actuator may experience significant external leakage during the retract actuation due to significant wear to the Bearing End bore and Piston rod beyond serviceable limits. The external leakage may be intermittent depending on multiple factors including extended position, side loading, and pressure. During the period when the leakage is present, it is significant enough that the actuator would be incapable of producing the designed retract force. If the leakage persisted it may deplete a significant amount of the reservoir fluid volume.
