Republic of Maldives

SAFETY INVESTIGATION REPORT 2023/03

INVESTIGATION OF THE OCCURRENCE INVOLVING MANTA AIR OPERATED

DHC-6-200, 8Q-RAL FLOATPLANE WHILST LANDING

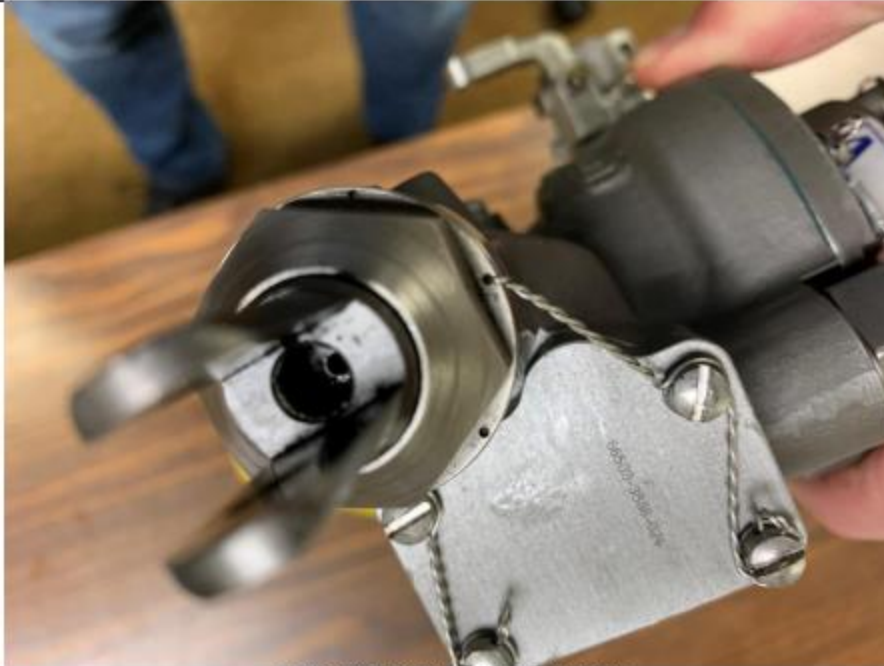
Testing and research carried out by Woodward found that the beta valve plunger assembly, a constituent part of the CSU, was detached at the brazed joint: clevis piece separated completely from the plunger.

Figure 1 Separated Beta Valve Assembly

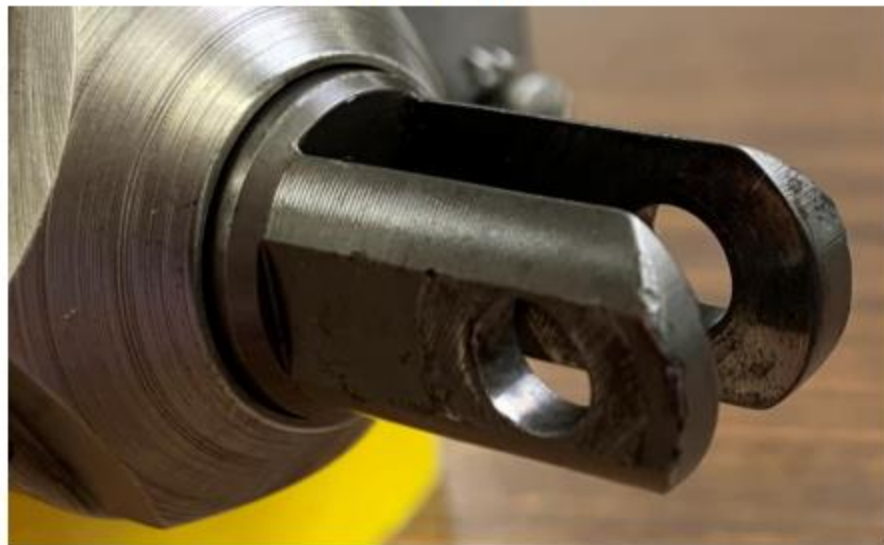
When the CSU was examined, the Beta valve clevis was found to be loose. The CSU was sent to Woodward Inc., for further investigation. The task was carried out by Woodward under the direct oversight of the NTSB.

Figure 2 Beta Valve Clevis Damage

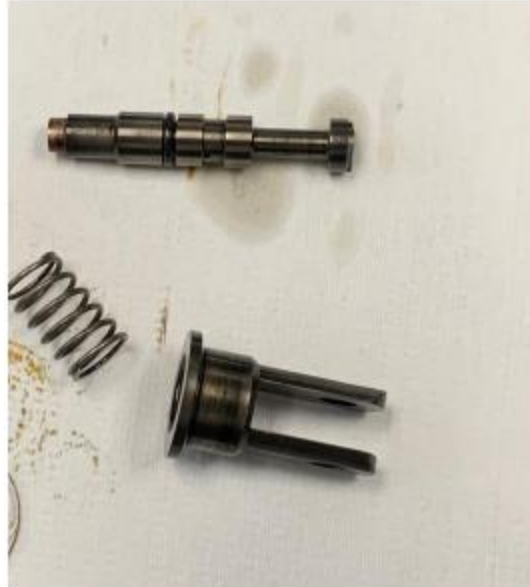
Following testing the unit was disassembled. The beta valve assembly was removed. The components of the beta valve are designed to be brazed together. The braze operation is performed by Woodward during manufacturing. As a process control, the joints are 100% tested with a 500lb load. On this returned unit it was confirmed that there was separation of the braze joint between the plunger and head (see Figure 3).

Figure 3 Beta Valve Separated

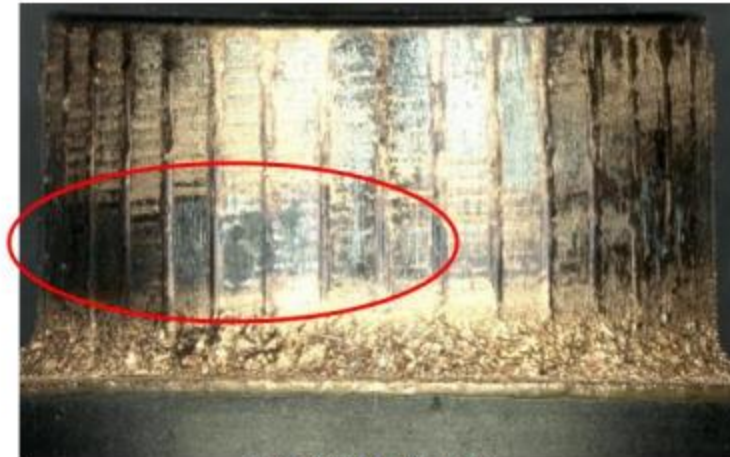
Upon further inspection the joint was fully covered in copper braze indicating the braze was properly applied. Additionally, there was no sign of corrosion or other environmental factors that appeared to weaken the joint. The beta valve assembly was bagged and sent to Woodward's materials lab for analysis. The materials lab confirmed there was no signs of corrosion/pitting but found a region with silver/dark gray appearance that was consistent with porosity (see Figure 4). However, the valve allows up to 50% porosity of the internal joint and the region detected was well below the requirement. The materials lab came to the following conclusions "The fracture surface showed predominantly shear overload of the copper braze material in a direction of the long axis of the assembly. Mechanical damage was present on both halves of the assembly which would have been caused by an event which placed a shear load on the braze joint. Composition of components and braze filler metal were all consistent with the specified materials."

Figure 4 Braze Joint Porosity

In summary, the beta valve was found separated and the braze joint was sent to Woodward's material lab for investigation. The lab determined the cause of the separation was due to a shear overload of the copper braze material. The Woodward team reviewed the operating loads that the joint would be subject to and determined that the loads are an order of magnitude lower than the 500 lb. load the braze joint is 100% inspected against. The braze joint was inspected and no corrosion/pitting was observed that would have reduced the joints structural integrity. Due to these findings, there was no evidence to suggest that the braze joint separated under normal operation, further root cause into the overload event was not isolated during the investigation.
