AIRCRAFT ACCIDENT REPORT P2020/03

PRELIMINARY REPORT

**ON INVESTIGATION OF THE ACCIDENT INVOLVING VIKING AIR
DHC-6-300, 8Q-TMF AIRCRAFT
AT VELANA INTERNATIONAL AIRPORT WATER AERODROME, MALDIVES
on 05 October 2020**

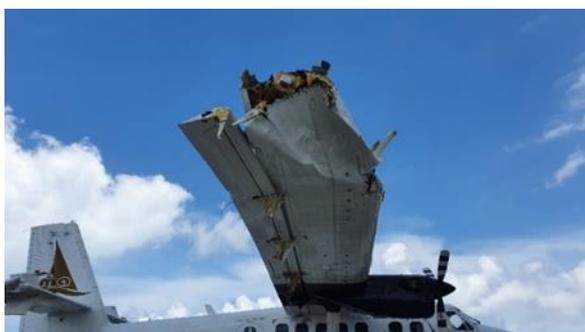
Figure1: RH Wing

1. Right Hand Wing:
 - a. Various damages in the area between ribs 25 to 28
 - b. The leading-edge bottom skin towards the wingtip buckled upwards
 - c. Wing tip severely crushed and material missing
 - d. Wing fin dislocated with the leading edge shifted outboard
 - e. The inboard trailing flap skin buckled upward
2. Left Hand Wing:
 - a. Leading edge bottom skin buckled upwards
3. Left Hand Propeller:
 - a. LH propeller blades (all three of them) bent aft
 - b. LH propeller assembly dislocated
4. Airframe:

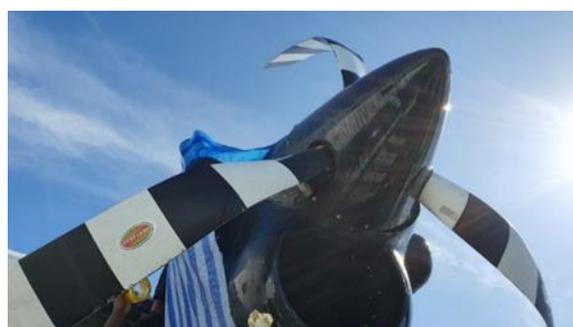
Figure 2: LH Propeller

Immediately after the "U turn" the left wing abruptly dropped which resulted in the left wing and LH engine propeller blades impact the water heavily causing damage to the wing and the propeller blades.
