## **Accident Investigation Coordinating Committee**

### **Aircraft Accident Report 2017/01**

Final Report on the Accident to  
Viking Air DHC-6-300, 8Q-TMV  
Velana International Airport, Maldives  
27 May 2017

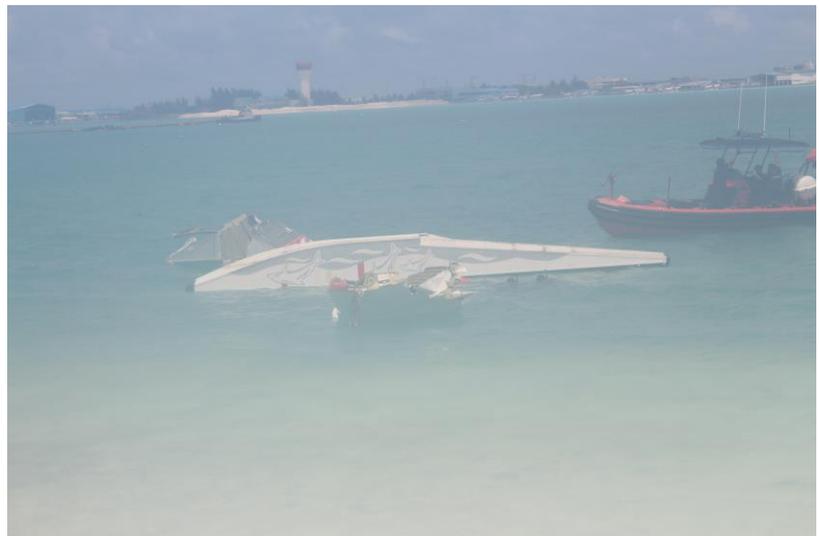
*Figure 1: Aircraft position when the investigation team arrived to the site*

While landing left float touched the water first, then the aircraft bounced and ballooned; then landed on the left float for a second time, and bounced again. Then the aircraft was banking excessively to the right digging the right wing tip in the water, making the aircraft veer to the right.

Then the aircraft crashed on water banking to the left with left float digging into water.

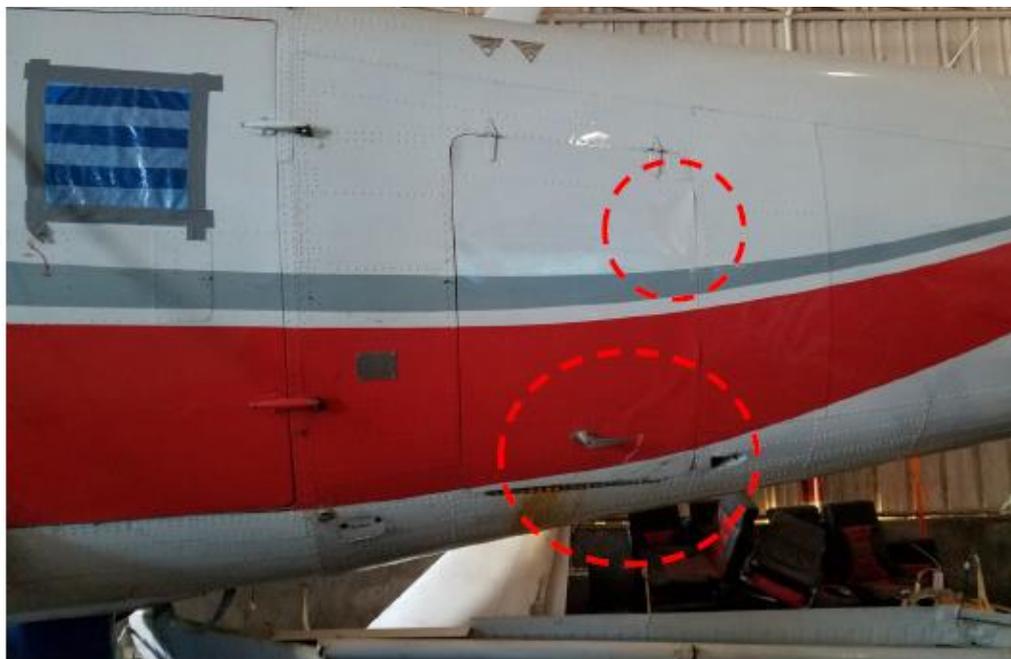
*1: Damage to outer skin of rear baggage compartment door. Large dents on the entire surface.*

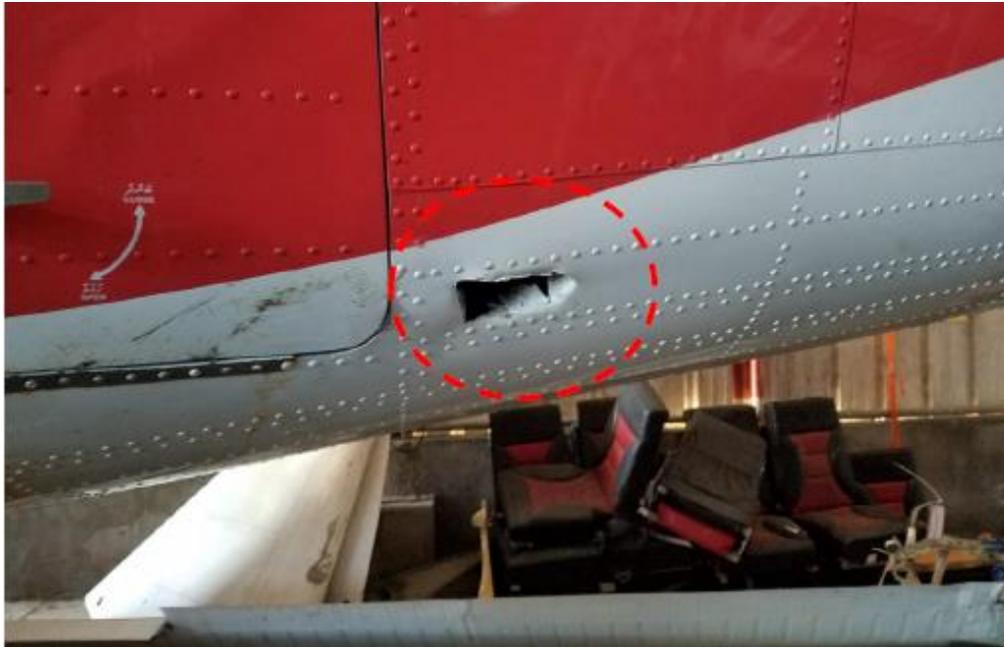
2: Large dent and puncture on step strut attachment point on fuselage aft of rear baggage compartment door.

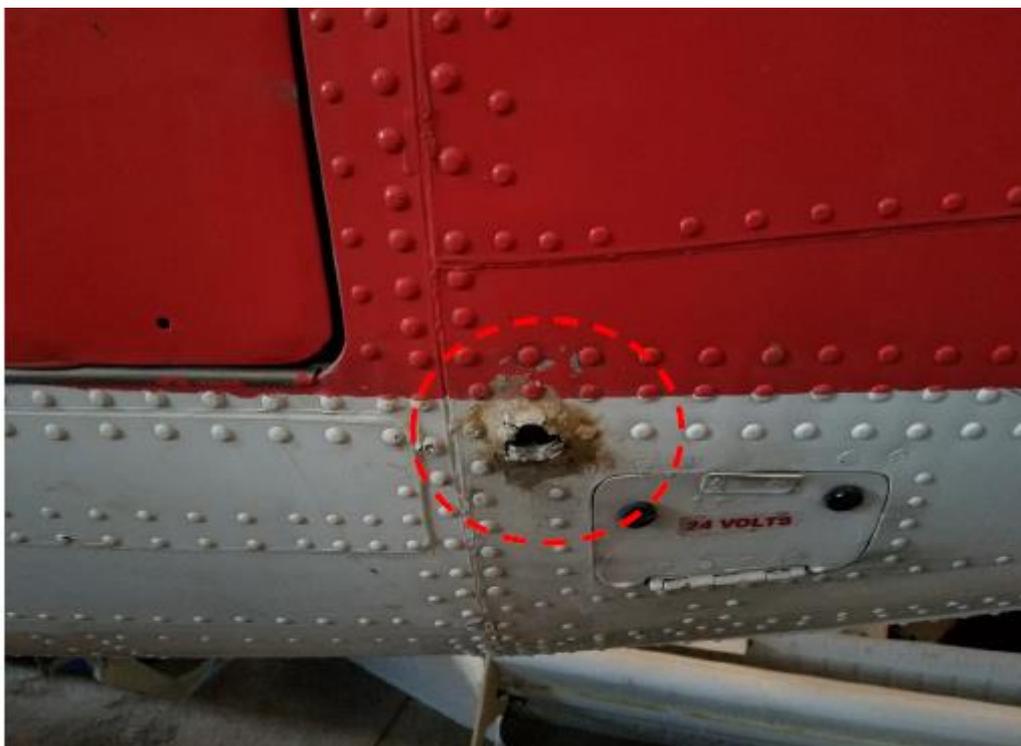
3: Step strut attachment point broken off leaving a hole. Cracks propagating from the damaged area

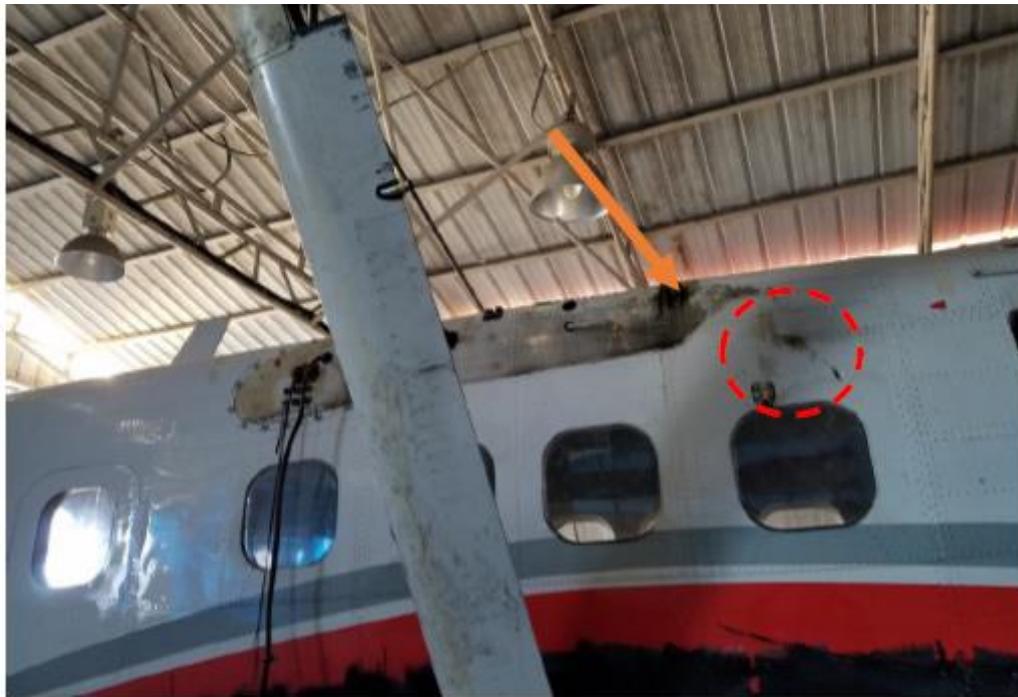
5: 7" Puncture of fuselage skin above port side cabin window 6.

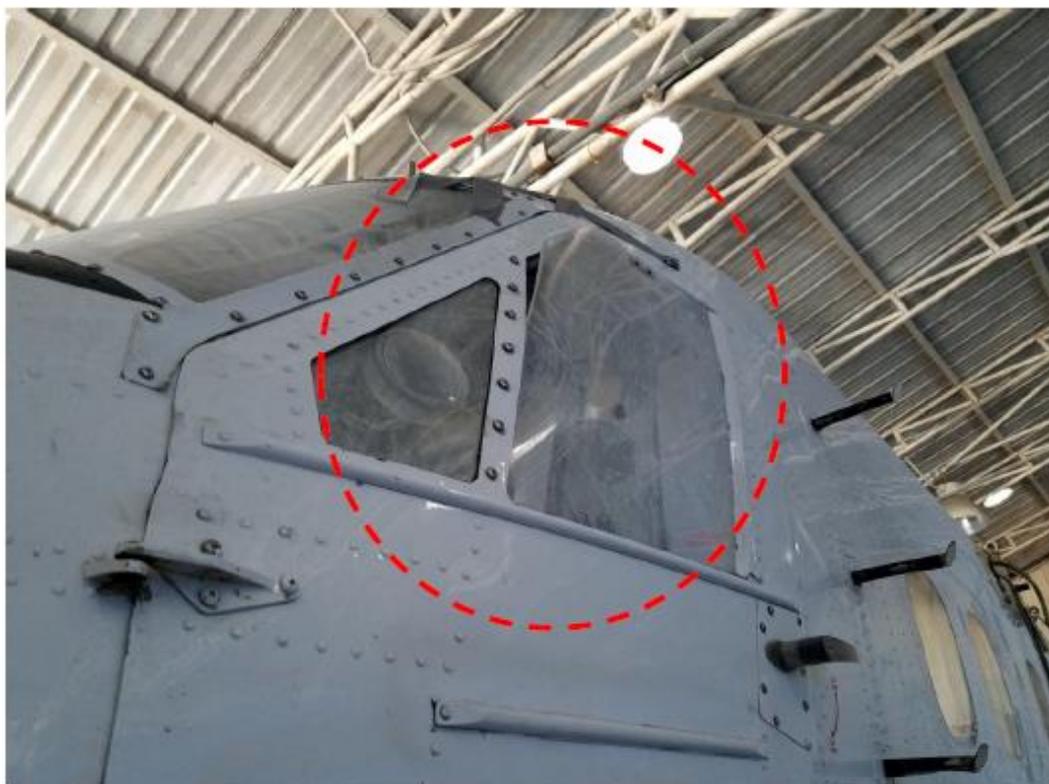
4: Sliding window on the port side deformed and pulled out of groove

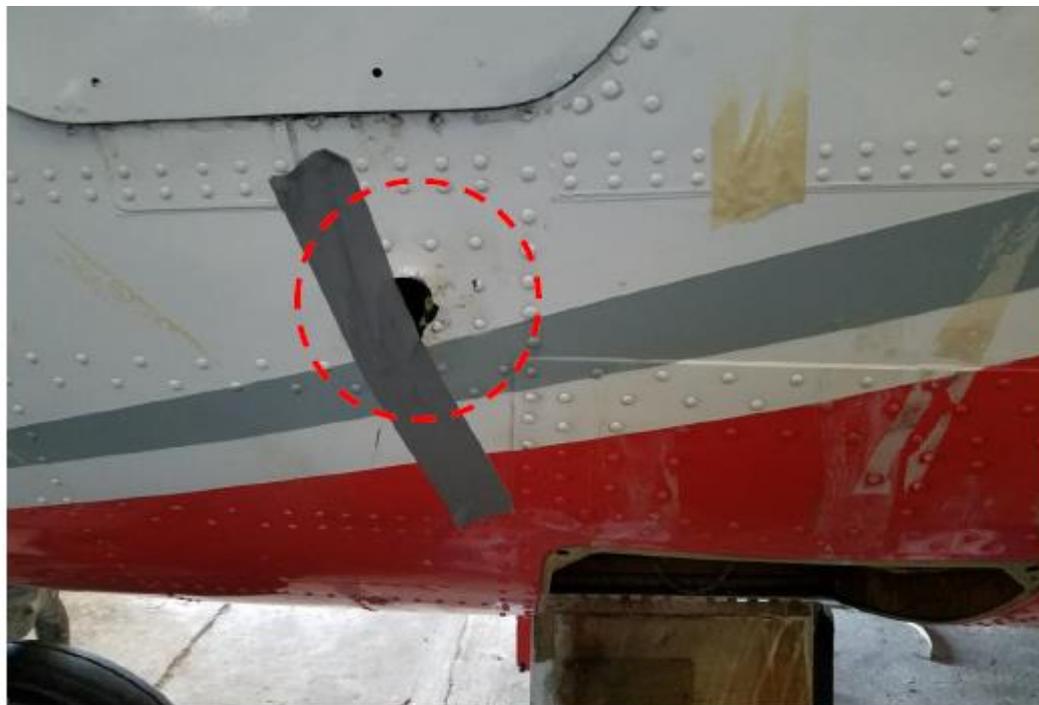
*6: Step strut attachment point sheared off leaving hole of approximately 3" diameter on the fuselage skin below port side Pilot door*

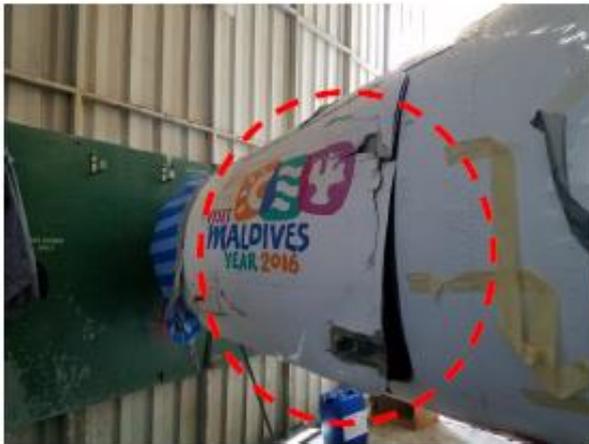
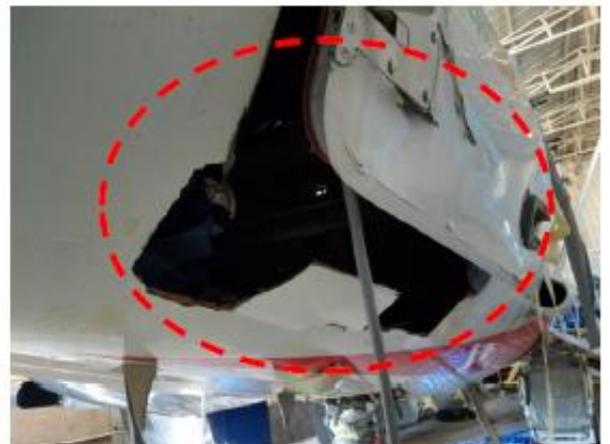
*7: Multiple cracks, fractures and major dents on the door. Door latch broken. Fuselage skin under door damaged and ripped off*

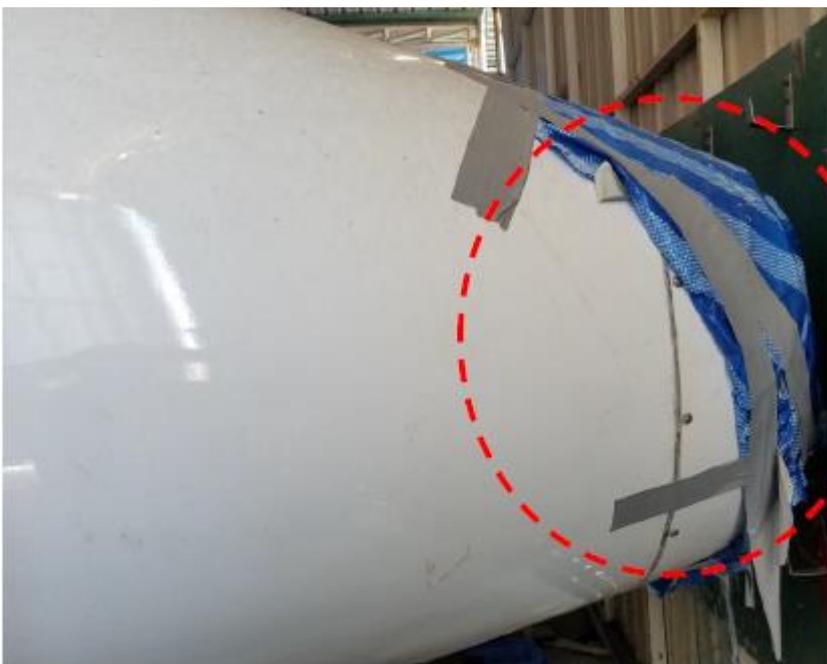
*8: Nose cone crushed inward due to impact when aircraft was being lowered to M5 dock*

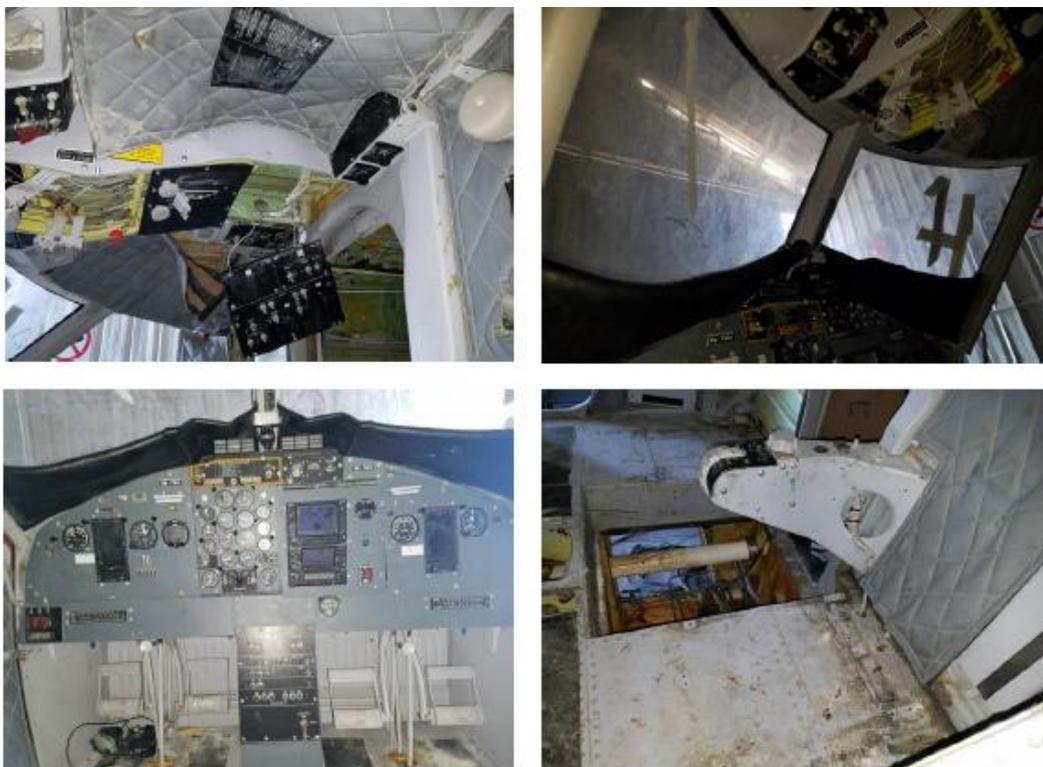
10: Water damage to all flight deck avionic equipment and furnishings

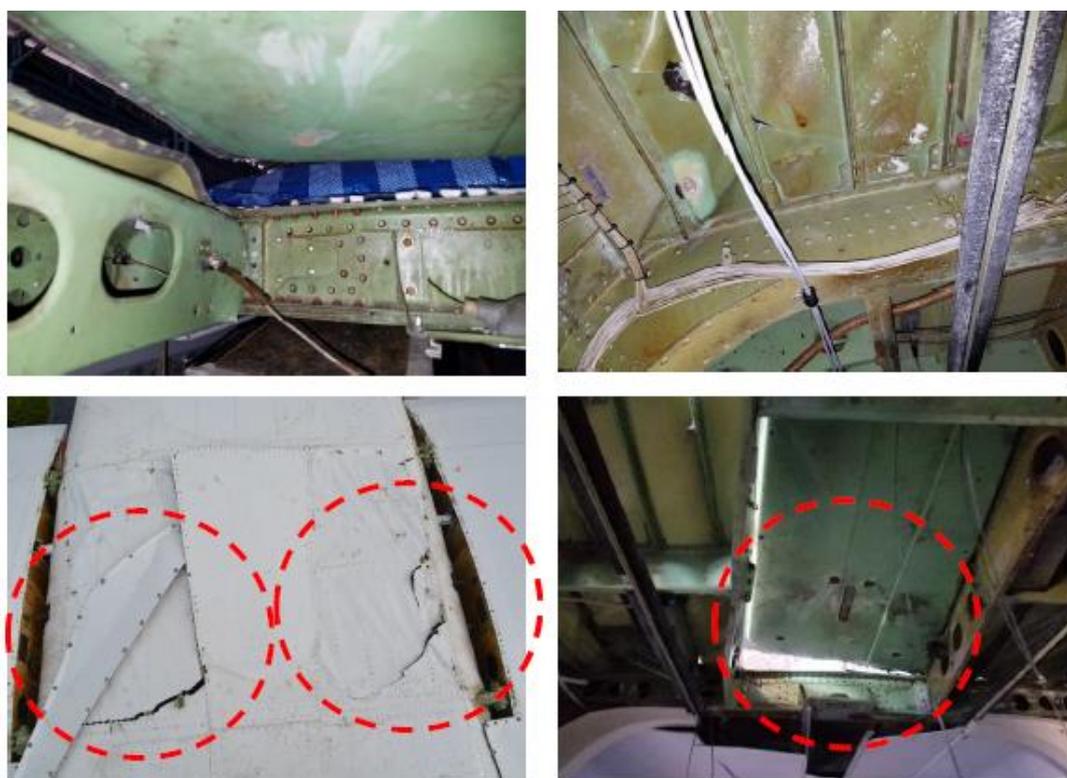
9: Fuselage skin crumpled and deformed on top and side of fuselage where ropes went around it to hoist the fuselage out of water. Rivets sheared and mating flanges exposed

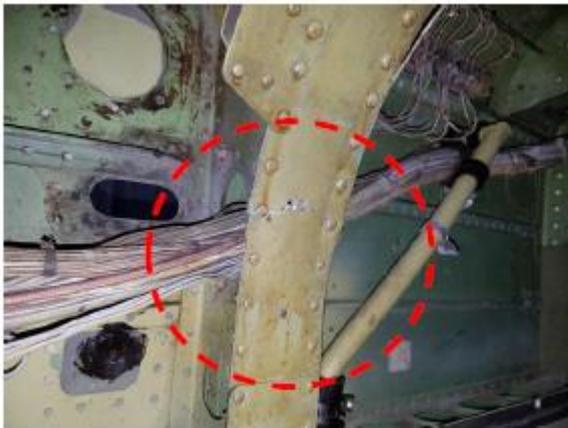
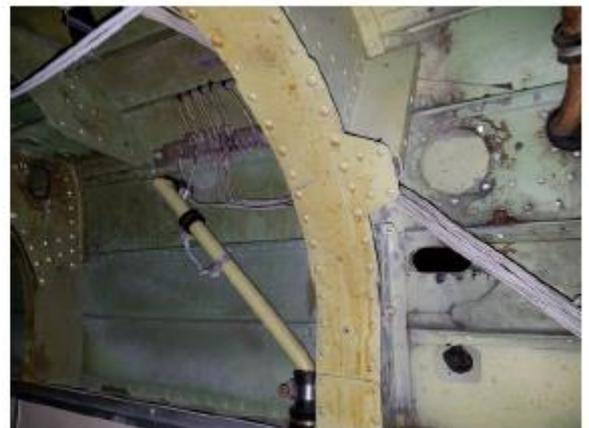
11: Frame 239 cracked

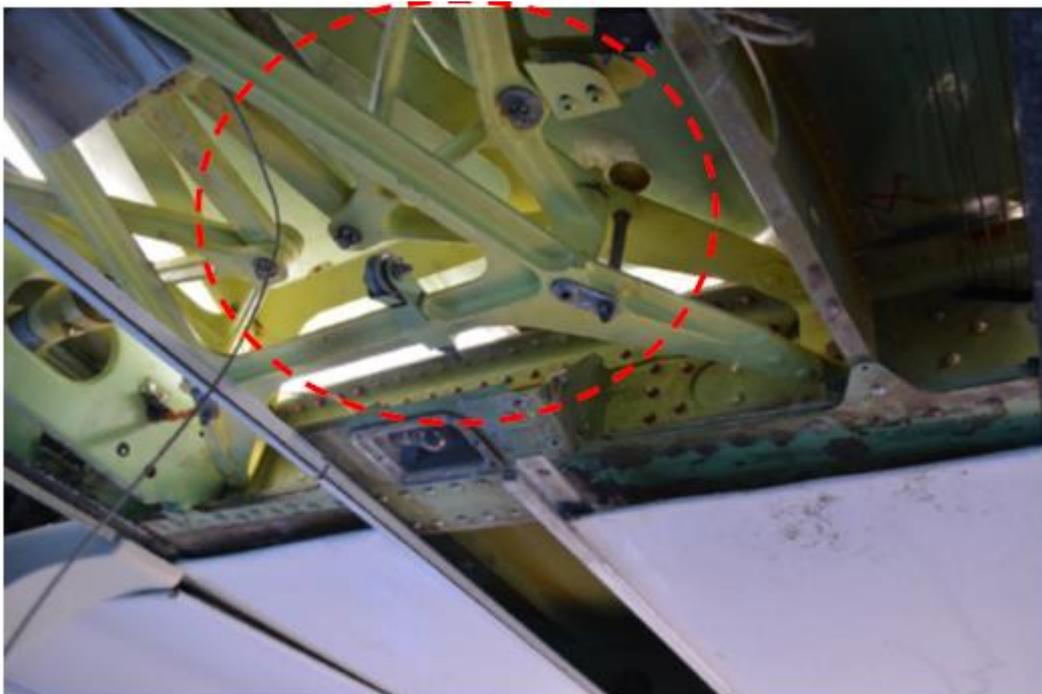
12: Fuselage top skin and stringers bent and crumpled above 'A Frame'

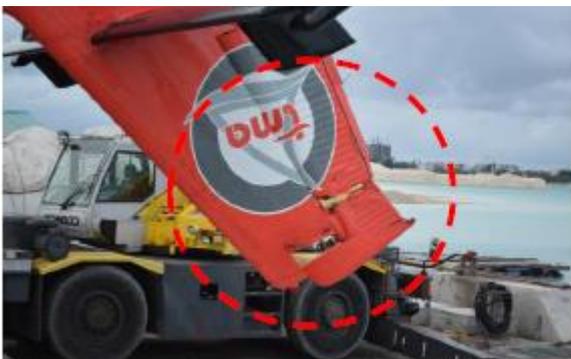
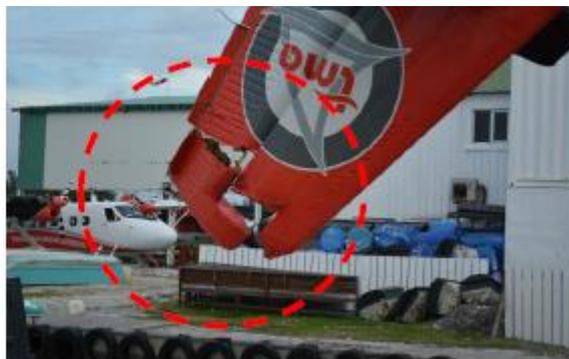
13: Rudder was found to be cracked and split in half

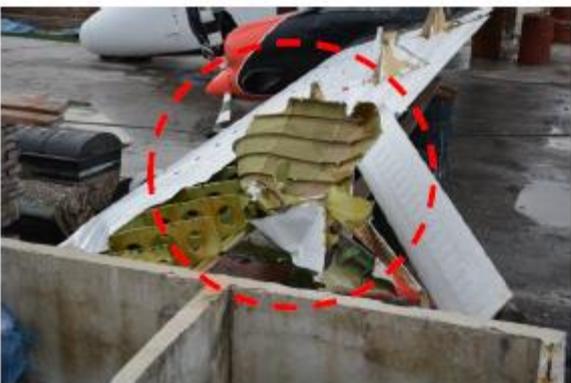
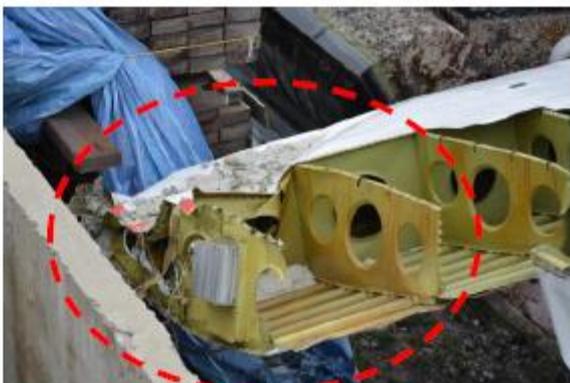
13: Damage to R/H wing from STA 376.20 to 272.00 including damage to aileron

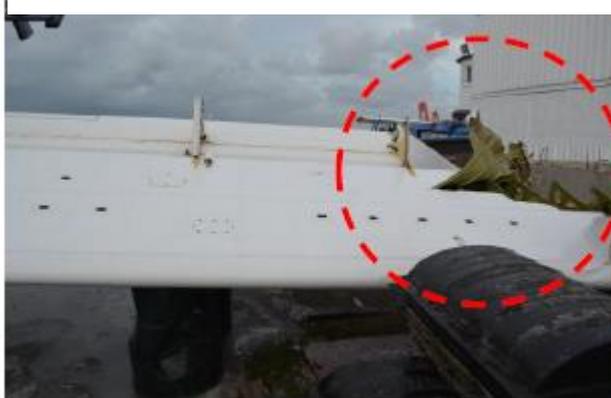
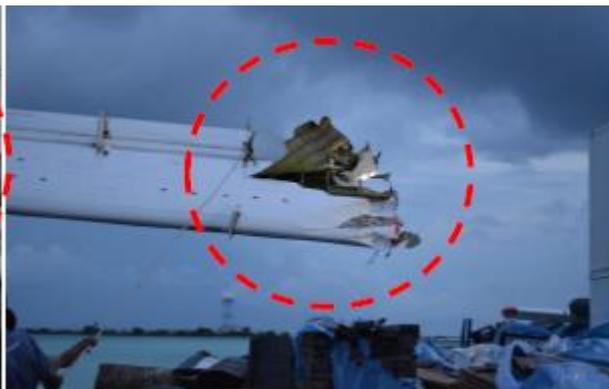
15: Damage from STA 376.20 to 322.00 L/H Wing

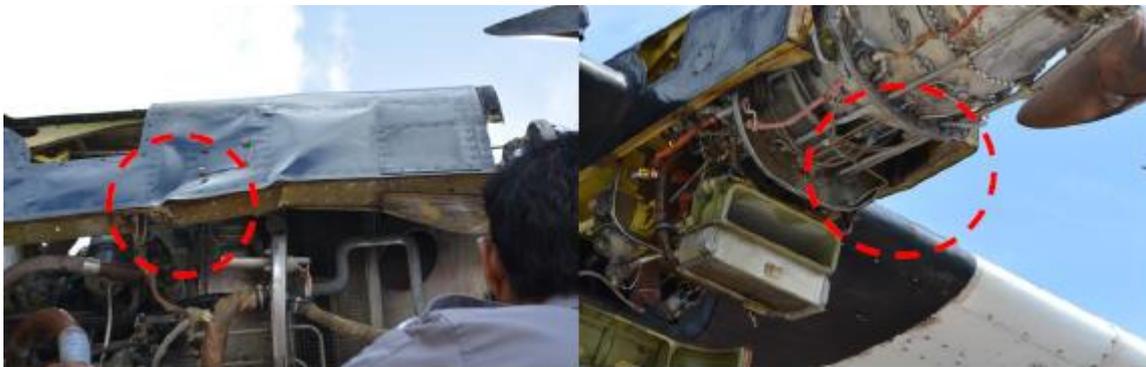
16: Cracks on outboard longeron of R/H and L/H engine
