ACCIDENT INVESTIGATION COORDINATING COMMITTEE

AIRCRAFT ACCIDENT REPORT P2021/02

PRELIMINARY REPORT

**ON INVESTIGATION OF THE SERIOUS INCIDENT INVOLVING VIKING AIR
DHC-6-300, 8Q-MBC AIRCRAFT
AT FINOLHU RESORT WATER AERODROME, MALDIVES**

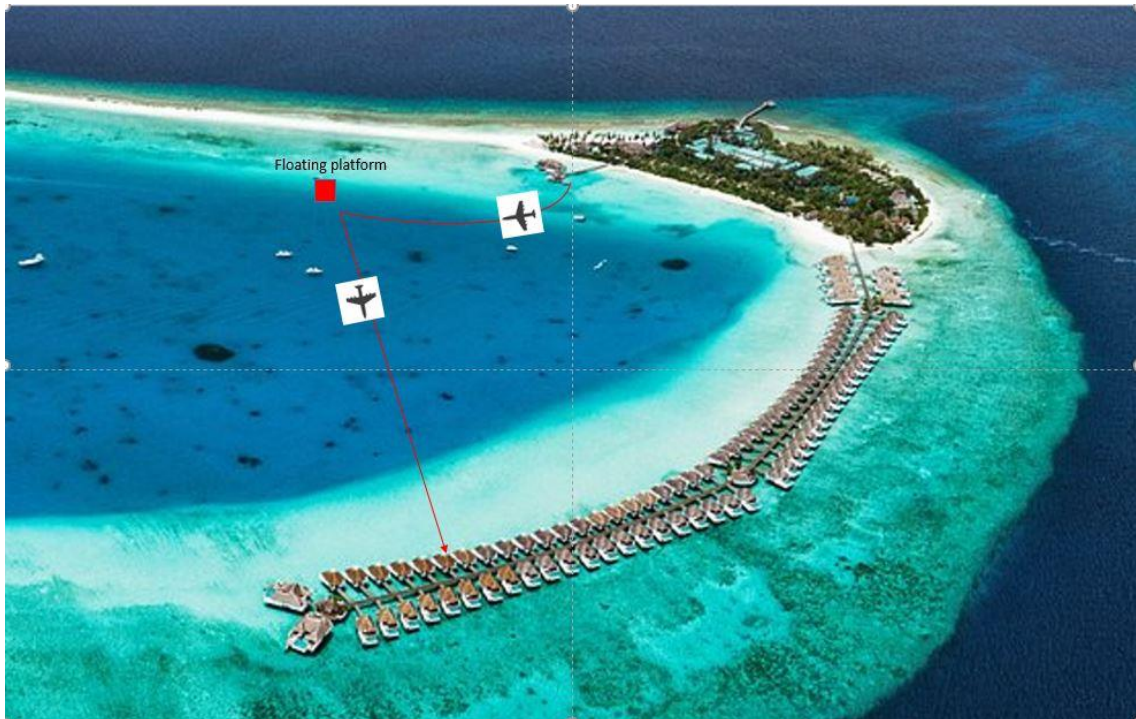
4.1 Aircraft take-off path

During take-off from the Island in a north-westerly direction, towards a stretch of water bungalows, the crew aborted the take-off. While aborting the take-off the crew attempted to reverse both the engines but were not able to move the power levers to reverse the aircraft. The crew then shut down both engines, but under momentum the aircraft kept moving until it collided with water bungalow and stopped. The aircraft sustained damages to its LH wing, RH wing tip, and one of the RH propeller blades.

The aircraft moved forward under momentum even after the engines were shut down and collided with water bungalows. As a result of the collision, both the aircraft and the bungalows sustained damages. The RH propeller, RH wing tip and the LH wing were damaged.

8Q-MBC approximate flight path
