ACCIDENT INVESTIGATING COORDINATING COMMITTEE
MALDIVES CIVIL AVIATION AUTHORITY
2nd Floor, Velaanaage, Ameer Ahmed Magu, Male', 20096, Maldives

PRELIMINARY SAFETY INVESTIGATION REPORT

Report Number: 2024/01/P
Date: 31 July 2024

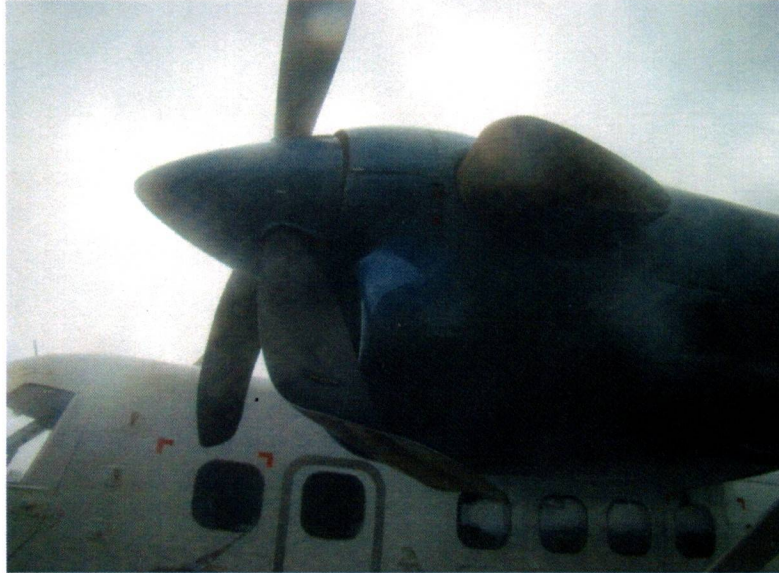
1. All the three LH propeller blades were severely bent.
2. The LH engine was seized, and propellers cannot be rotated freely.

Fig 3: LH propeller blades

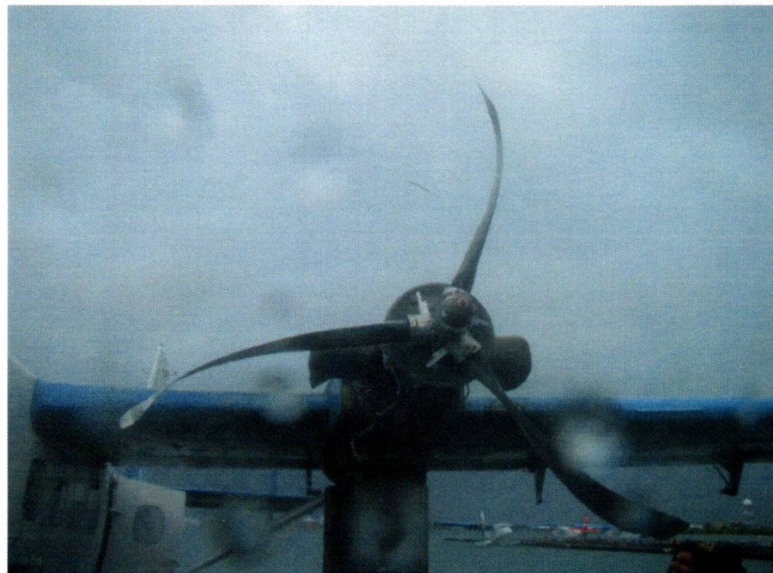
Fig 4: LH propeller blades

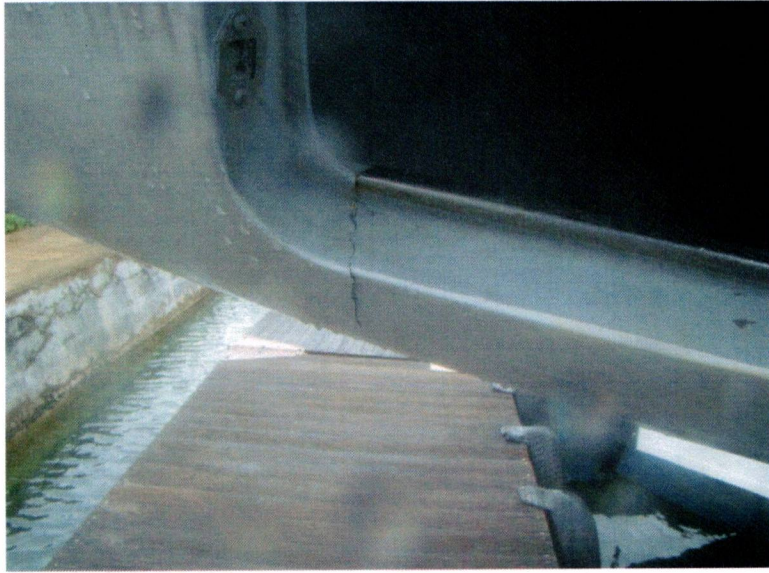
Fig 5: Nose skin cracked STA 100

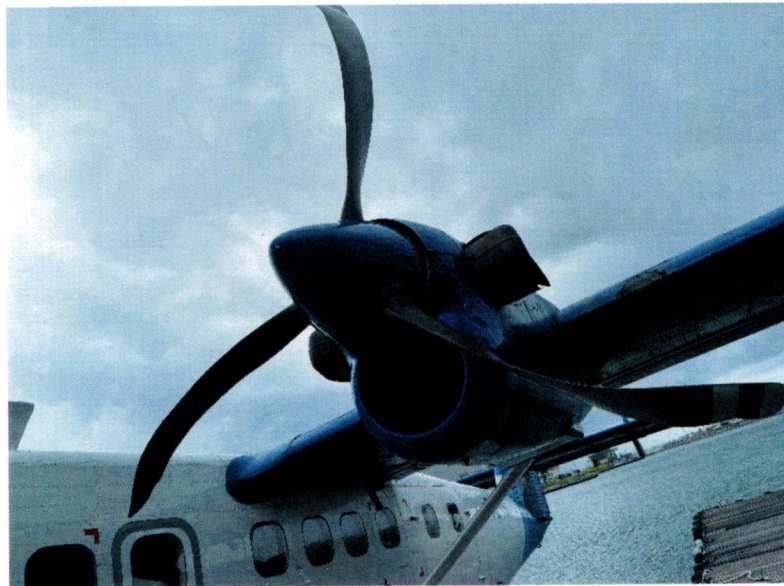
Fig 6: LH Propeller damaged

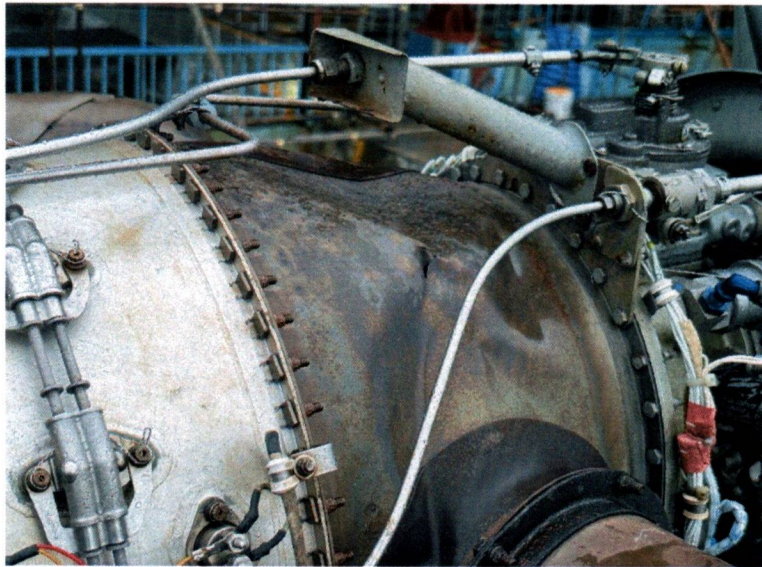
Fig 7: LH engine exhaust section casing skin buckled and cracked

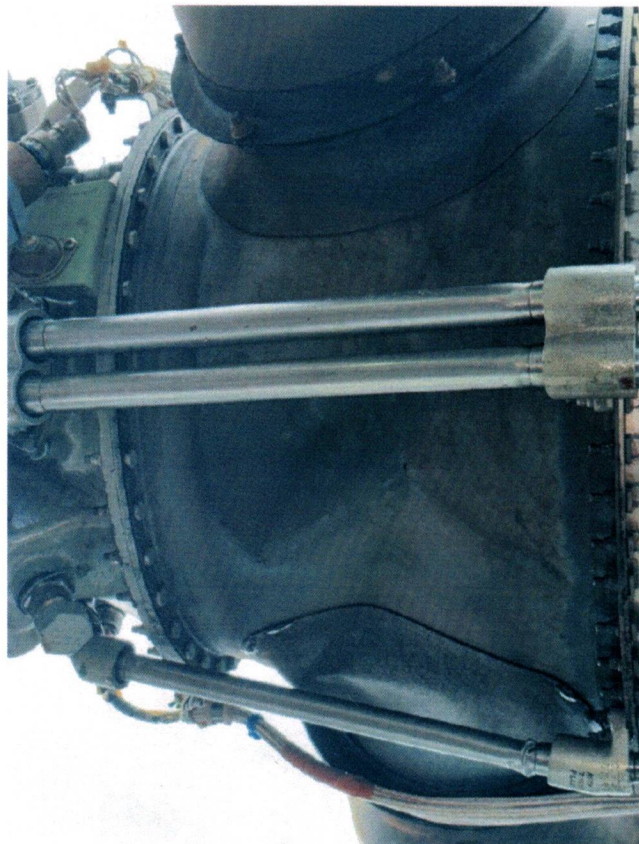
Fig 8: LH engine exhaust section casing skin buckled and cracked
