SAFETY INVESTIGATION REPORT 2023/01

WING IMPACTED WATER DURING LANDING

VIKING AIR DHC-6-300 TWIN OTTER, 8Q-TAQ

VOMMULI WATER AERODROME

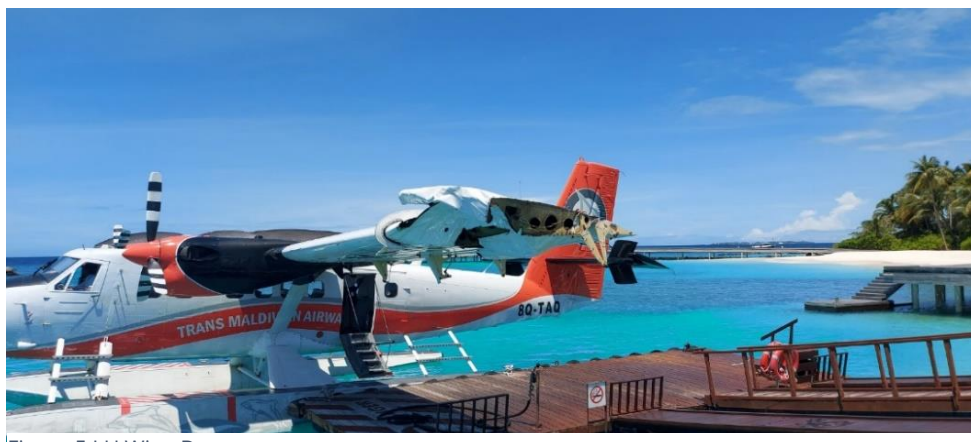
Figure 5 LH Wing Damage

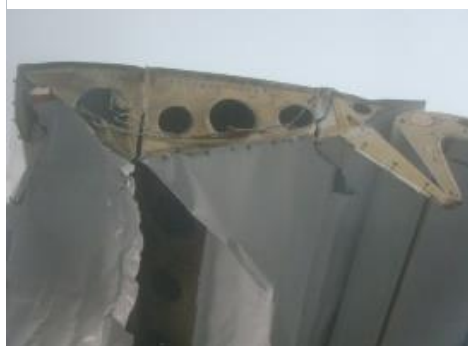
Figure 6 LH Wing (RIB NO. 28) Damage

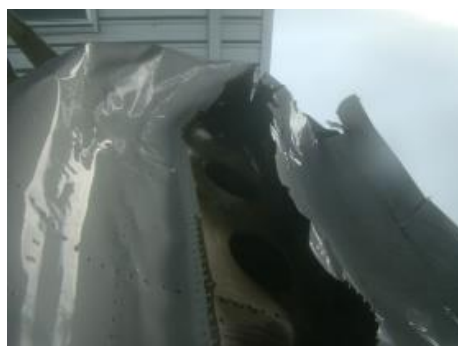
Figure 7 LH Wing Damage

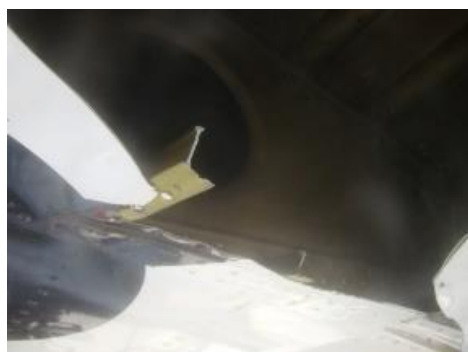
Figure 8 LH Wing Damage

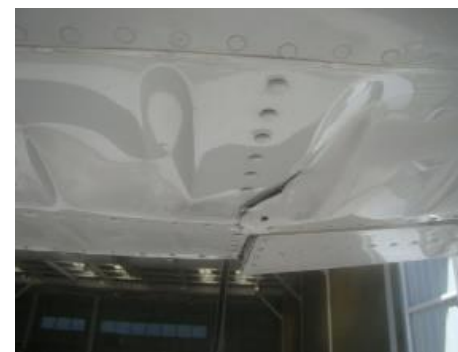
Figure 9 LH Aileron Damage

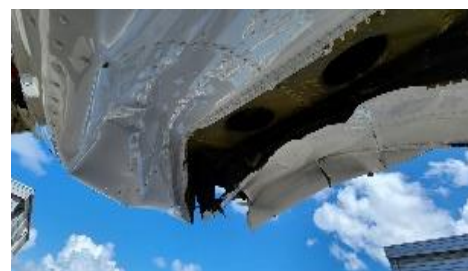
Figure 10 LH Wing Leading Edge Damage

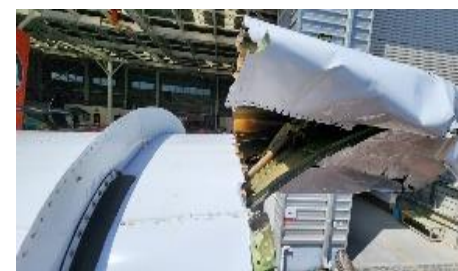
Figure 11 LH Wing Top Damage

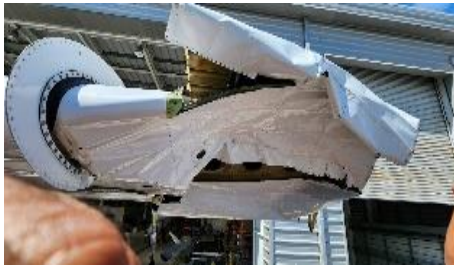
Figure 12 LH Wing Leading Edge Damage
