AIRCRAFT SERIOUS INCIDENT REPORT 2019/01

FINAL REPORT

**ON THE INVESTIGATION OF THE SERIOUS INCIDENT INVOLVING CESSNA 150M,
8Q-GAC AIRCRAFT, NEAR GAN INTERNATIONAL AIRPORT, MALDIVES**

ON 09 AUGUST 2019

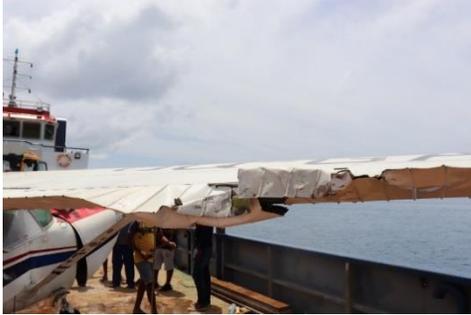
- Aileron and flap substantially damaged
- Right elevator substantially damaged
- Engine and propeller damaged
- Minor damage to RH wheels and brakes

Figure 2: RH wing / flaps

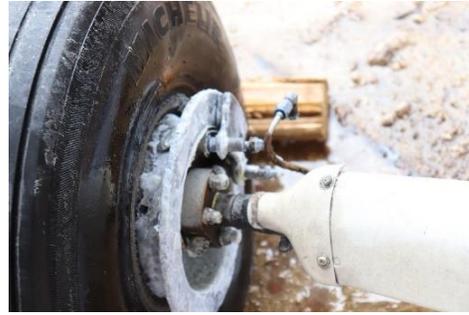
Figure 3: RH wheel assembly

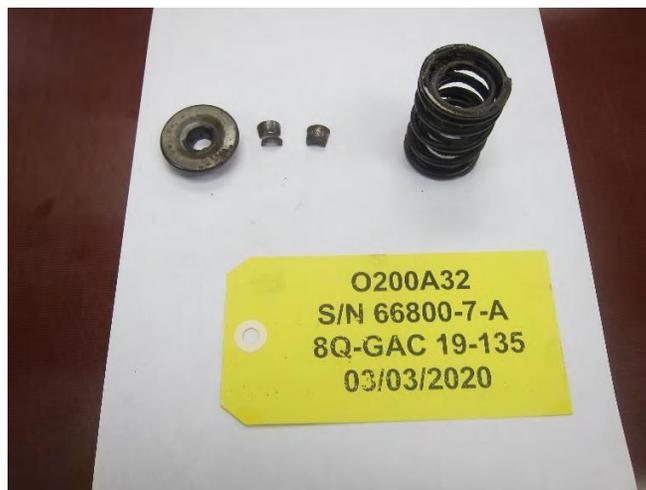
"The intake valve on the #4 cylinder separated from the valve springs/guide and punctured the intake port after the stem was bent almost 90 degrees. One half of the two-piece valve key for the #4 cylinder's intake valve was fractured. The intake rocker also displayed rub damage consistent with contact interference with the valve keys or the valve spring keepers. It was not clear if the rocker damage was an initiating or resultant event."

Figure 4: Affected intake valve springs and valve keys

On cylinder #4, the cylinder stem of the intake valve was protruding from the right side of the cylinder in the intake port area. One of the two intake valve keys was fractured. There

were wear masks and deformation damage noted on the outside of the valve keys. The valve keeper displayed markings consistent with rocker contact. The intake valve was displaced from the seat and the stem was bent almost 90 degrees. "

During examination of the engine at Continental Engine Overhaul Facility, it was observed that fractured valve keys (keepers) resulted in separation of an intake valve that punctured the intake port on number 4 cylinder. The part numbers for the Lock, valve spring seat (valve keepers) were not listed on the Work Order and there was no confirmation that those were replaced at the time of the overhaul.

The aircraft could not maintain altitude to reach GAN airport due engine power loss resulting from mechanical failure of number 4 cylinder assembly.

1. The operator to establish procedures to:
 - a. Ensure that all maintenance, repair and overhaul of the engines / airframes / components are carried out as per the prescribed procedures in the Technical Publications plus the policies and procedures prescribed in the Manuals approved by MCAA;
 - b. Ensure updated manuals are made available at all times for maintenance and overhaul operations personnel;
 - c. Ensure all the tasks carried out plus specific references are recorded in the Work Orders/Task Cards, as required by MCARs;
 - d. Ensure safety briefings are carried out in accordance with MCAR Air Operations NCO.SPEC.125 before each flight.

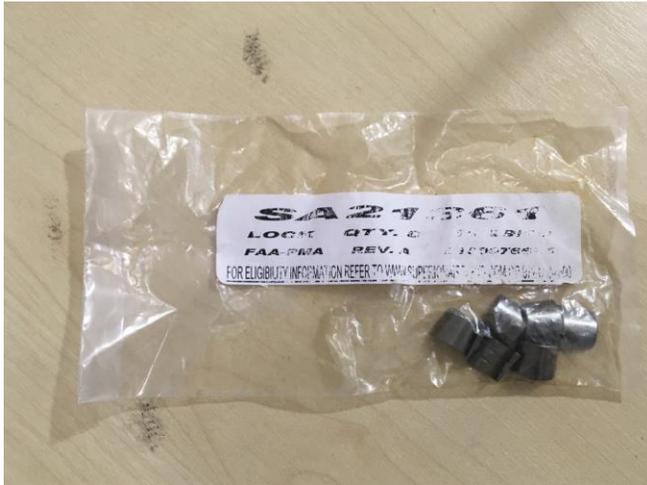
The "Maintenance Manual, Standard Practice, For Spark Ignited Engines" publication M-0, Change 5, dated January 2018, published by the Continental Aerospace Technologies, covers Mandatory Overhaul Replacement Parts in Table C-1 in section C-2.4, which states that the Valve Keepers (intake / exhaust) require "Mandatory Replacement at Engine Overhaul". This was the latest revision of the Maintenance manual Standard Practice that was current at the time of the overhaul. However, the Organisation had access to an outdated version of the manual which was Change 4, issued, and dated July 2017. According to the maintenance staff who worked in the overhaul shop it was noted that in all the previous engine overhauls the valve keys were replaced only if they were worn or otherwise not acceptable to be installed.

Review of the Company records from the Bonded Stores confirm that a stock of 50 pieces of the 'Locker, valve spring seat' p/n: 21361 was available since 2016.

Figure 4: 'Locker, valve spring seat' p/n: 21361

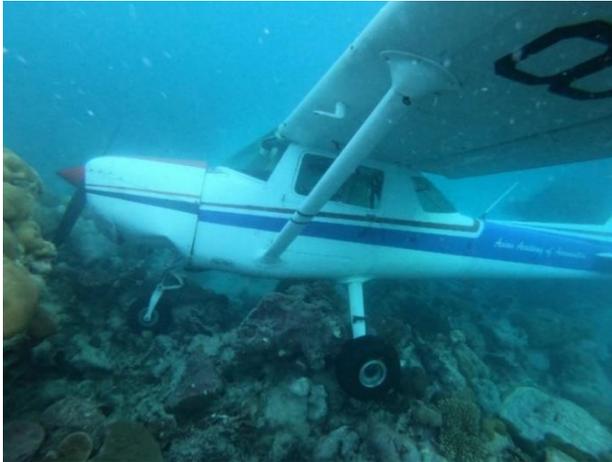
Whether the aircraft sustained damages or not during ditching cannot be determined. From underwater pictures taken after the aircraft sank to the bottom, it was seen that a lot of dents were on the belly of the aircraft.

Figure 6: Aircraft on the seabed

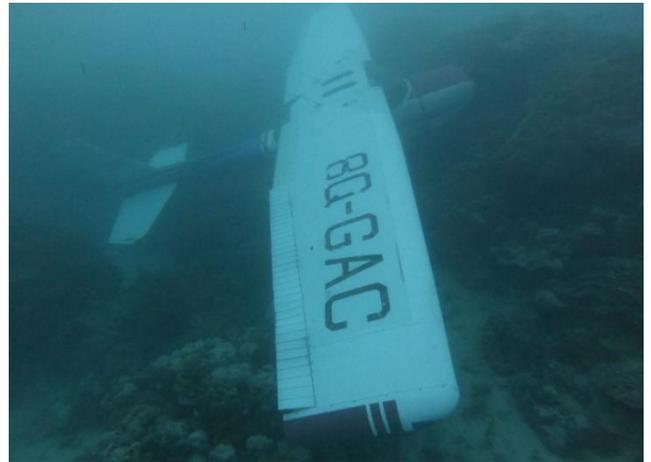
Figure 7: Aircraft on the sea bed

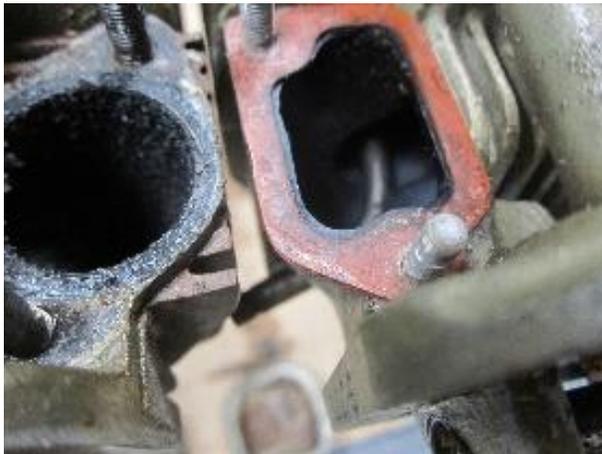
Figure 8: Disassembled engine

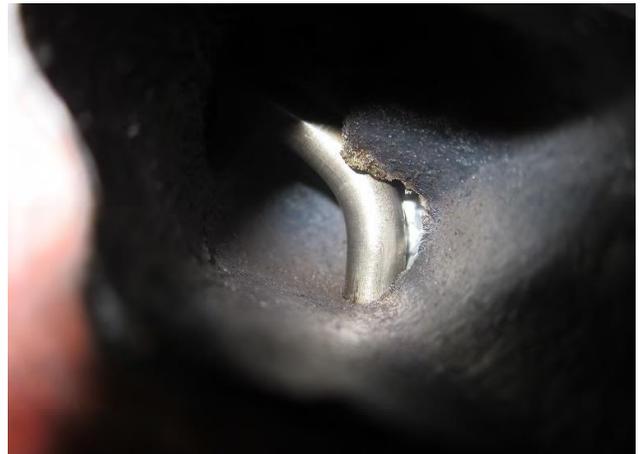
Figure 9: Bent Intake valve stem

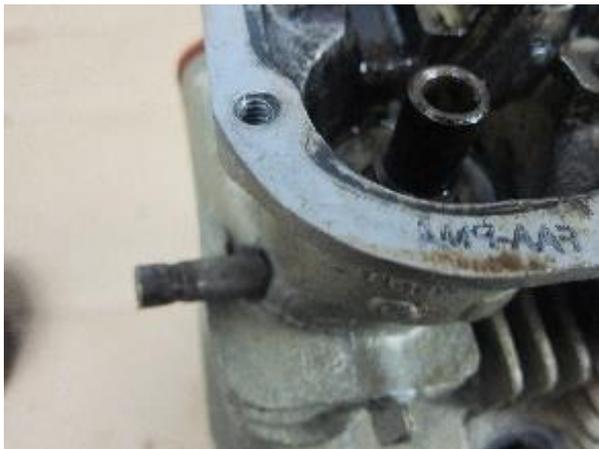
Figure 10: Intake valve stem protruding from the cylinder

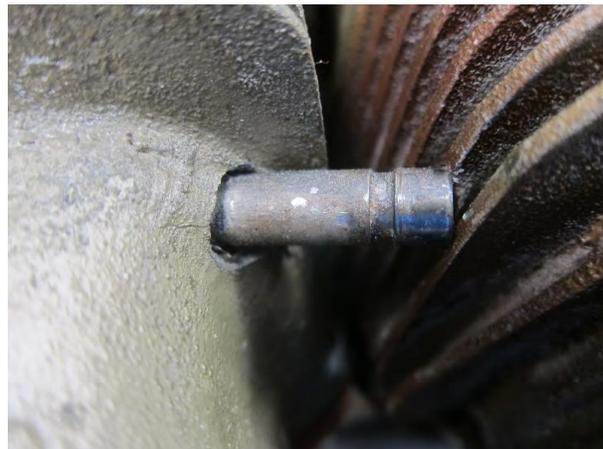
Figure11: Protruding engine intake valve stem

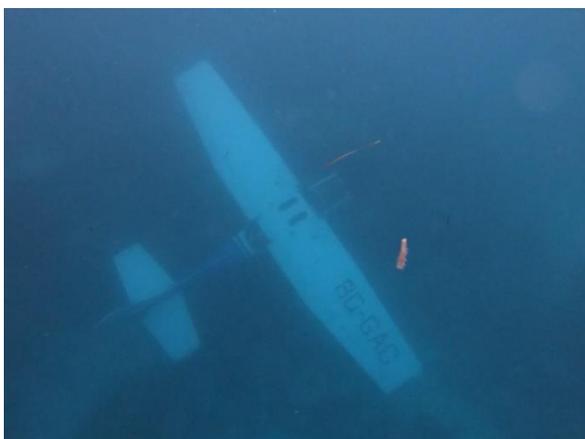
Figure 12: Aircraft on the seabed

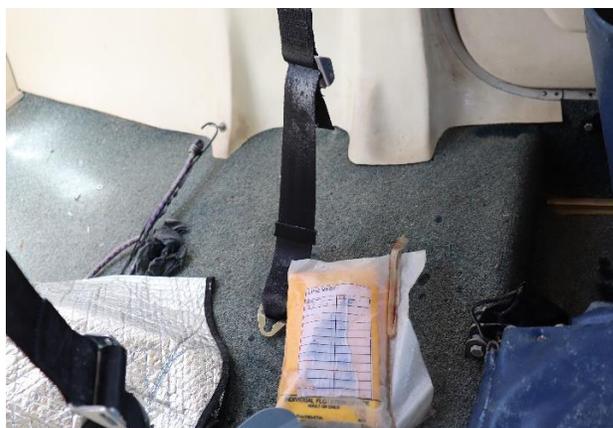
The only survival equipment on board were life jackets, and according to the student pilot, the life jackets were neither worn nor inflated, prior to or even after the ditching. It was evident, through student pilot's interview that no safety briefings were carried out in accordance with MCAR Air Operations, NCO.SPEC.125 Safety Briefing.

Figure 13: Unopened life jacket observed on cabin floor after the salvage
