## **Accident Investigation Coordinating Committee**

### **Report 2018/01**

Preliminary Report on the Serious Incident to  
Airbus, A330-300 (9M-XXC), A350-900 (A7-ALL)  
Velana International Airport, Maldives  
7 July 2018

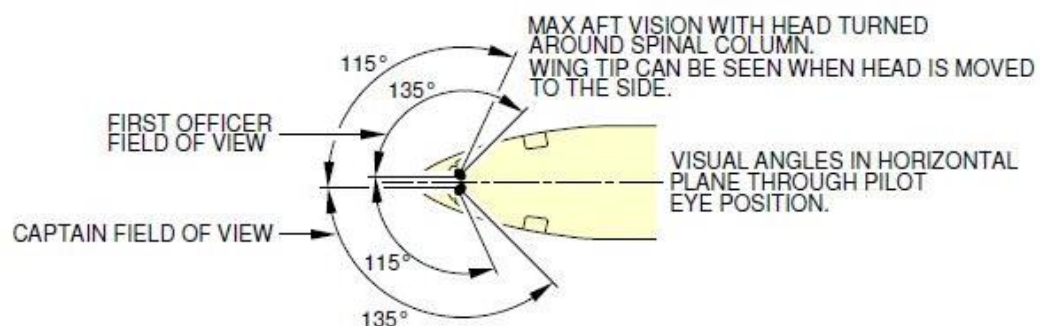
Figure 1 – A330-300 visibility from cockpit in static position

On the A330-300, the visual angle in the horizontal plane through the co-pilot's normal eye position and looking towards the wingtip is 115°. If the pilot moves his head to the side, the visual angle in the horizontal plane increases to 135°, and the wing tip becomes visible.

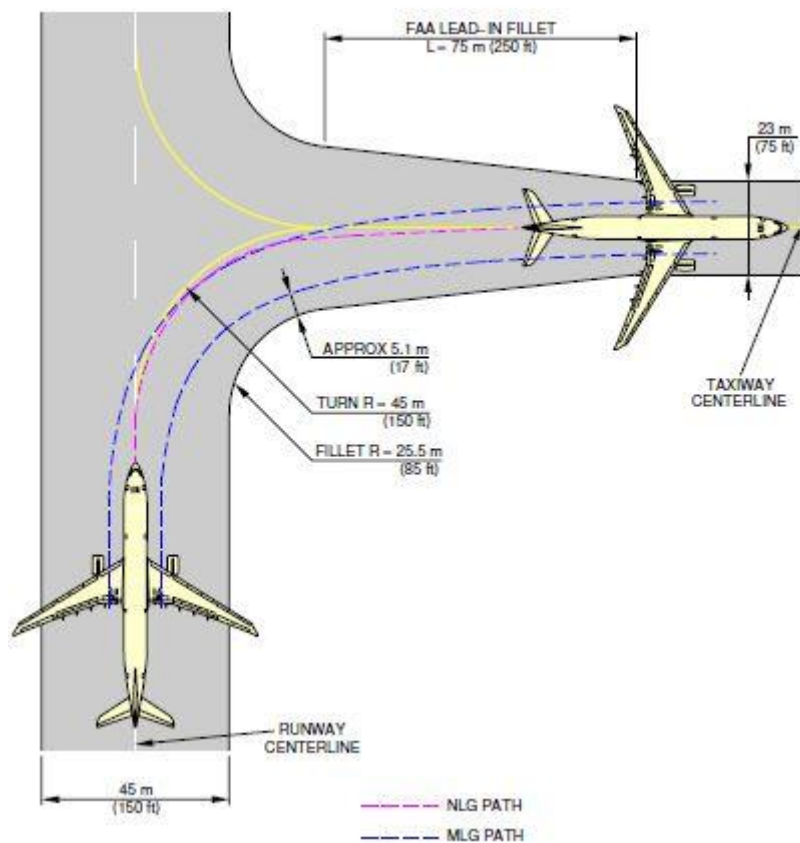
Figure 2 – 90 degree turn: runway to taxiway

The clearances required for a 90 degree turn on the A330-300 are given in figure below. This example is on a 90 degree turn from runway to taxiway using "Cockpit Over Centerline Method".

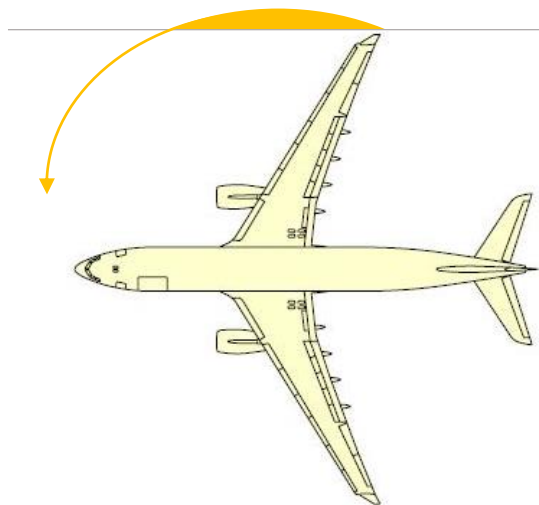
Figure 3 – Swept wing growth

The A330 like most modern large transport aircraft have swept wings that are subject to a phenomenon known as 'swept wing growth' or 'wing creep'. This occurs during a turn when the wing tip describes an arc greater than the normal wingspan due to the geometry of the aircraft and the arrangement of the landing gear<sup>1</sup>.

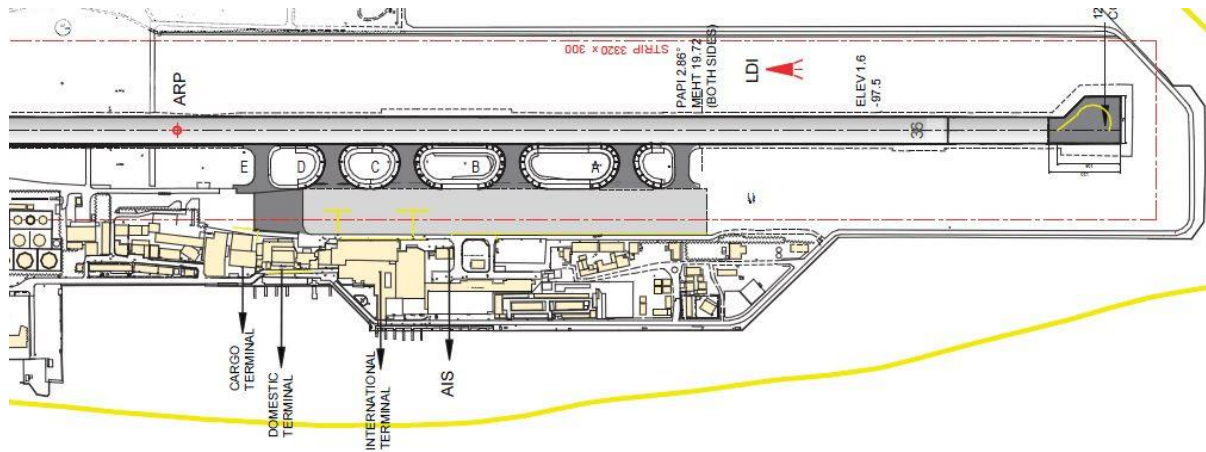
Figure 4: VIA international apron and associated taxiways.

The international apron is a concrete apron with a PCN of 55, accessible via taxiways A to E. Taxiway C is 23 m wide with a PCN of 57.

- *TWY lines and parking stands are not marked on the apron.*
- *Aircraft will be guided to the parking stand by marshallers and wing walkers.*
- *Exercise caution due to close proximity of terminal and associated buildings within maneuvering area.*
- *Avoid tight turns using excessive power while taxiing to/from apron.*
- *If taxiing to/from Apron is deemed unsafe by ATC, aircraft will be towed to/from Apron. Expect ATC instructions to shut down engines on RWY for tow-in.*
- *If taxiing to/from the Apron is deemed unsafe by the Commander, the Flight Crew may request towing to/from the Apron. Follow ATC instructions to shut down engines.*
