ACCIDENT INVESTIGATION COORDINATING COMMITTEE

**ACCIDENT REPORT ON
8Q-TMT (TWIN OTTER)
That collided with the fixed platform at Condrad (Rangali),
South Ari Atoll
on 9th July 2012**

Operator: Trans Maldivian Airways
Manufacturer: De Havilland (Canadian)
Model: DHC-6-300 (Floatplane)

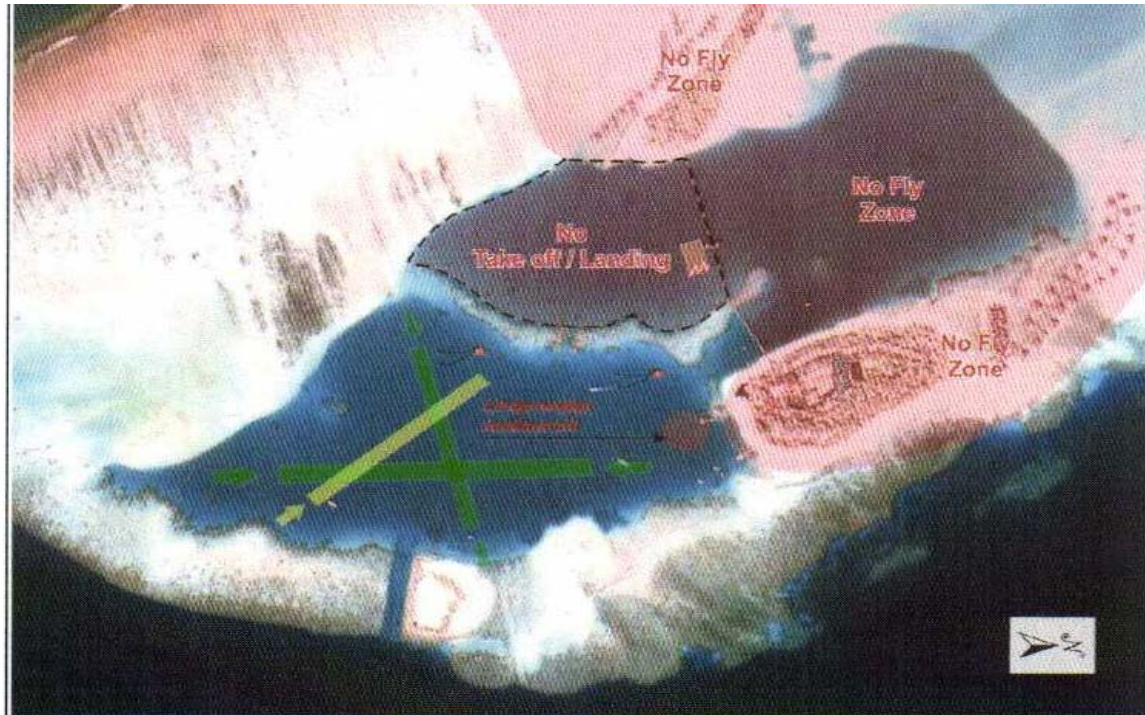
Appendix 1- Aerodrome Layout

The platform is a jetty attached platform where most pilots use only the front of the platform for docking as it gives more space and convenient for passengers. However, some pilots have reported the difficulty in using attached platforms in adverse weather conditions or high tail winds. The resort is a high-end tourist resort and had no other optional floating platforms as the resort requires having the platform attached to avoid boat transfers. There are two mooring buoys which are normally used for night shutdowns only.

- Floating platform to be installed as an alternate docking option during adverse weather conditions at locations where fixed platforms are used.
- A procedure for the flight crew to get weather information (wind direction and speed) at all out stations.
- Operational limitations to be introduced for all operational phases (take-off, landing, docking, beaching etc) of the flight.
- Cabin crew to wear life vest while operating outside the aircraft.
- "Decision making" to be emphasized in CRM training.
- Review company procedure for medical examination of the crew after an accident.
