ACCIDENT INVESTIGATING COORDINATING COMMITTEE
MALDIVES CIVIL AVIATION AUTHORITY
2nd Floor, Velaanaage, Ameer Ahmed Magu, Male', 20096, Maldives

PRELIMINARY SAFETY INVESTIGATION REPORT

Report Number: 2024/02/P
Date: 31 July 2024

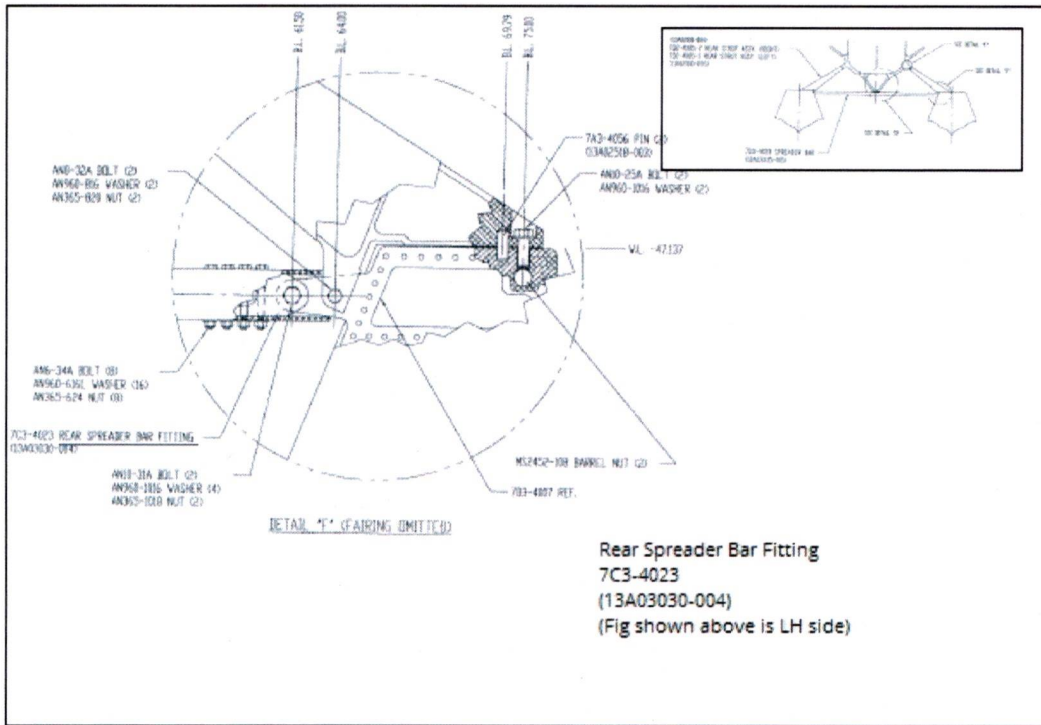
Affected parts

1. Visible damage on the float assembly.
2. Rear spreader bar attachment bolt missing.
3. Right float aft spreader bar, float attachment fitting damaged.
4. The right propeller blade cut into the right float.
5. Flywire LH buckled and RH snapped.
