ACCIDENT INVESTIGATION COORDINATING COMMITTEE

SERIOUS INCIDENT INVESTIGATION REPORT 2024/02

FINAL REPORT
ON INVESTIGATION OF THE SERIOUS INCIDENT INVOLVING
DHC-6-300, 8Q-TMO AIRCRAFT
AT WESTIN MALDIVES (MIRIANDHOO) WATER AERODROME,
ON 09 JUNE 2024

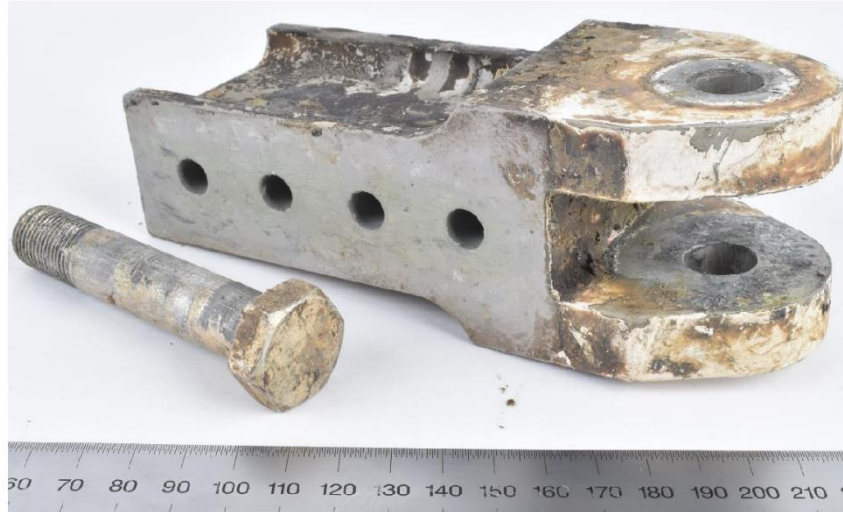
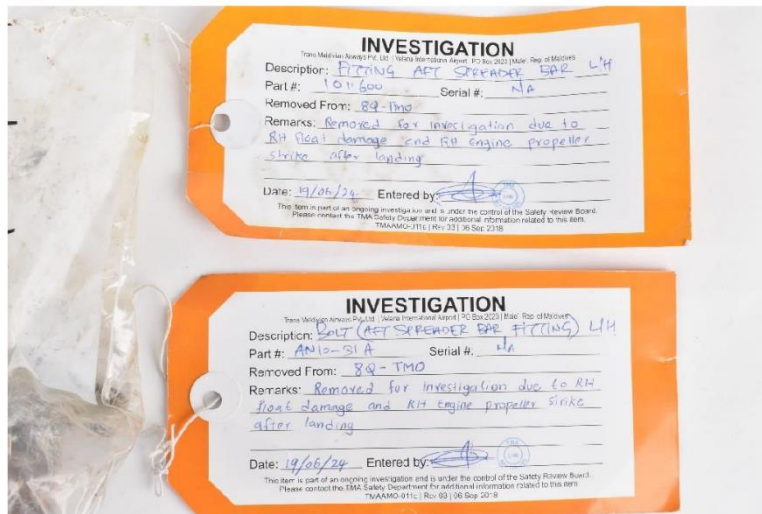
Fig. 1 The samples designated Bolt 1 and Fitting 1 are presented as received in (a) with identifying information presented in (b). The scale is in millimeters.

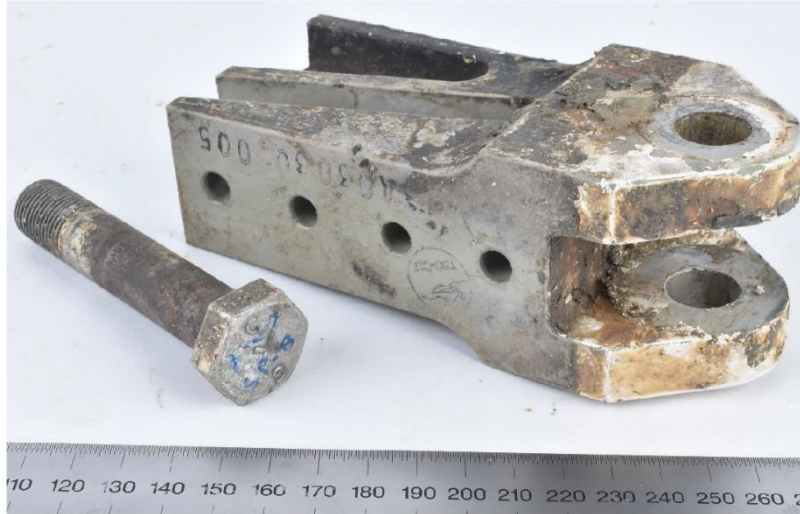
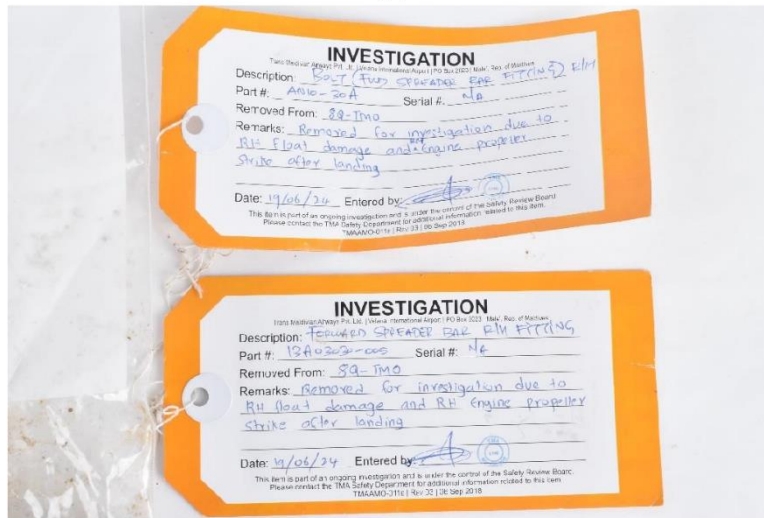
Fig. 2 The samples designated Bolt 2 and Fitting 2 are presented as received in (a) with identifying information presented in (b). The scale is in millimeters.

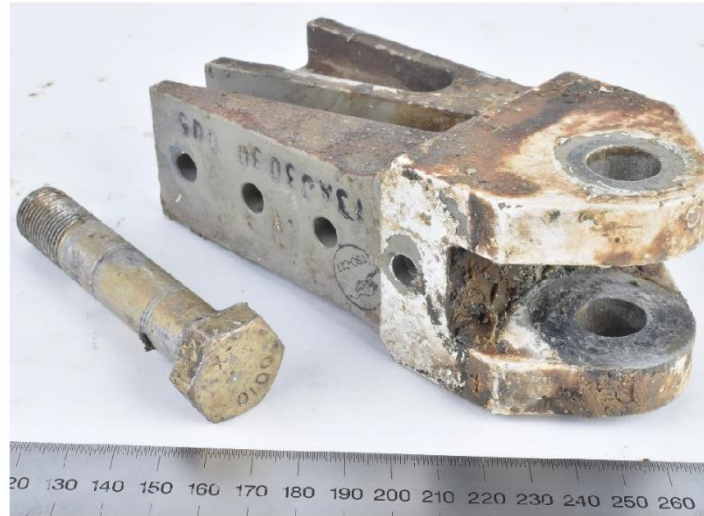
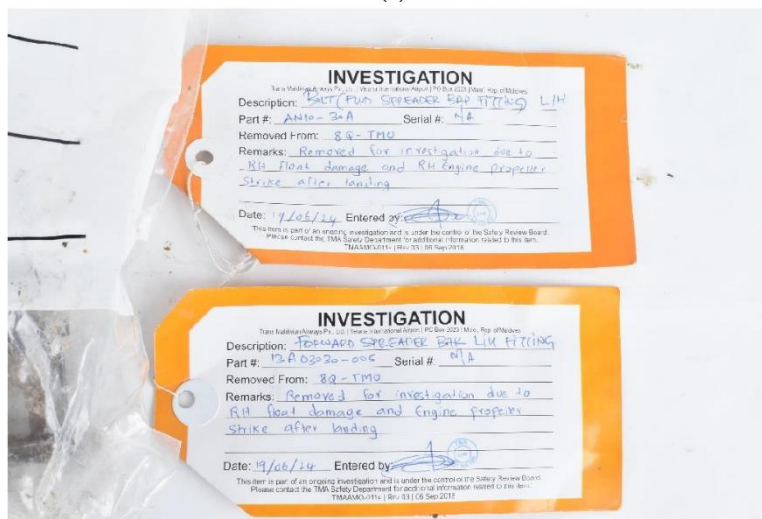
Fig. 3 The samples designated Bolt 3 and Fitting 3 are presented as received in (a) with identifying information presented in (b). The scale is in millimeters.

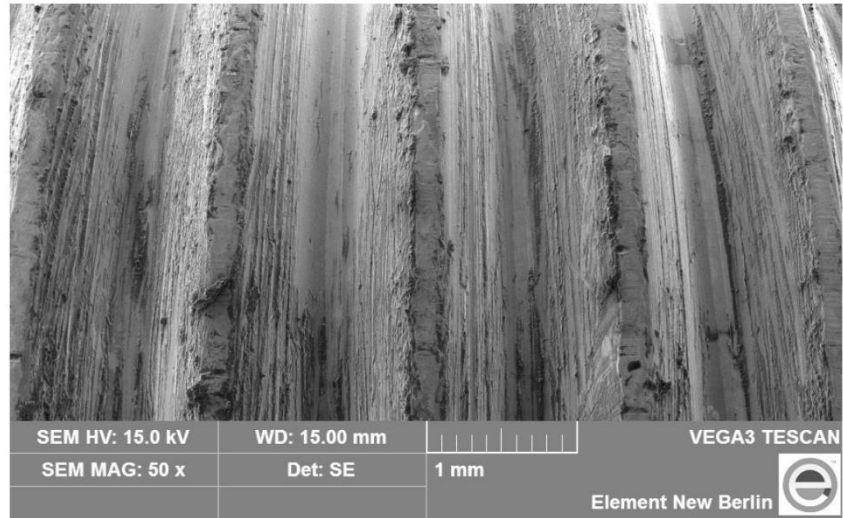
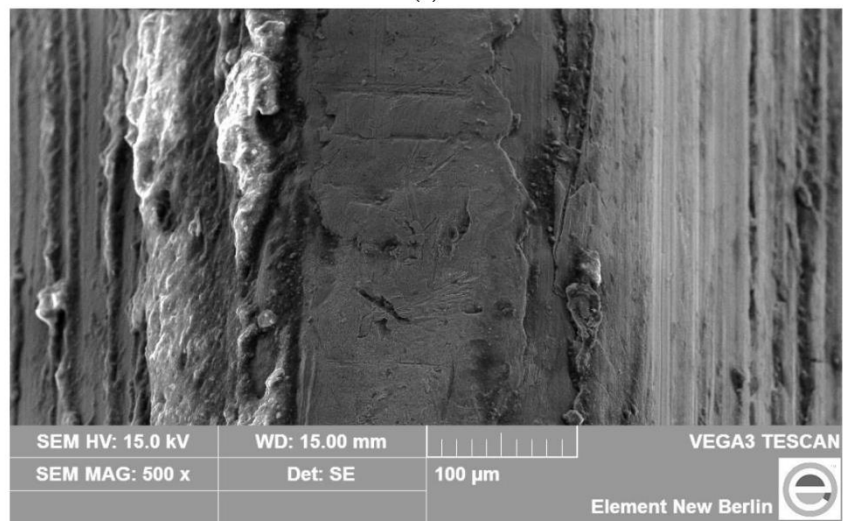
Fig. 4 A scanning electron micrograph of a representative area of Bolt 1 is presented in (a) and at higher magnification in (b). No indications of cracking or failure were evident.

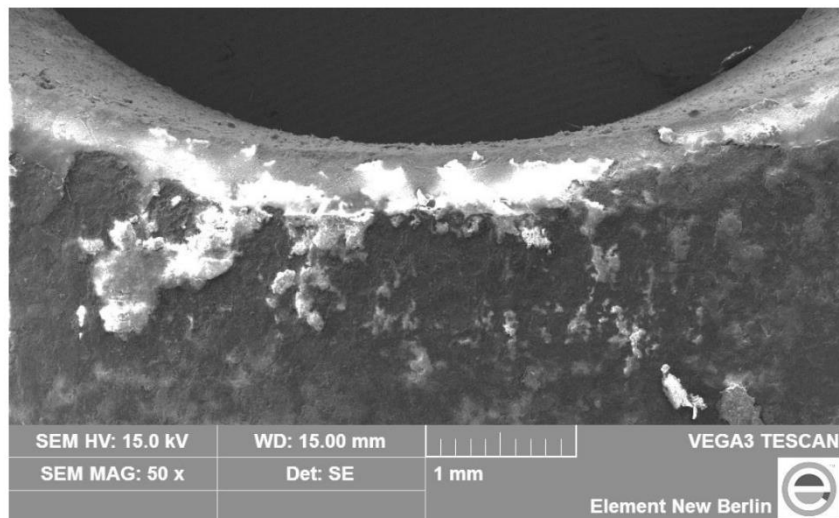
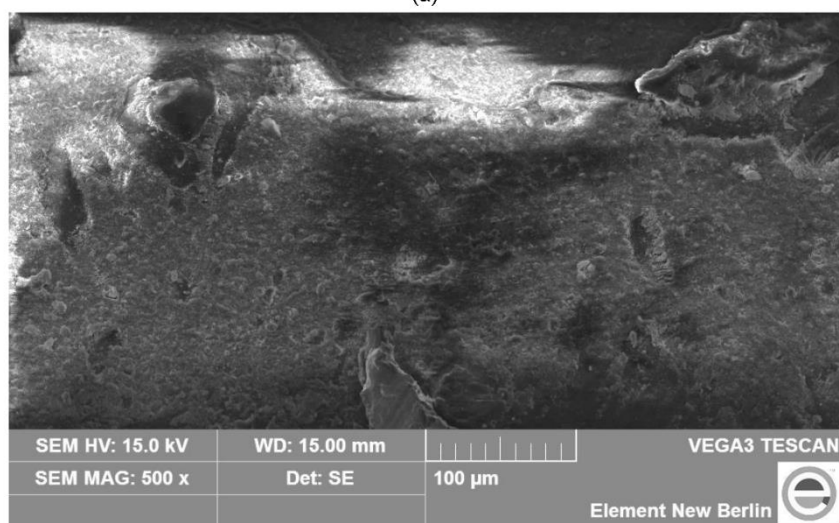
Fig. 5 A scanning electron micrograph of a representative area of Fitting 1 is presented in (a) and at higher magnification in (b). No indications of cracking or failure were evident.

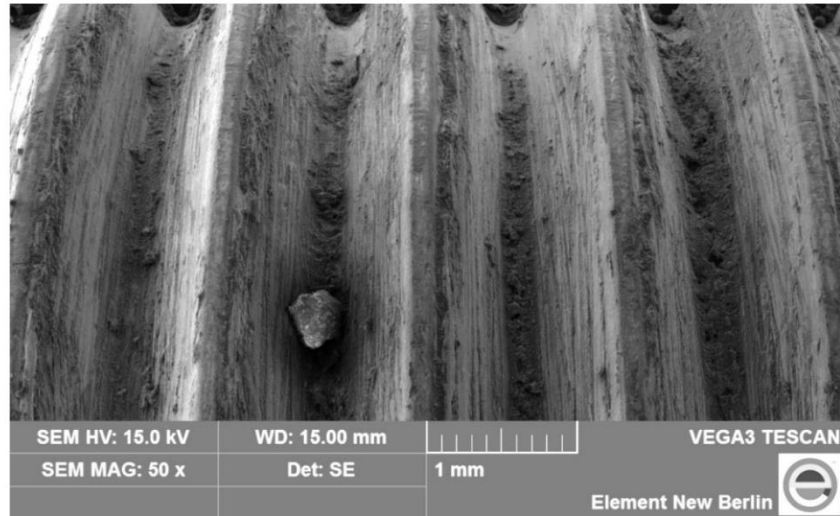
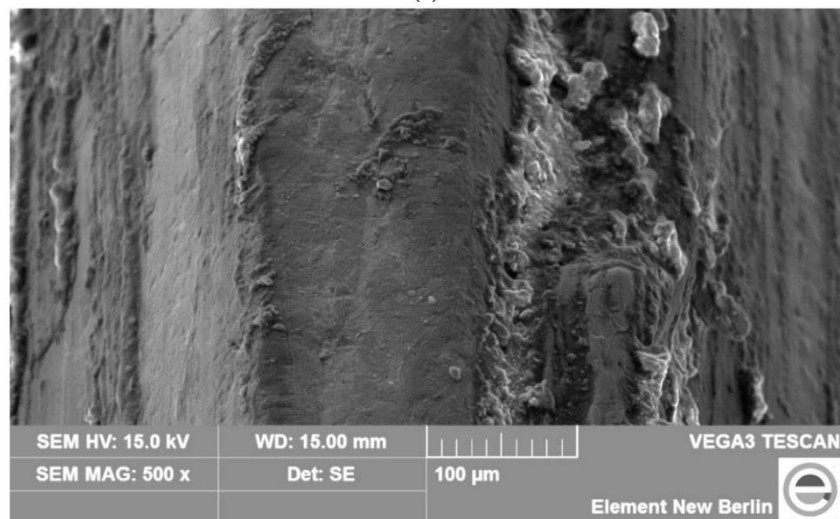
Fig. 6 A scanning electron micrograph of a representative area of Bolt 2 is presented in (a) and at higher magnification in (b). No indications of cracking or failure were evident.

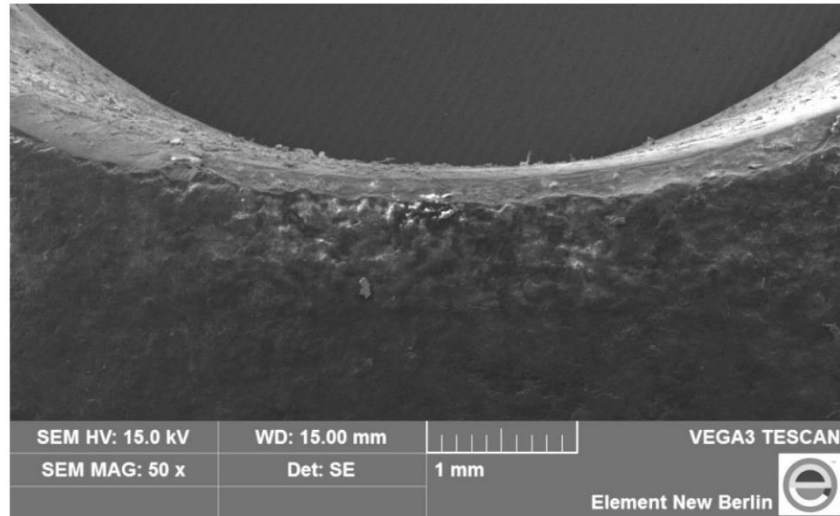
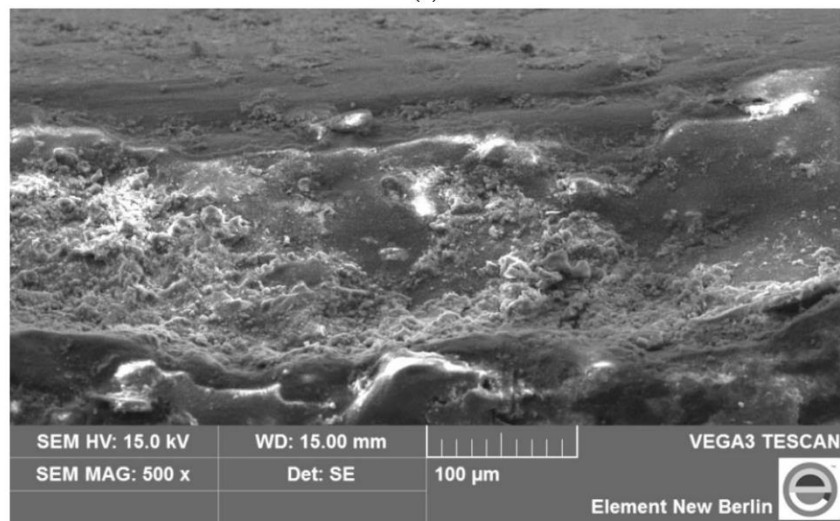
Fig. 7 A scanning electron micrograph of a representative area of Fitting 2 is presented in (a) and at higher magnification in (b). No indications of cracking or failure were evident.

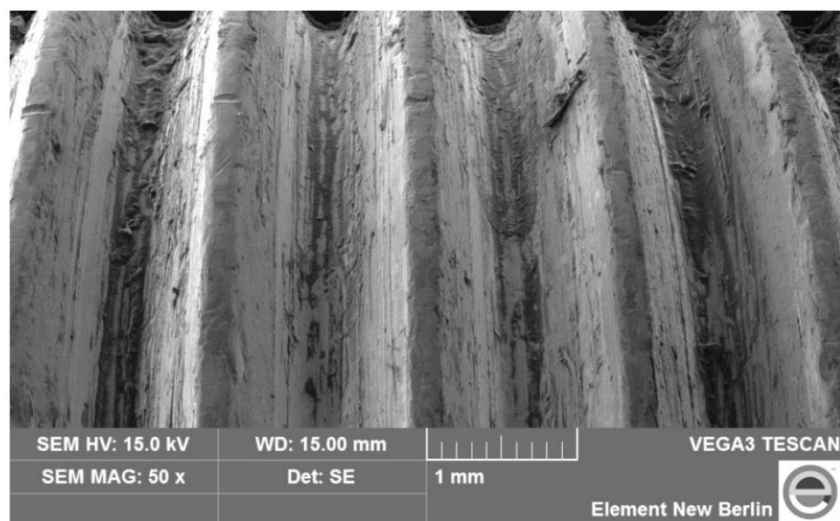
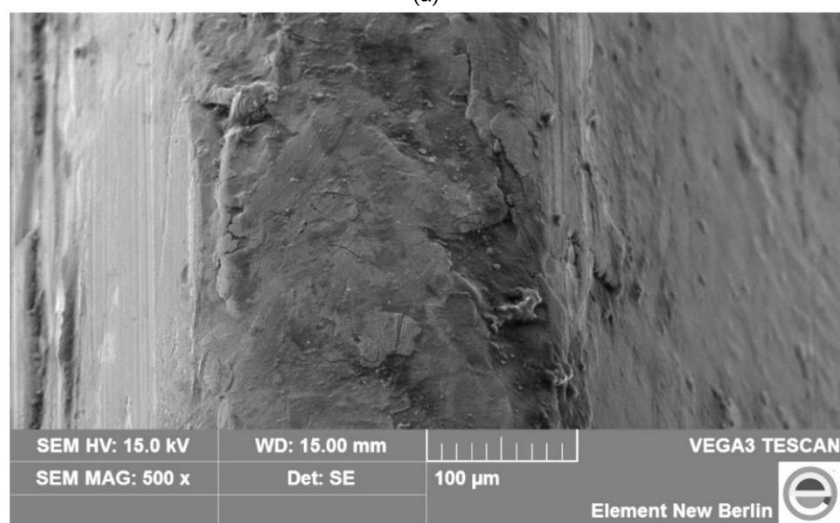
Fig. 8 A scanning electron micrograph of a representative area of Bolt 3 is presented in (a) and at higher magnification in (b). No indications of cracking or failure were evident.

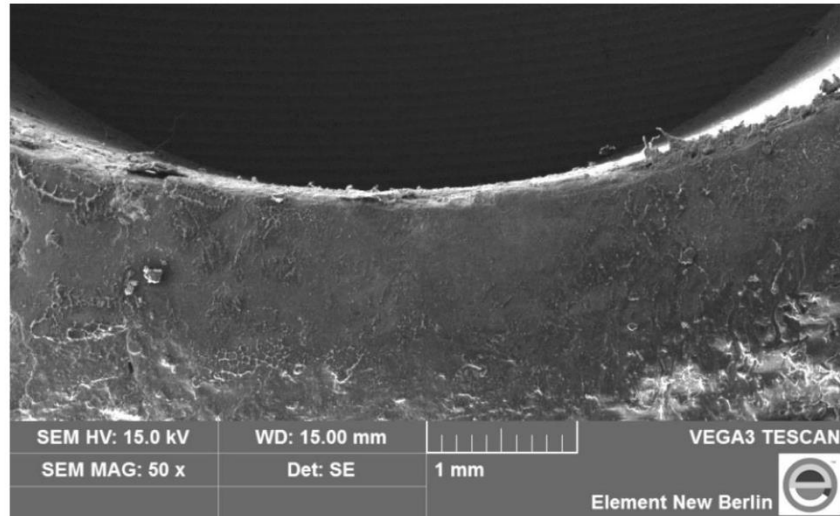
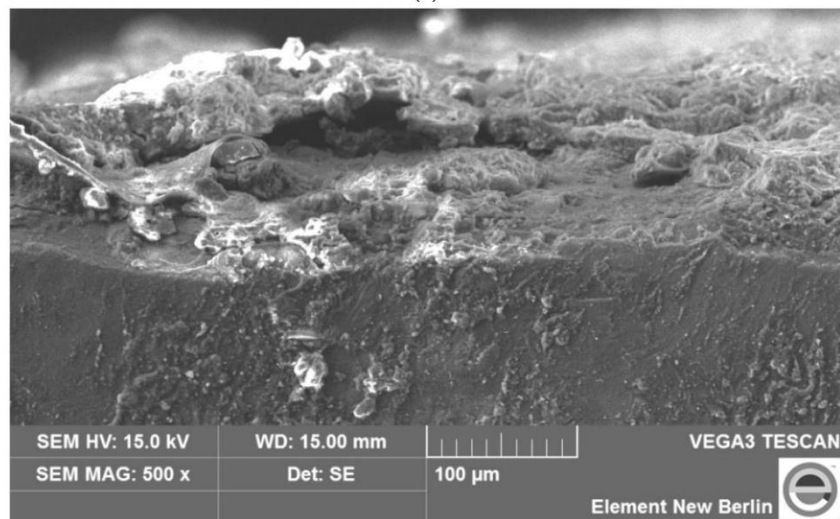
Fig. 9 A scanning electron micrograph of a representative area of Fitting 3 is presented in (a) and at higher magnification in (b). No indications of cracking or failure were evident.

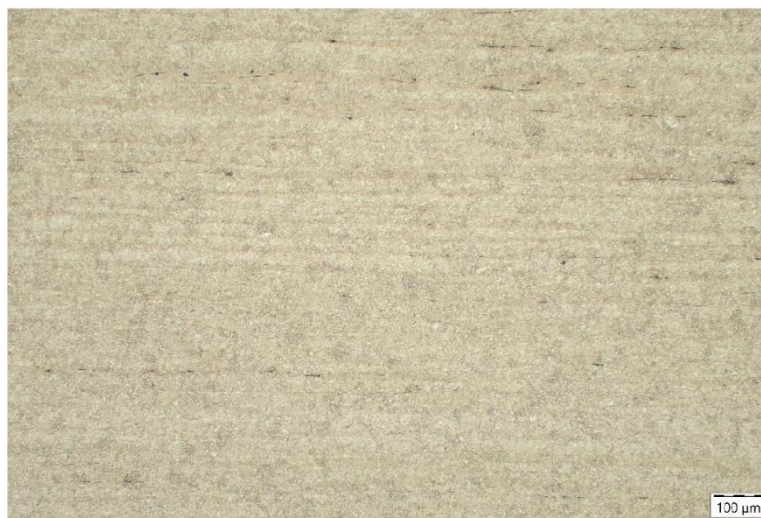
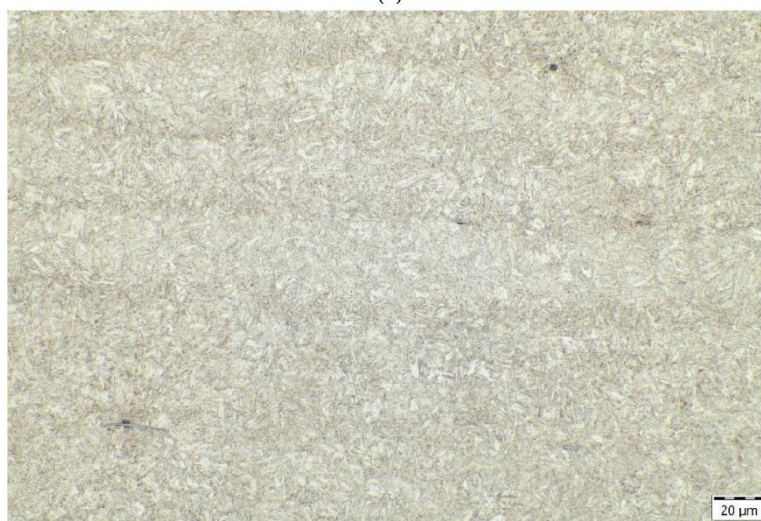
Fig. 11 The core of the metallographic specimen prepared from Bolt 1 is presented in (a) and at a higher magnification in (b). The microstructure was indicative of tempered martensite. Sulfide inclusions are evident in the view. 2% Nital.

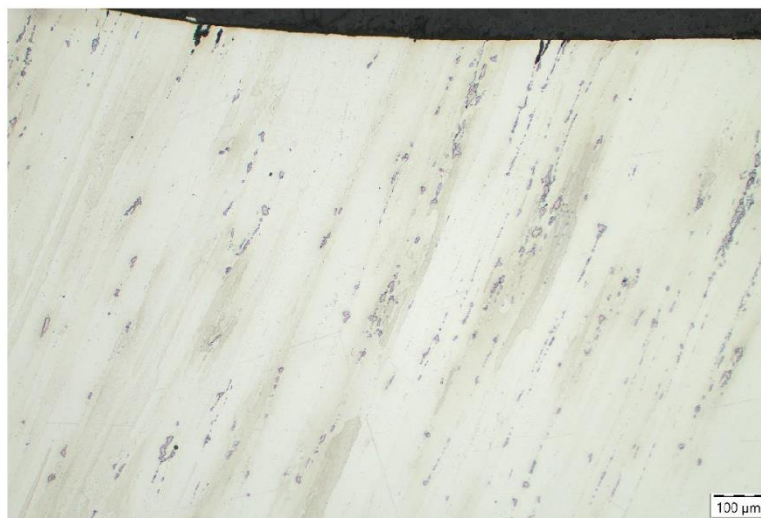
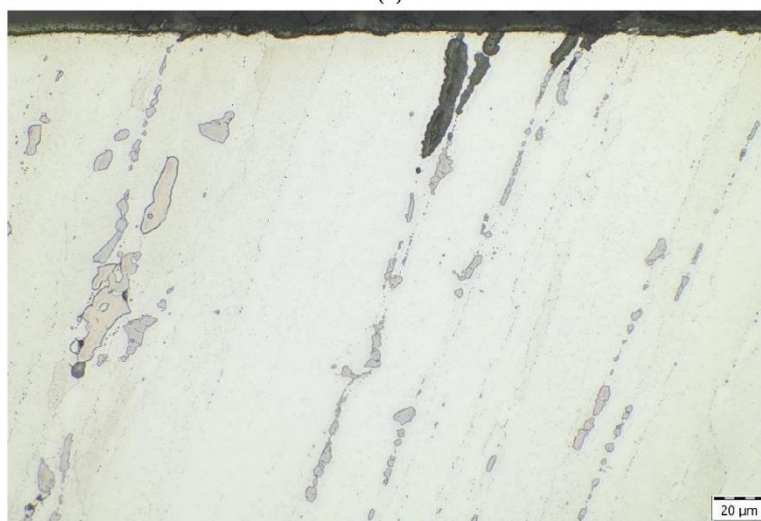
A metallographic cross-section was prepared from each sample and is presented in Figures 10 through 21. The bolt samples exhibited microstructures indicative of tempered martensite. Bolt 1 exhibited several cracks in the tips of the threads, a representative crack is measured in Figure 10. The fitting samples exhibited microstructures judged to be typical of a heat treated 2024 aluminum. The fitting samples exhibited inclusions at or near the surface of the bolt hole.

Fig. 12 The surface of the metallographic specimen prepared from Fitting 1 is presented in (a) and at higher magnification in (b). The microstructure was typical of a 2024-T3 aluminum. Inclusions are evident near the surface. 20% NaOH.

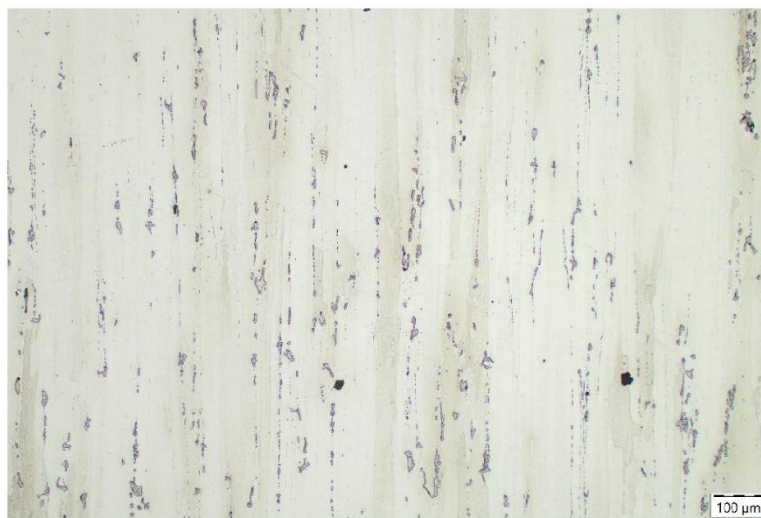
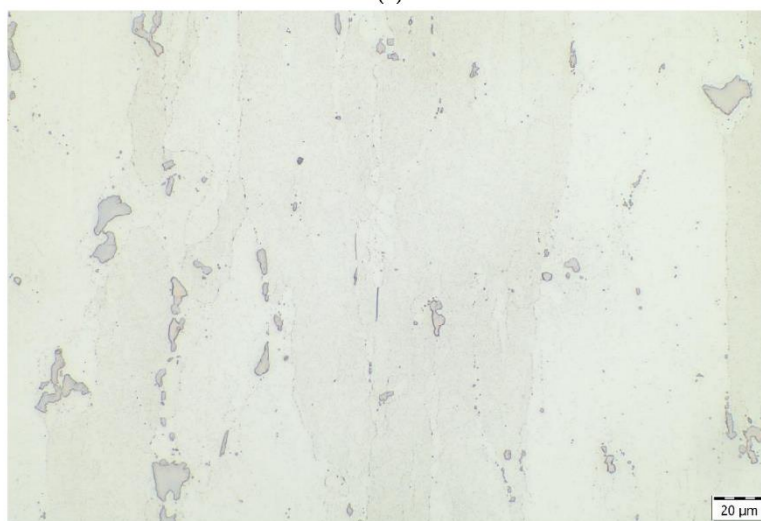
Fig. 13 The core of the metallographic specimen prepared from Fitting 1 is presented in (a) and at higher magnification in (b). The microstructure was typical of a 2024-T3 aluminum. 20% NaOH.

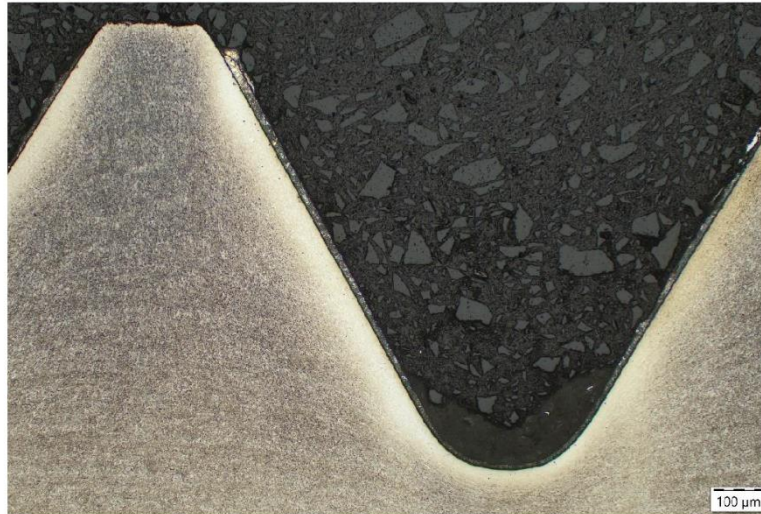
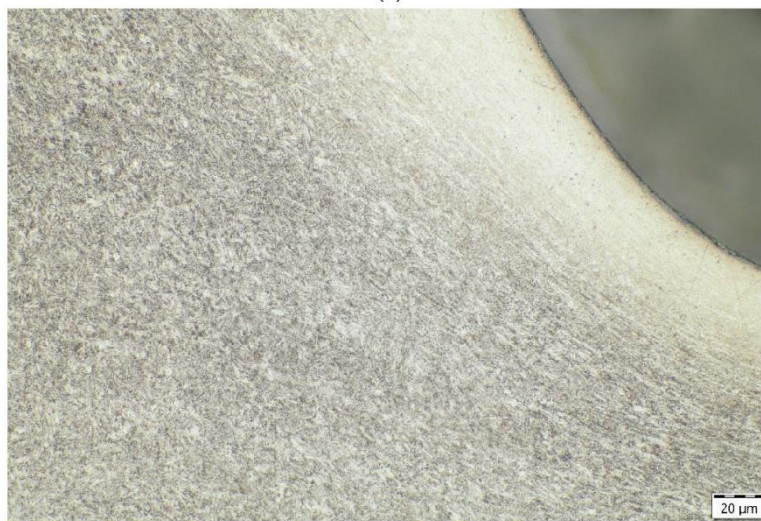
Fig. 14 The surface of the metallographic specimen prepared from Bolt 2 is presented in (a) and the root of the thread is presented at higher magnification in (b). The microstructure was indicative of tempered martensite. Grain flow from the forming operation is evident in the view. 2% Nital.

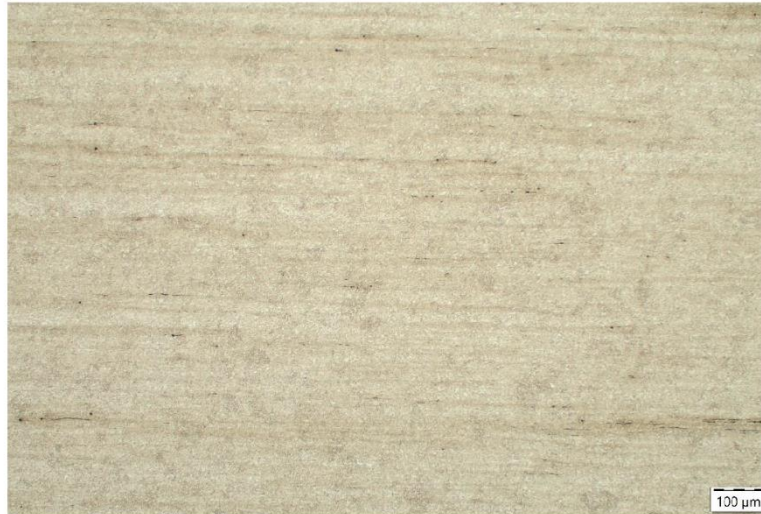
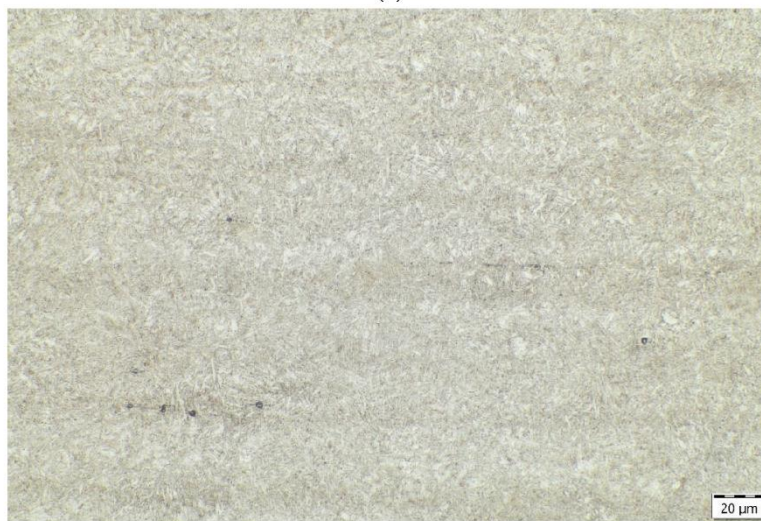
Fig. 15 The core of the metallographic specimen prepared from Bolt 2 is presented in (a) and at higher magnification in (b). The microstructure was indicative of tempered martensite. Sulfide inclusions are evident in the view. 2% Nital.

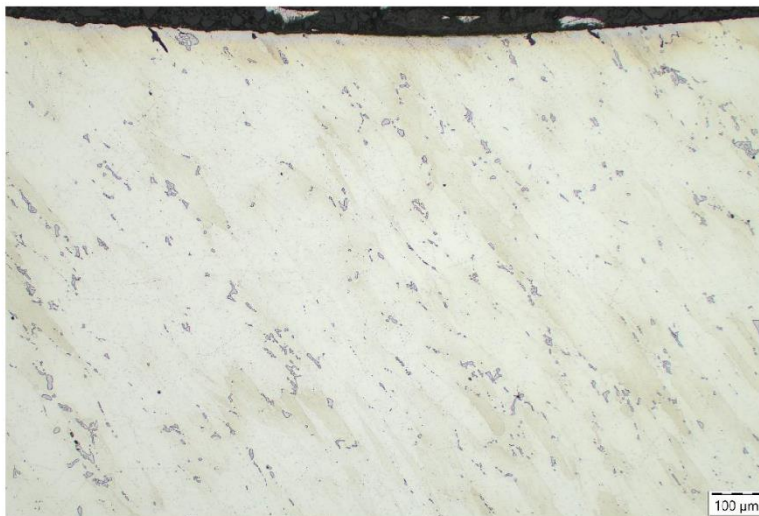
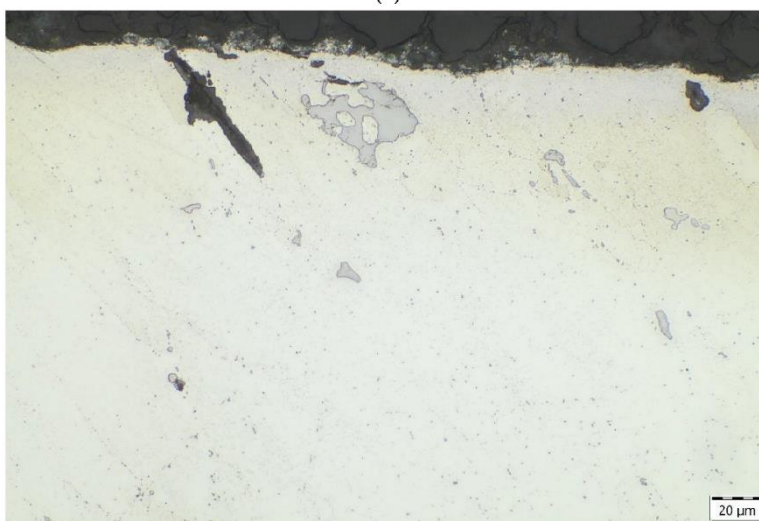
Fig. 16 The surface of the metallographic specimen prepared from Fitting 2 is presented in (a) and at higher magnification in (b). The microstructure was typical of a 2024-T3 aluminum. Near surface inclusions are evident in the view. 20% NaOH.

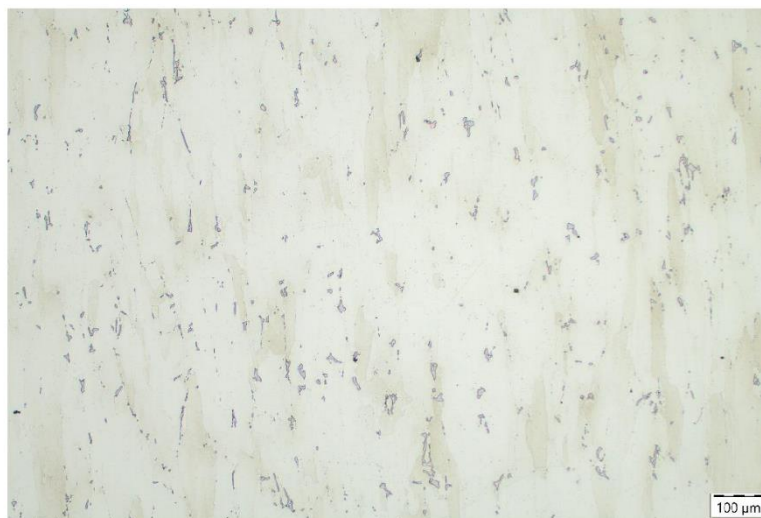
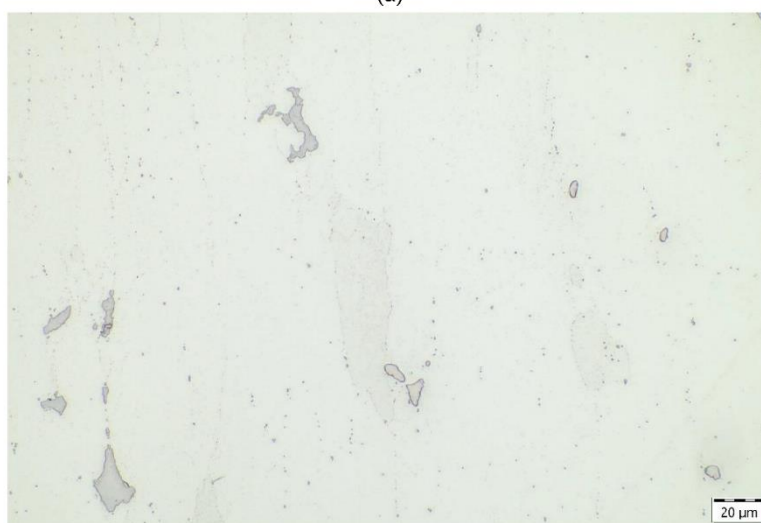
Fig. 17 The core of the metallographic specimen prepared from Fitting 2 is presented in (a) and at higher magnification in (b). The microstructure was typical of a 2024-T3 aluminum. 20% NaOH.

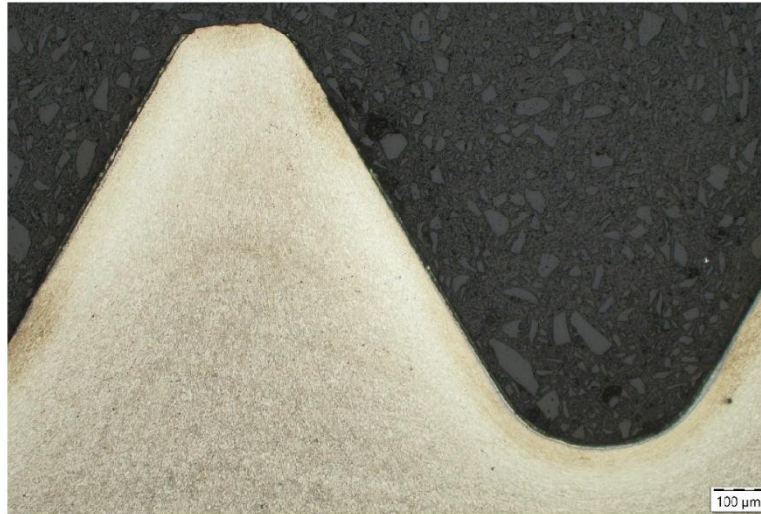
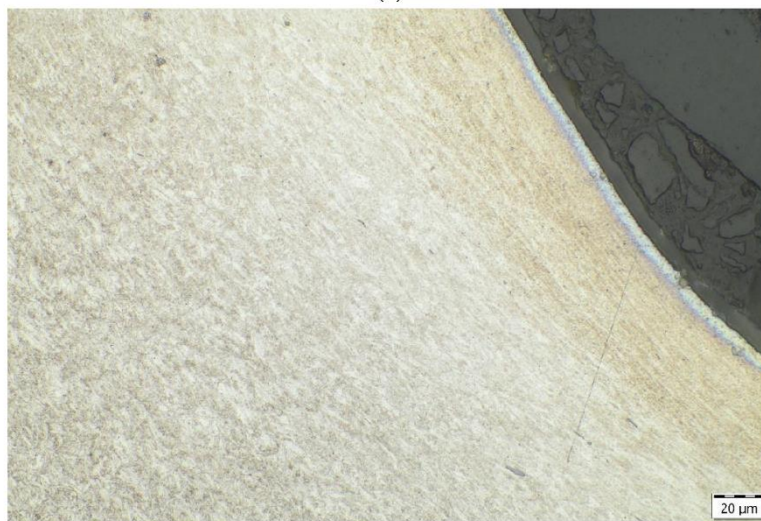
Fig. 18 The surface of the metallographic specimen prepared from Bolt 3 is presented in (a) and the root of the thread is presented at higher magnification in (b). The microstructure was indicative of tempered martensite. Grain flow from the forming operation is evident in the view. 2% Nital.

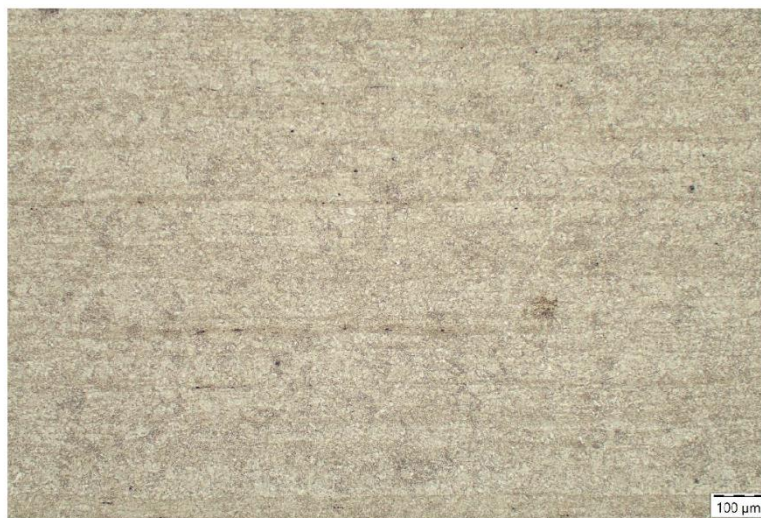
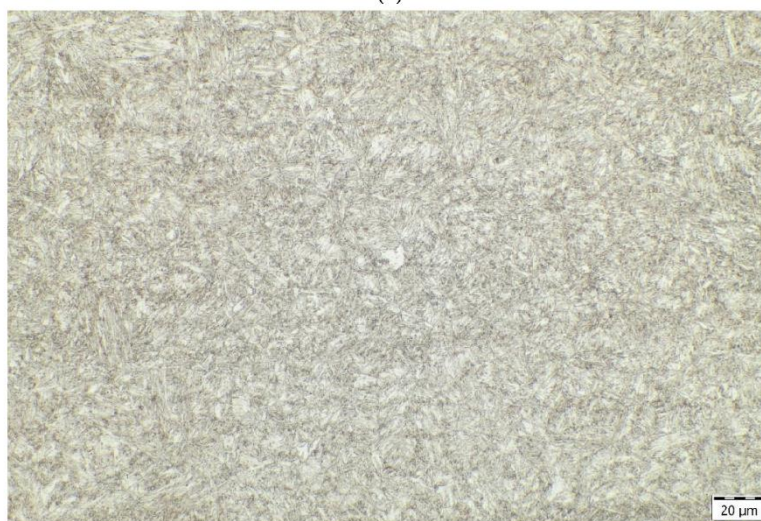
Fig. 19 The core of the metallographic specimen prepared from Bolt 3 is presented in (a) and at higher magnification in (b). The microstructure was indicative of tempered martensite. Sulfide inclusions are evident in the view. 2% Nital.

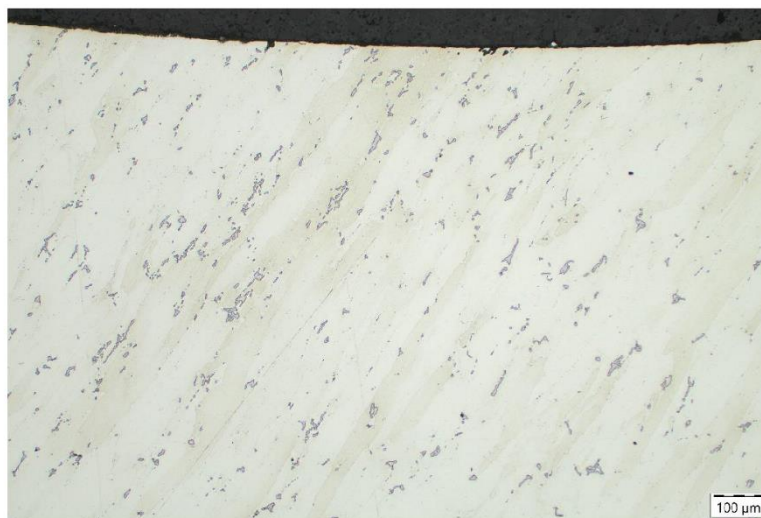
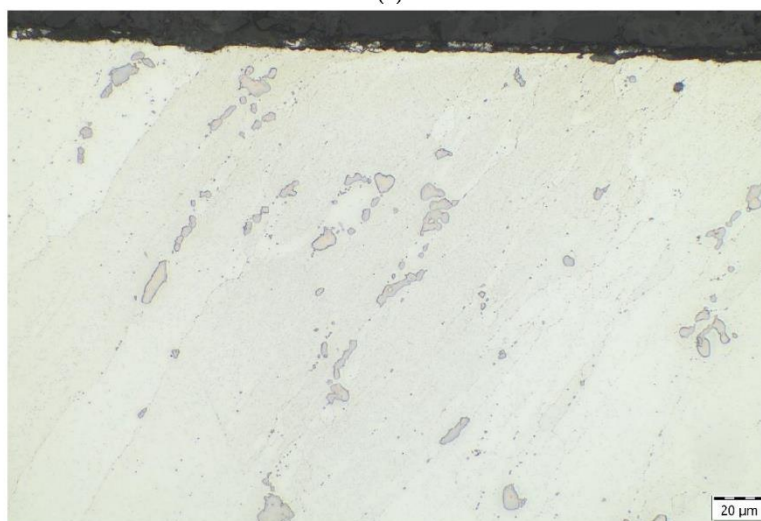
Fig. 20 The surface of the metallographic specimen prepared from Fitting 3 is presented in (a) and at higher magnification in (b). The microstructure was typical of a 2024-T3 aluminum. 20% NaOH.

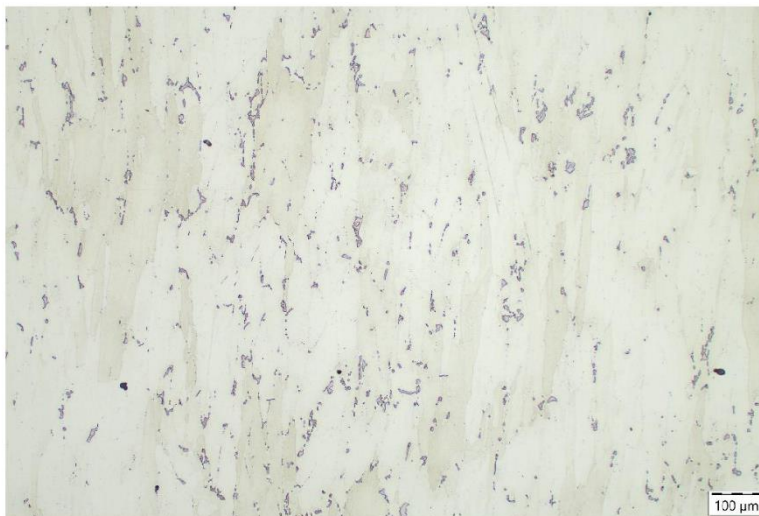
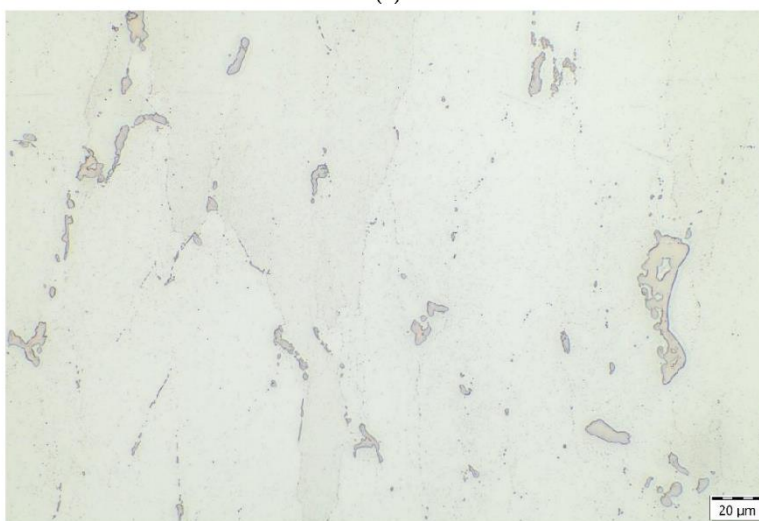
Fig. 21 The core of the metallographic specimen prepared from Fitting 3 is presented in (a) and at higher magnification in (b). The microstructure was typical of a 2024-T3 aluminum. 20% NaOH.
