ACCIDENT INVESTIGATION COORDINATING COMMITTEE

SAFETY INVESTIGATION REPORT 2022/01

**INVESTIGATION OF THE RUNWAY EXCURSION
SERIOUS INCIDENT INVOLVING BOMBARDIER DHC-8-300 AIRCRAFT,
8Q-IAK OPERATED BY ISLAND AVIATION SERVICES (IAS)
AT KADHDHOO AIRPORT, MALDIVES**

05 May 2022

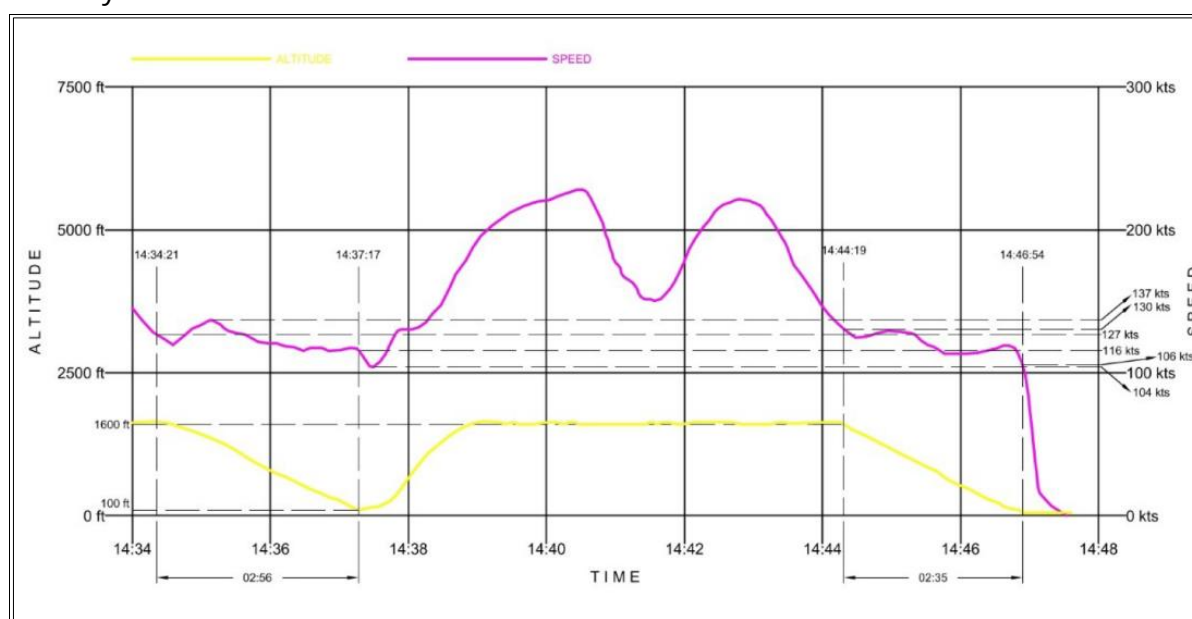
The aircraft approached Runway 21 and touched down approximately 442 meters before the end of Runway 21 and overran on to the grass, finally stopping approximately 35 m (115 feet) past the end of the runway.

An overview of the speeds, altitudes (plotted against time) of the aircraft covering the two approaches made to land at KDO are illustrated in the Flight Radar Plot for DQA274, dated 05 May VRMO-VRMK.

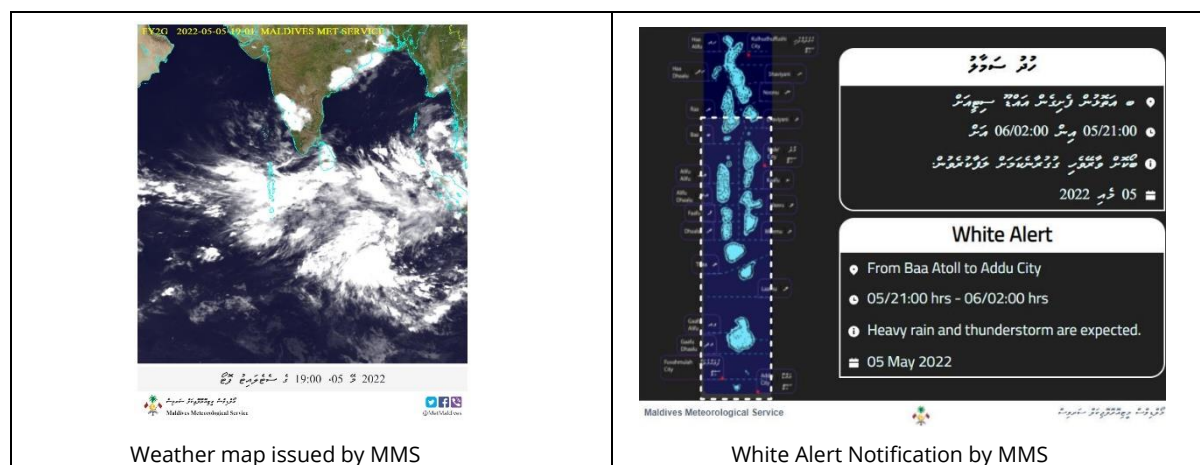
Figure 1 – Weather Map and Alerts

The incident occurred on a day when the whole archipelago was experiencing adverse weather conditions, typical of the westerly monsoon. A cautionary weather alert was also in effect, with a forecast onset of thunderstorms and heavy rain about an hour after the time of incident (**Figure 1 - Weather Map and Alerts**).
