ACCIDENT INVESTIGATION COORDINATING COMMITTEE

AIRCRAFT OCCURRENCE INVESTIGATION 2021/02

FINAL REPORT

**INVESTIGATION OF THE SERIOUS INCIDENT INVOLVING
TRANS MALDIVIAN AIRWAYS OPERATED VIKING AIR DHC-6-300
8Q-MBC FLOATPLANE AT FINOLHU RESORT WATER AERODROME,
MALDIVES**

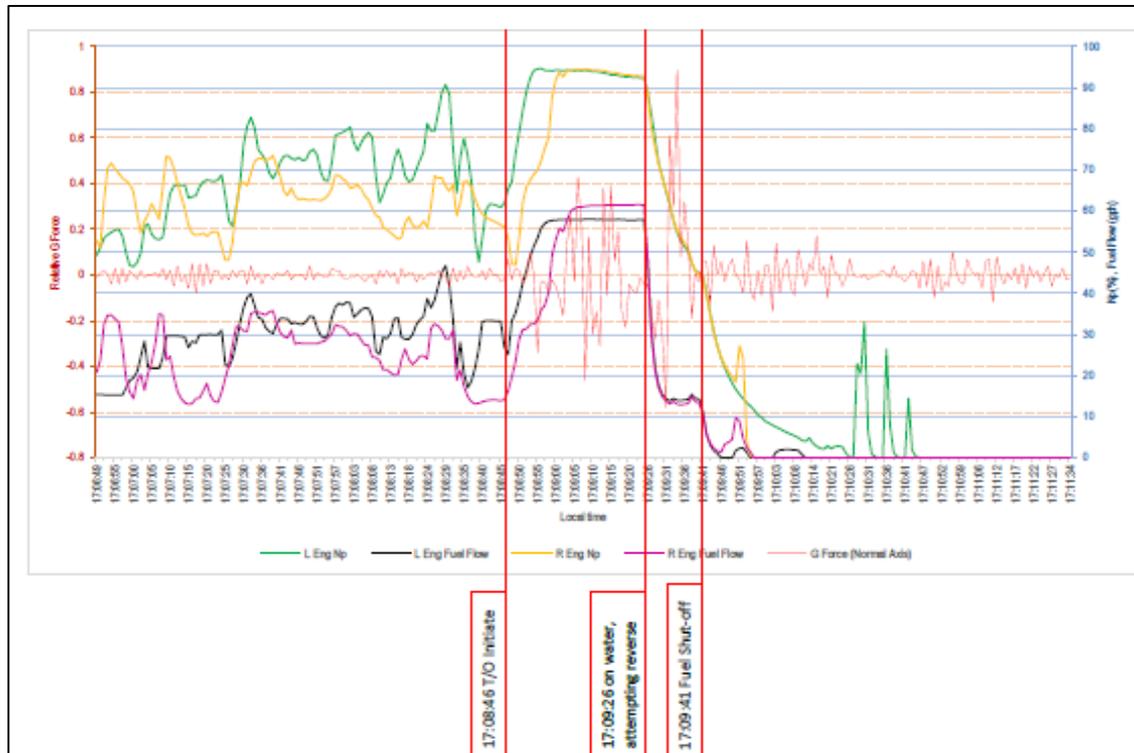
a. (Np, Fuel flow, G Force)

The PIC recalls that as soon as the aircraft was airborne, an unfavorable gust of wind caused the aircraft to settle back on water. The G950 data also indicated that, at around the same time, engine power on both engines was reduced to idle thus indicating the take-off was aborted at that point.
