AIRCRAFT SERIOUS INCIDENT REPORT 2020/02

**FINAL REPORT ON INVESTIGATION OF THE
SERIOUS INCIDENT INVOLVING CESSNA 172 RG AIRCRAFT, 8Q-GAD,
OPERATED BY ASIAN AVIATION ACADEMY
AT GAN INTERNATIONAL AIRPORT, MALDIVES,
ON 04 JANUARY 2020**

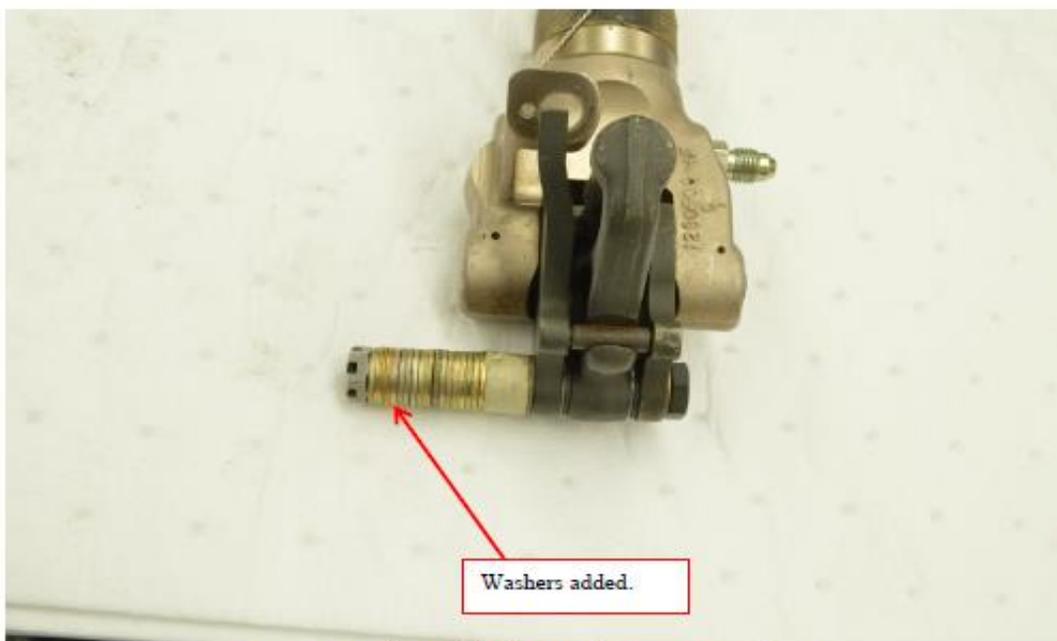
Figure 2 Washers Added to Simulate Gear Attachment

The actuator was attached to a hydraulic hand pump containing MIL-H-5606 hydraulic fluid. Washers were added to the lock mechanism/rod end through bolt to simulate attachment to NLG (Figure 2). Several washers were also repositioned per the installation drawing to provide the correct lock mechanism spacing.
