Republic of Maldives

SAFETY INVESTIGATION REPORT 2023/03

INVESTIGATION OF THE OCCURRENCE INVOLVING MANTA AIR OPERATED

DHC-6-200, 8Q-RAL FLOATPLANE WHILST LANDING

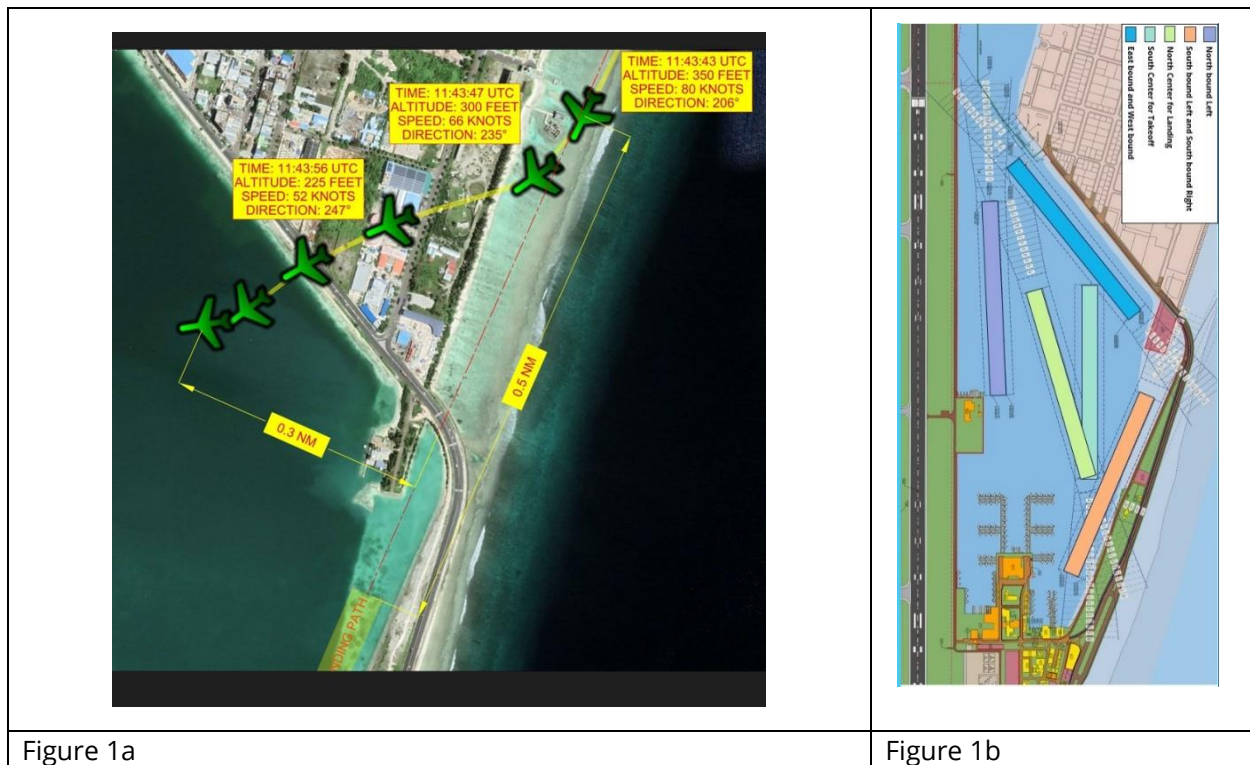
Figure 1a

The PIC stated that he was unable to even glance at the flight instruments or engine instruments since the aircraft was at a critically low altitude. When the crew regained control of the aircraft, the aircraft had veered to almost 60° to the right, and an imminent crash was feared. The PIC stated that an attempt was made to add power on the LH engine but was unable to move the lever as it was stuck and added that he felt both the power levers were stuck.
