SAFETY INVESTIGATION REPORT 2023/01

WING IMPACTED WATER DURING LANDING

VIKING AIR DHC-6-300 TWIN OTTER, 8Q-TAQ

VOMMULI WATER AERODROME

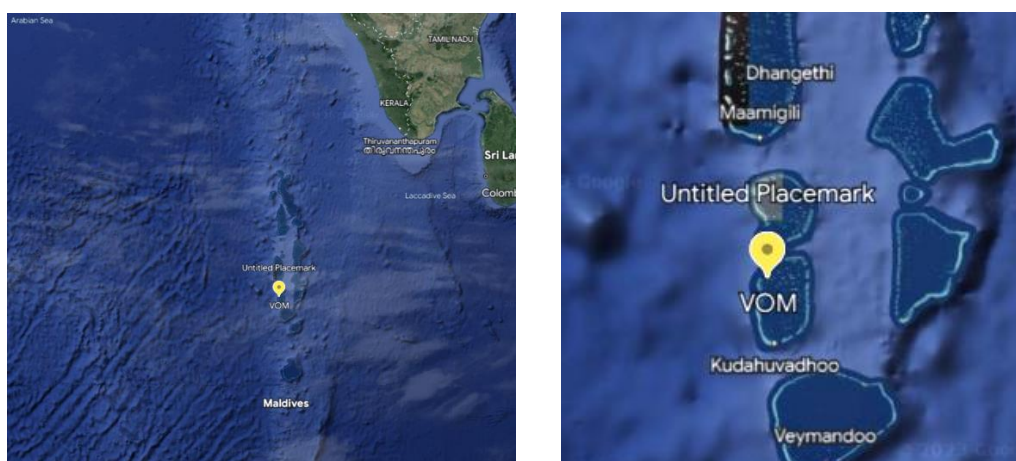
Fig 1(a) and 1 (b) – showing geographical location of Vommuli water aerodrome

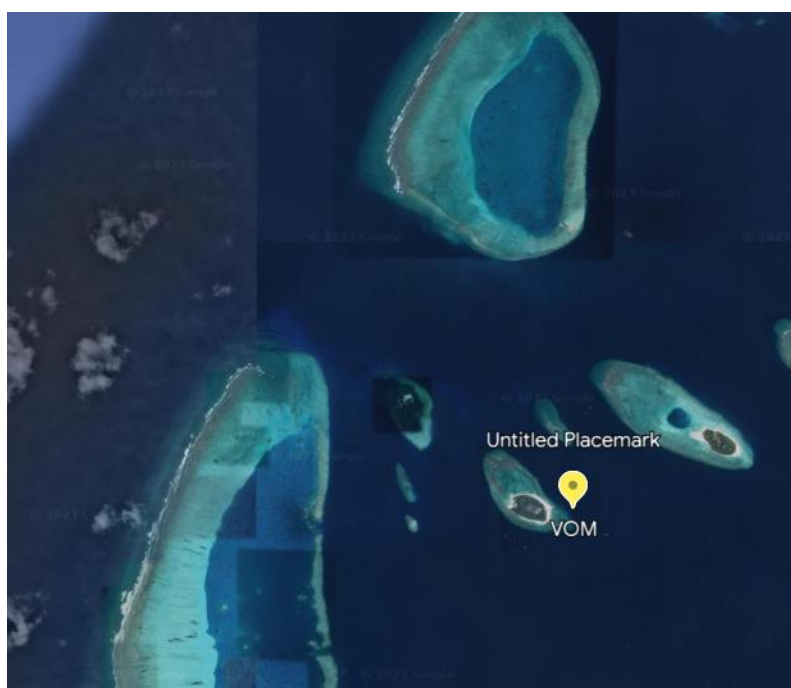
The surface conditions at both the landing areas at VOM have high swell patterns with long swell distances and these conditions exist throughout the year. About 4km to the northwest of the VOM, a 2km wide open channel exists, in between two lagoons, facing the ocean, on the western periphery / coastline of the atoll. Through this opening, high roller waves from the Arabian sea moves into the atoll with little or no restriction and passes through the VOM landing areas. These swells exist in both the designated landing areas. The waves are unpredictable and flows in multiple directions.

Fig 2: Vommuli water aerodrome

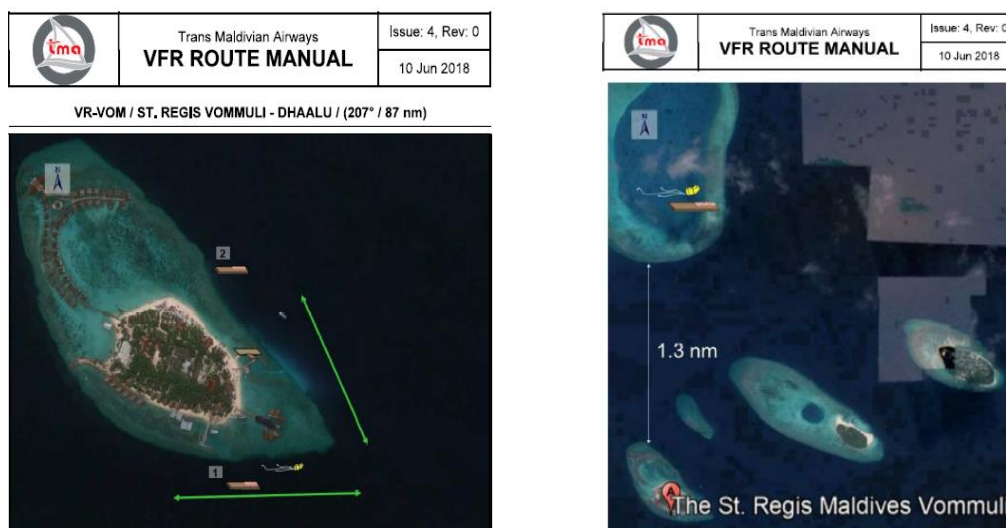
TMA categorizes VOM as a Category C aerodrome and TMA Operations Manual Part A, General, Issue 2, Rev 9, dated 20 Oct 2022, under 8.1.2.3 covers Aerodrome categories – Water. Under sub-section C, Category C Aerodrome conditions are defined, which includes, those aerodromes deemed challenging in all weather conditions.

Fig 3(a) and 3(b): Vommuli water aerodrome chart from TMA VFR route manual

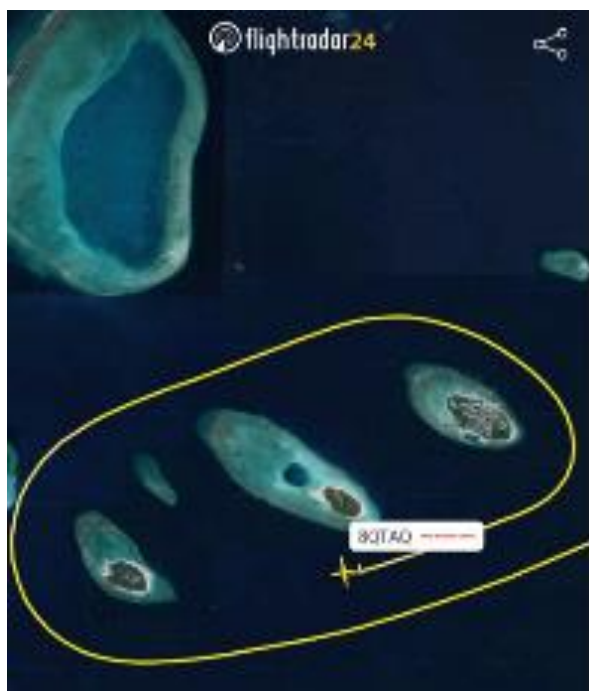
The accident sector was flown by a qualified FO, but having limited experience in landing under the prevailing water conditions. The PIC (a Line Training Instructor) stated that both crews discussed and selected the most suitable landing line which was towards the edge of the Vommuli island reef. As required by the procedures in the TMA Operations Manual, Part A, the aircraft performed a flyover inspection (Fig. 4) to assess the aerodrome surface conditions prior to landing.

Fig 4: Aircraft flyover path captured from FlightRadar24.com (Image used with permission)
